# Arboricultural Consultancy for HBOS

| <b>Insured</b> | Mrs C Watson | <b>Address</b> | 31 Hollybank Road, Emsworth, West Sussex, PO10 7UE | | |
| <b>Client</b> | Lloyds Banking Group | <b>Contact</b> | David Elliot | <b>Claim No.</b> | 101431391 |

**31 Hollybank Road, W. Sussex, PO10 7UE**

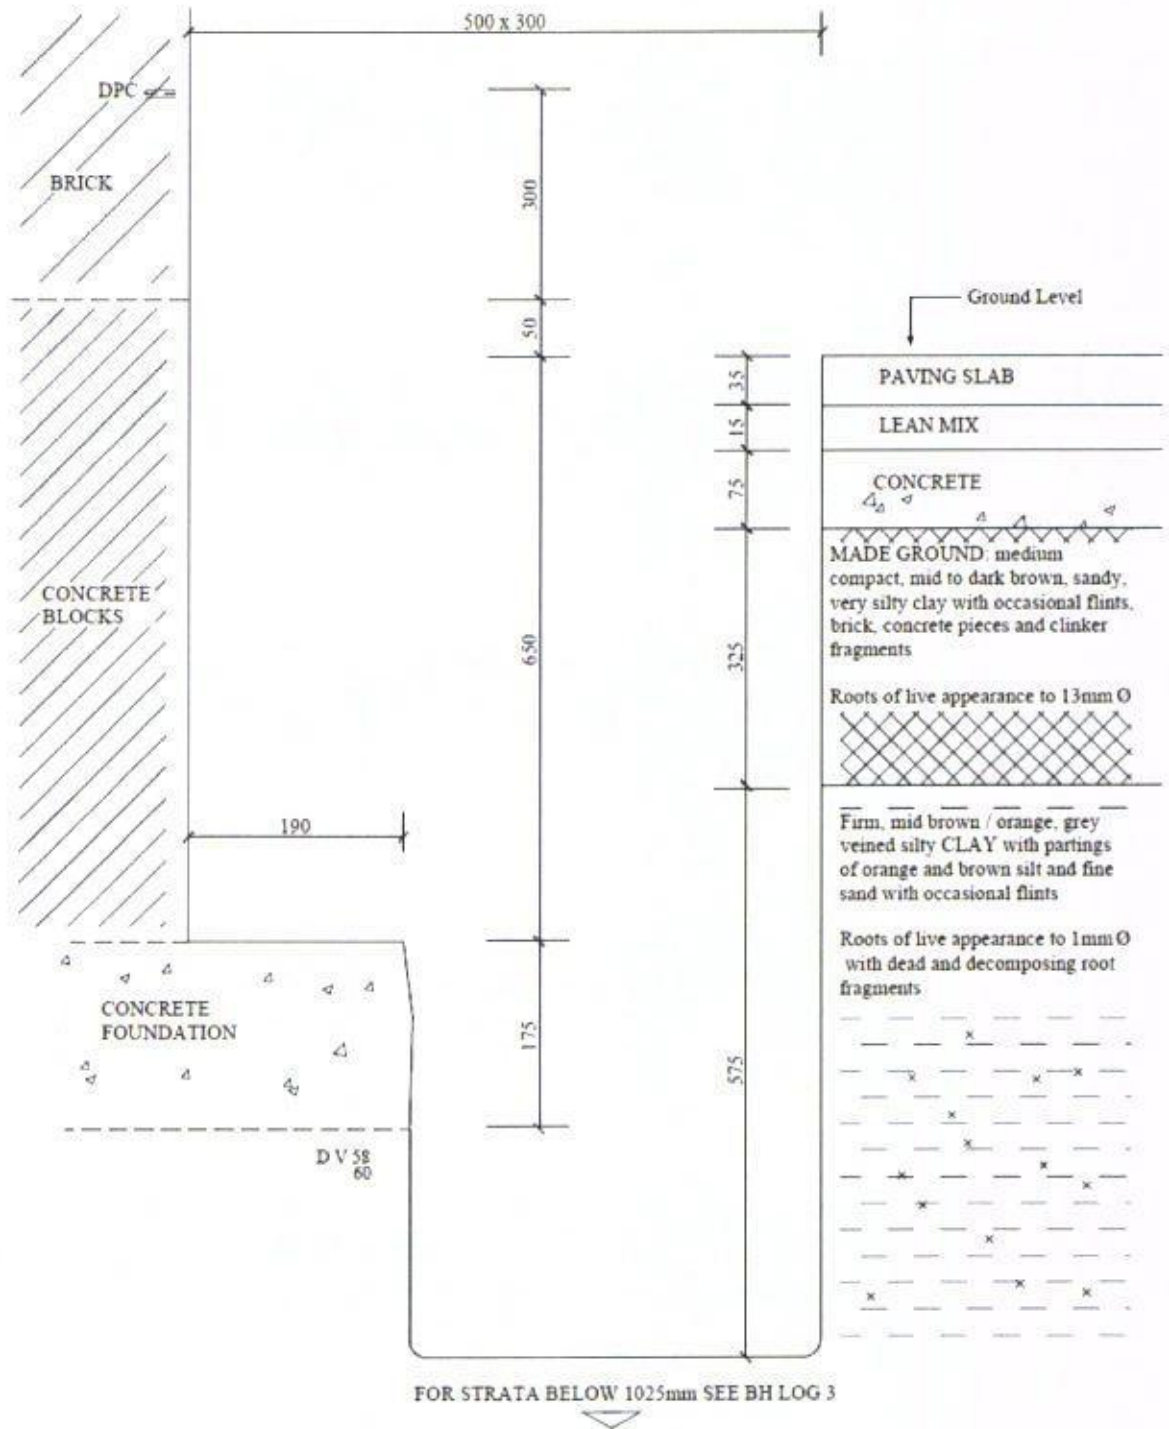
# TP/BH3 Foundation Detail

| Depth (m) | Description of Strata | Thickness (m) | Legend | Sample | Test Type | Result | Depth (m) | Field Records/Comments | Depth to water (m) |
|---|---|---|---|---|---|---|---|---|---|
| GL | Turf over MADE GROUND: medium compact, mid to dark brown, sandy, very silty, gravelly clay with occasional flints and brick, concrete and clinker fragments | 0.20 | | | | | | No roots observed | |

| Depth (m) | Description of Strata | Thickness (m) | Legend | Sample | Type | Test Result | Depth (m) | Field Records/Comments | Depth to water (m) |
|---|---|---|---|---|---|---|---|---|---|
| | Very stiff, moist as above | 1.00 | — x<br>—<br>—<br>x —<br>—<br>—<br>— x | D | | | 5.50 | | |

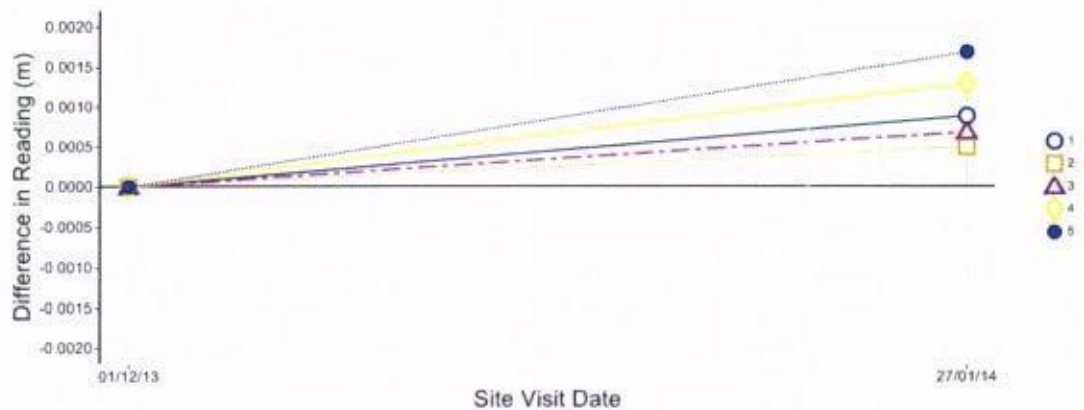
## Level Monitoring Difference Graphs

The following graphs display the progressive movement that each Level Monitoring Station recorded at each separate site visit date to give an overall look at how much the property is moving.

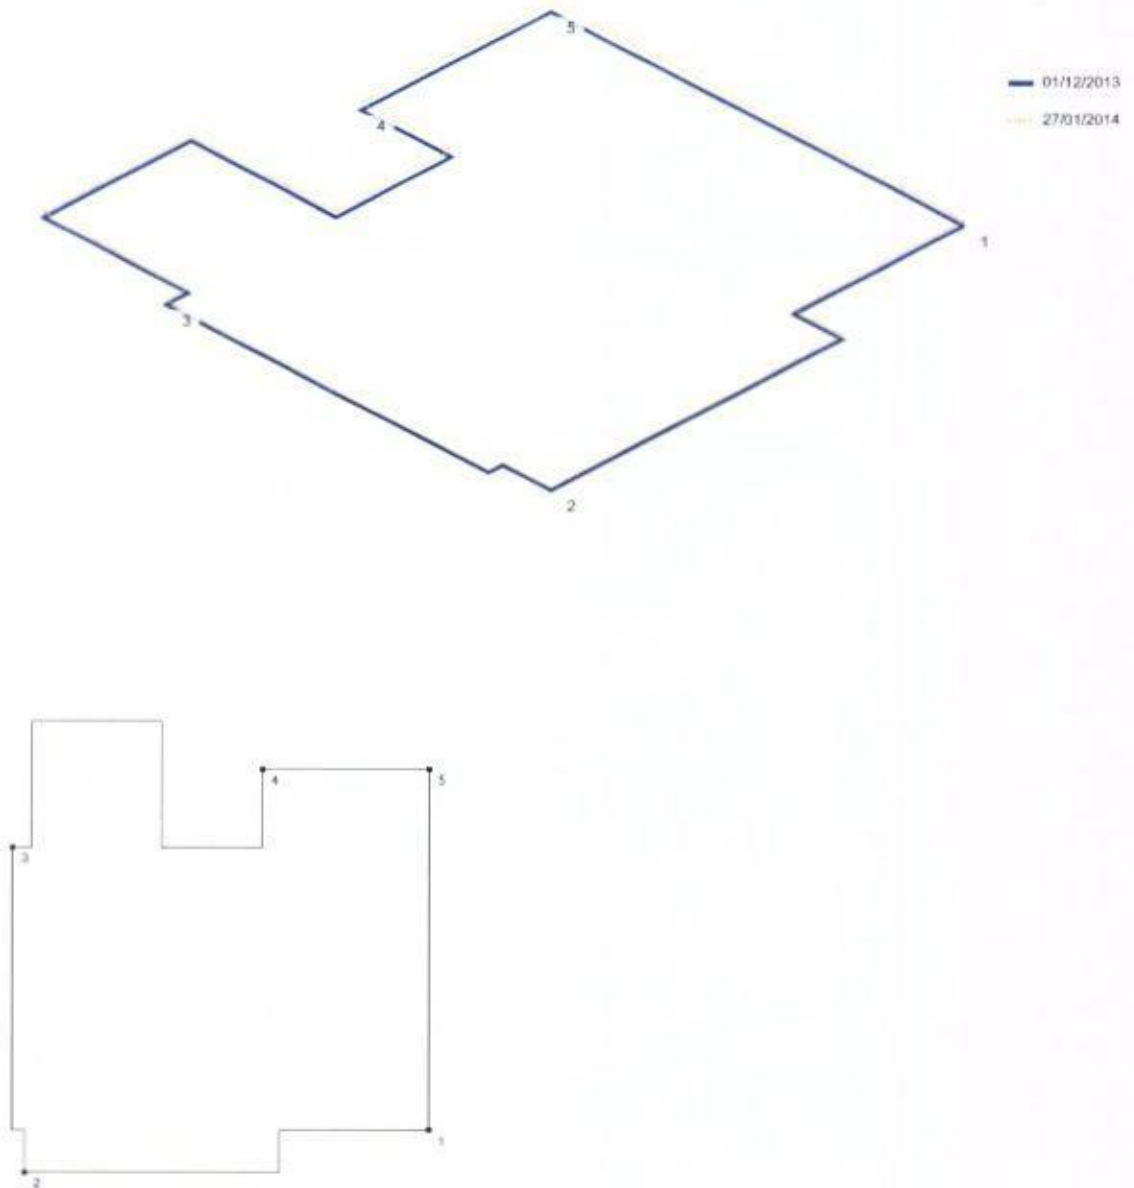
## Level Monitoring Displacement Map

The following image shows an isometric representation of the movement of the property, based on the Level Monitoring Stations that were installed.
