# Arboricultural Consultancy for HBOS

| <b>Insured</b> | Mrs C Watson | <b>Address</b> | 31 Hollybank Road, Emsworth, West Sussex, PO10 7UE | | |
| <b>Client</b> | Lloyds Banking Group | <b>Contact</b> | David Elliot | <b>Claim No.</b> | 101431391 |
| <b>Report Date</b> | 22/11/2013 | | | | |

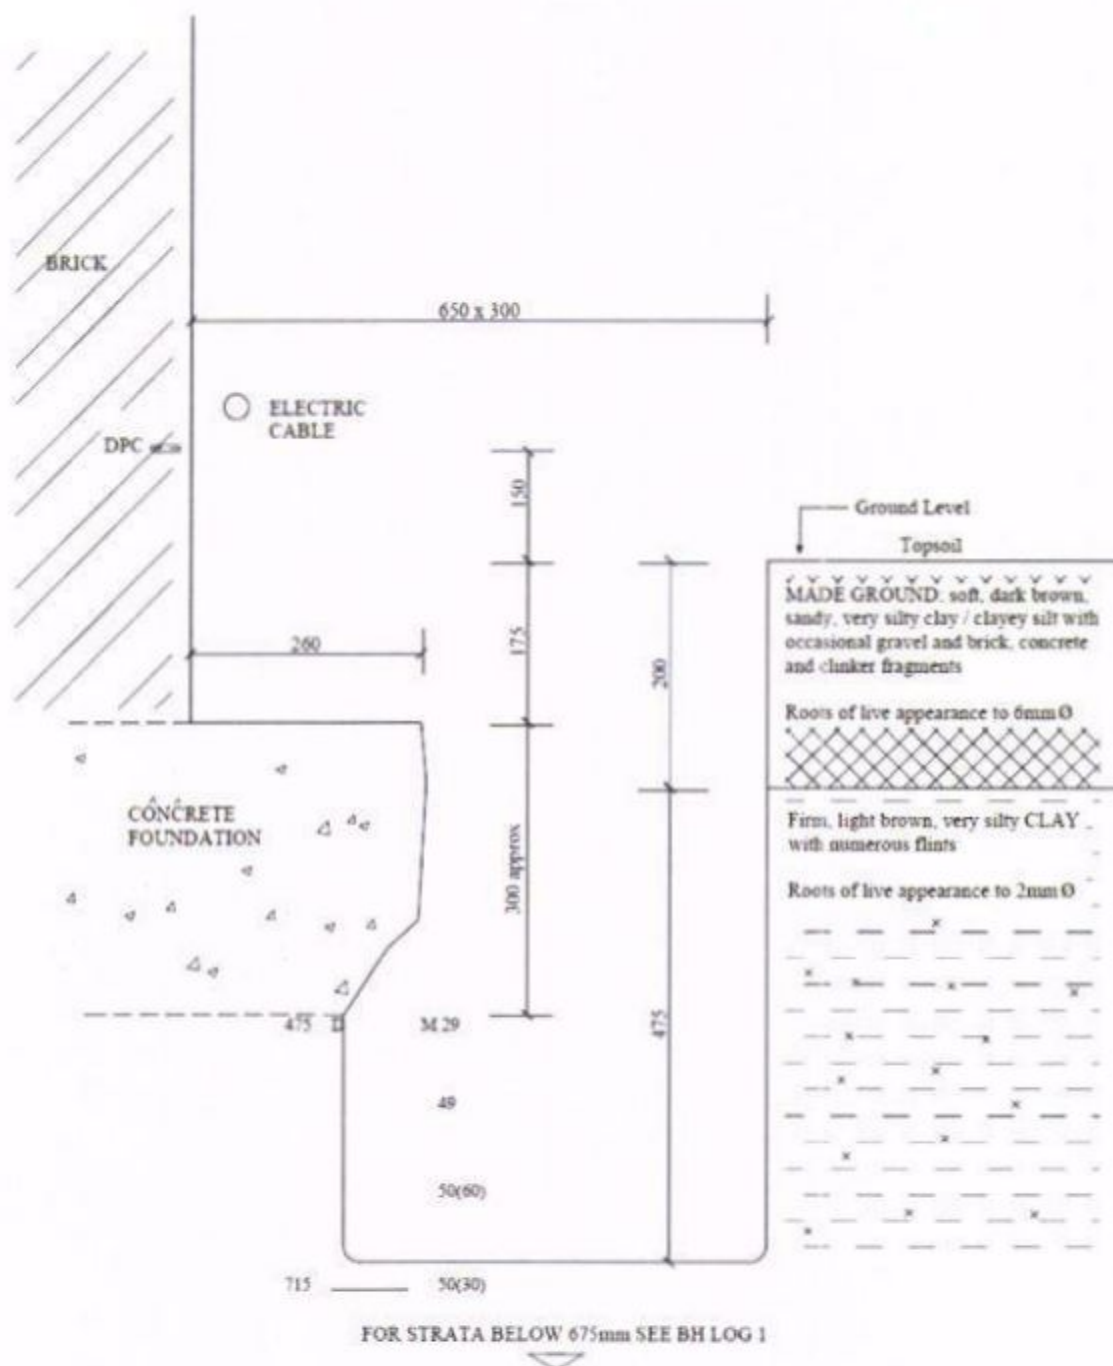
TP/BH1 Foundation Detail

| Depth<br>(m) | Description of Strata | Thick-<br>ness<br>(m) | Legend | Sample | Type | Test Result | Depth<br>(m) | Field Records/Comments | Depth<br>to water<br>(m) |
|---|---|---|---|---|---|---|---|---|---|
| | Very stiff, mid brown / orange, grey veined silty CLAY with partings of orange and brown silt and fine sand with occasional gravel, flint fragments and stone nodules | 1.70 | x _<br>_<br>_<br>_ x<br>_<br>_ x<br>_<br>_<br>_ | D | | | 2.50 | No roots observed below 2.2m | |

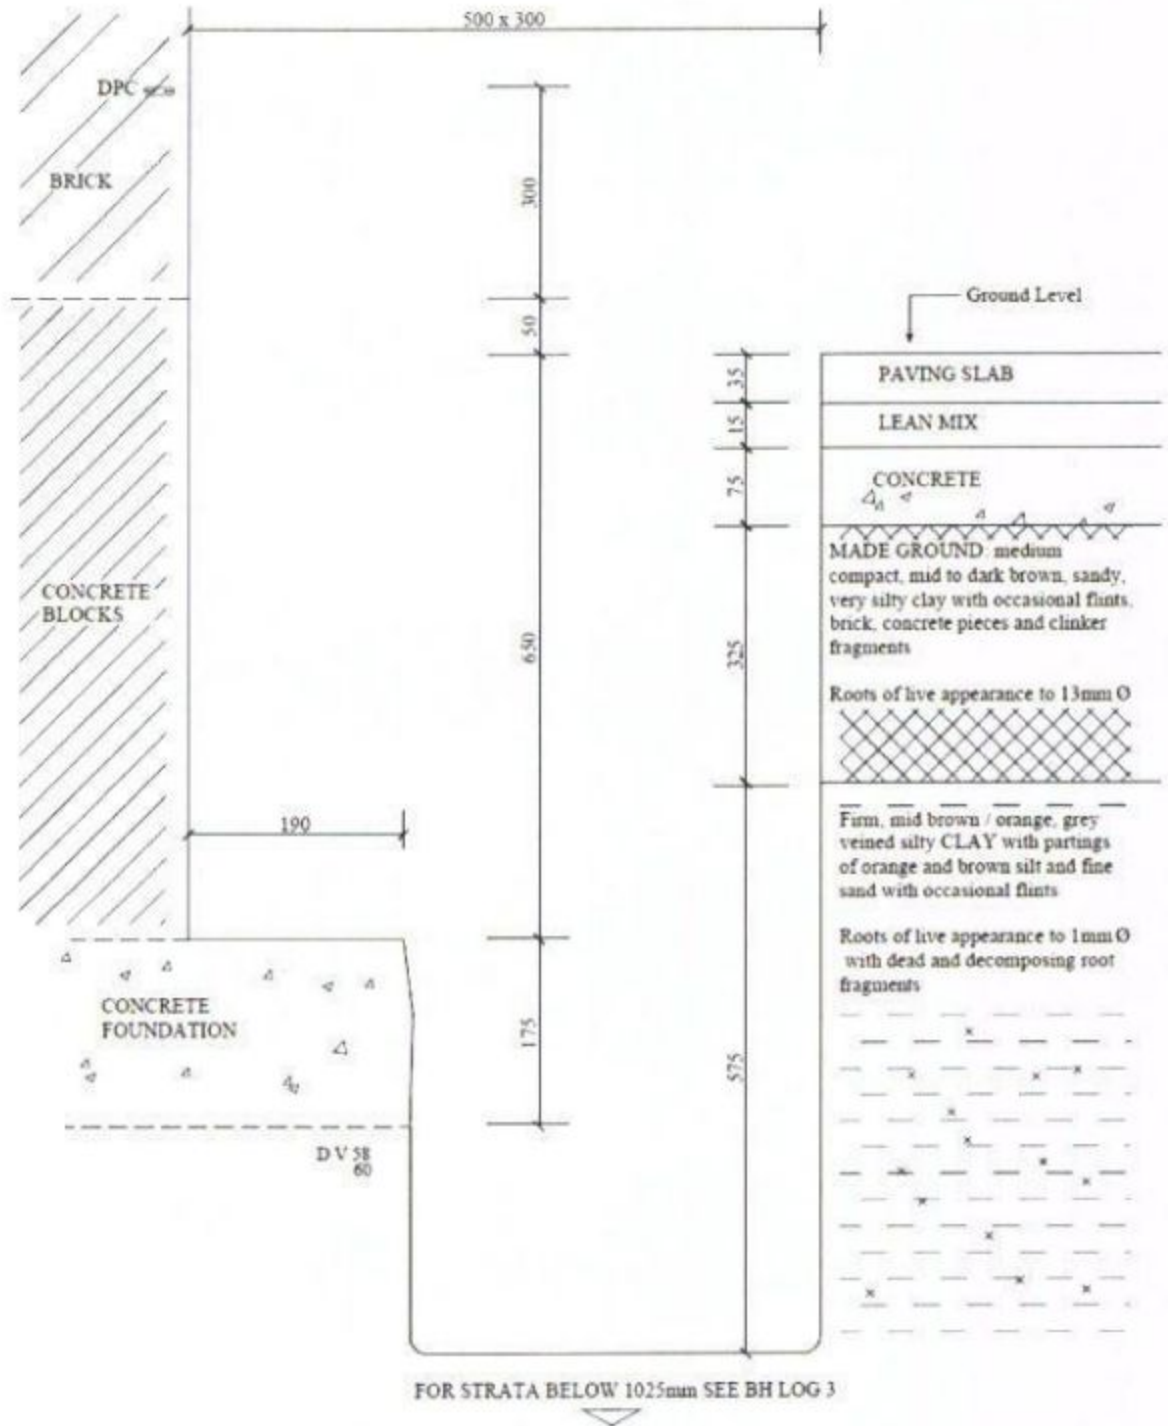
TP/BH3 Foundation Detail

| Depth (m) | Description of Strata | Thickness (m) | Legend | Sample | Test Type | Result | Depth (m) | Field Records/Comments | Depth to water (m) |
|---|---|---|---|---|---|---|---|---|---|
| GL | Turf over MADE GROUND: medium compact, mid to dark brown, sandy, very silty, gravelly clay with occasional flints and brick, concrete and clinker fragments | 0.20 | | | | | | No roots observed | |

| Depth<br>(m) | Description of Strata | Thick-<br>ness<br>(m) | Legend | Sample | Type | Test Result | Depth<br>(m) | Field Records/Comments | Depth<br>to water<br>(m) |
|---|---|---|---|---|---|---|---|---|---|
| 6.00 | Very stiff, moist as above | 1.00 | ___ x<br>_____<br>_____<br>_____x | D | | | 5.50 | | |

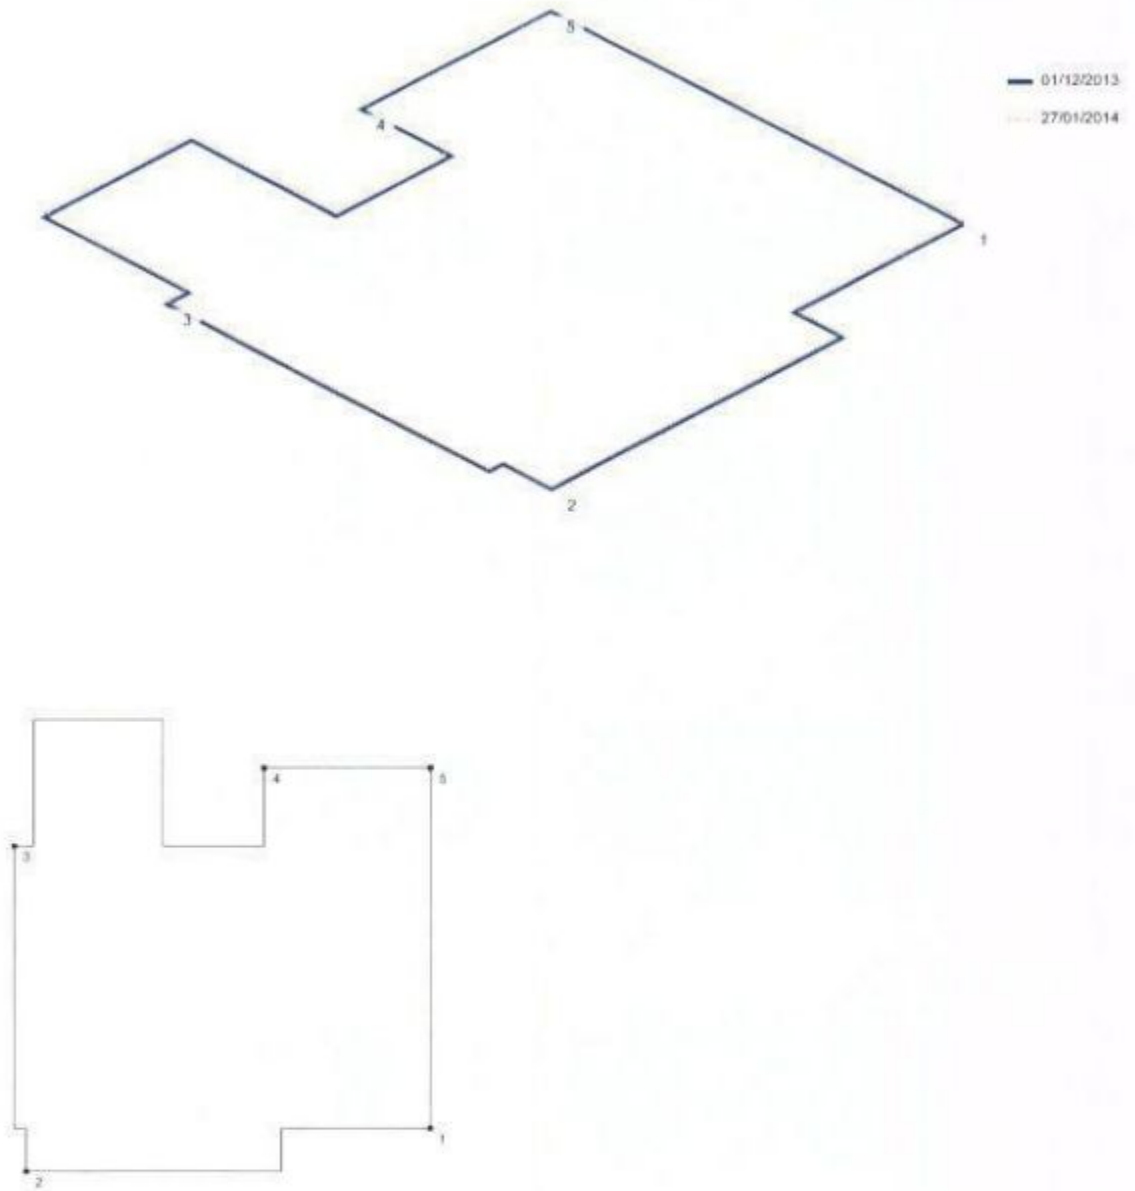
## Level Monitoring Displacement Map

The following image shows an isometric representation of the movement of the property, based on the Level Monitoring Stations that were installed.
