# Revisit Report

| Claim address | 22 Oakmont Drive,<br>Waterlooville,<br>Hampshire,<br>PO8 8TH |

## **Subsidence Report**

# PRELIMINARY REPORT

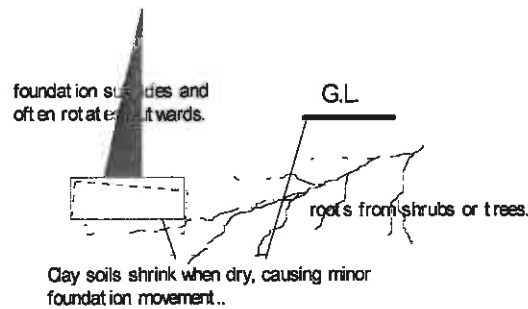
Properties in clay areas typically suffer from subsidence as a result of dry weather conditions compounded by moisture extraction from vegetation. During these conditions, clay will lose its moisture through evaporation. As the clay dries it shrinks. The degree of shrinkage from dry weather is generally not sufficient to cause structural damage unless the foundations are particularly shallow. Usually subsidence damage is the result of vegetation, especially trees, extracting even more moisture from deep within the ground within its' zone of influence.

There is a direct correlation between the moisture uptake of vegetation and its leaf canopy. Reducing the leaf canopy will reduce the water demand of the vegetation. If the vegetation is removed entirely, so the water demand is removed.

When removing vegetation, particularly established broad leaf trees, consideration must be given to heave. Heave occurs where the clay soil expands as the moisture returns. Structural damage can occur as the property suffers from extreme upward movement.

In the majority of cases vegetation works will be sufficient to allow superstructure repairs alone. However, in exceptional cases this may not be sufficient and underpinning may have to be used in order to arrest the movement.

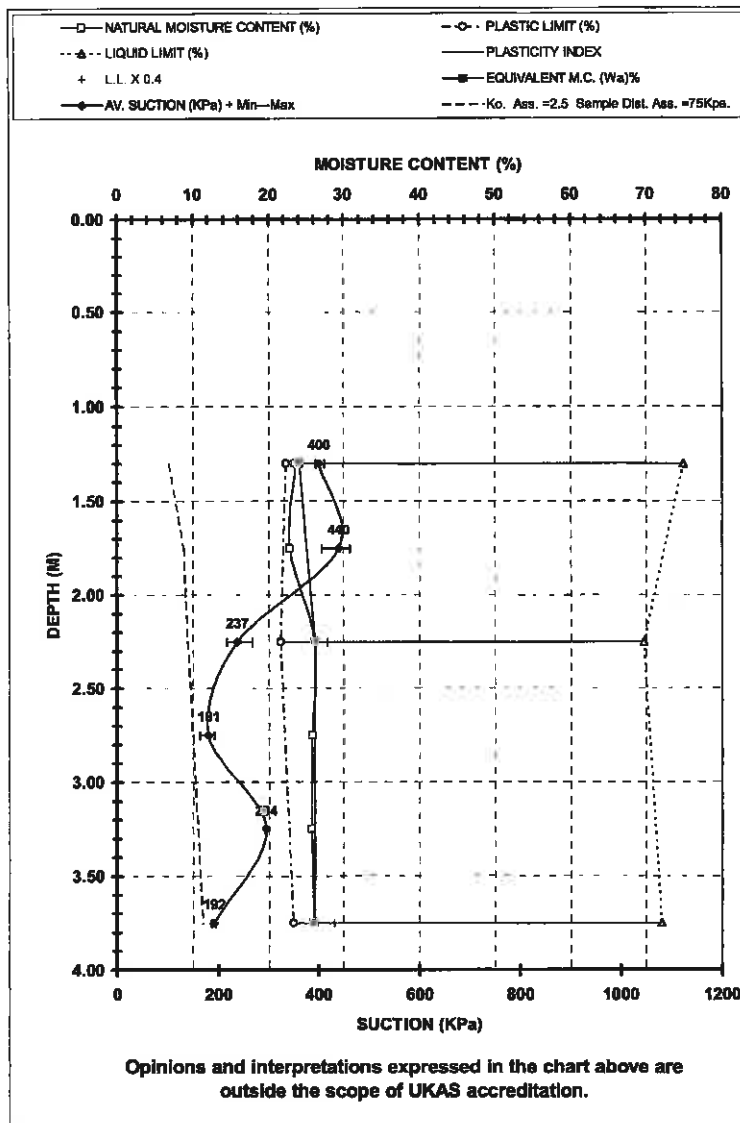
| DEPTH. | M.C. | L.L. | P.L. | P.I. | 425um | AV. Filter Paper | dh | BRIEF SOIL DESCRIPTION |
|---|---|---|---|---|---|---|---|---|
| 3.75 | 26 | 72 | 23 | 49 | 100 | 41.1106 (3) | 2.2 | Firm/stiff brown CLAY with occasional light grey veinings, rare sand & fine gravel. |

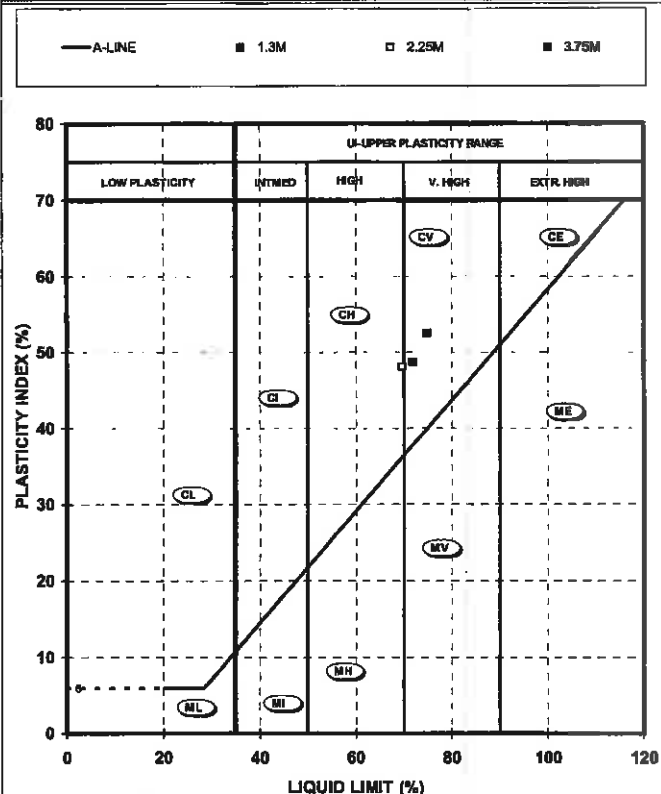
**Heave Potential Analysis :-****Total of Column dh (potential heave increment per layer)**

BRE Digest 412 Feb 1996 'Using Suction Profiles'

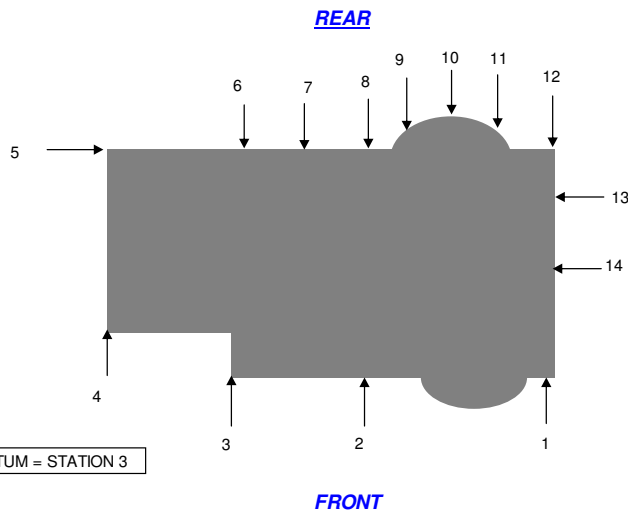
- 22/02/2012  
The Occupier was not unduly worried
- All stations have been installed within the same brick course. There fore initial readings can be interpreted as Distortion Data
- Further readings will be taken in Apr '12

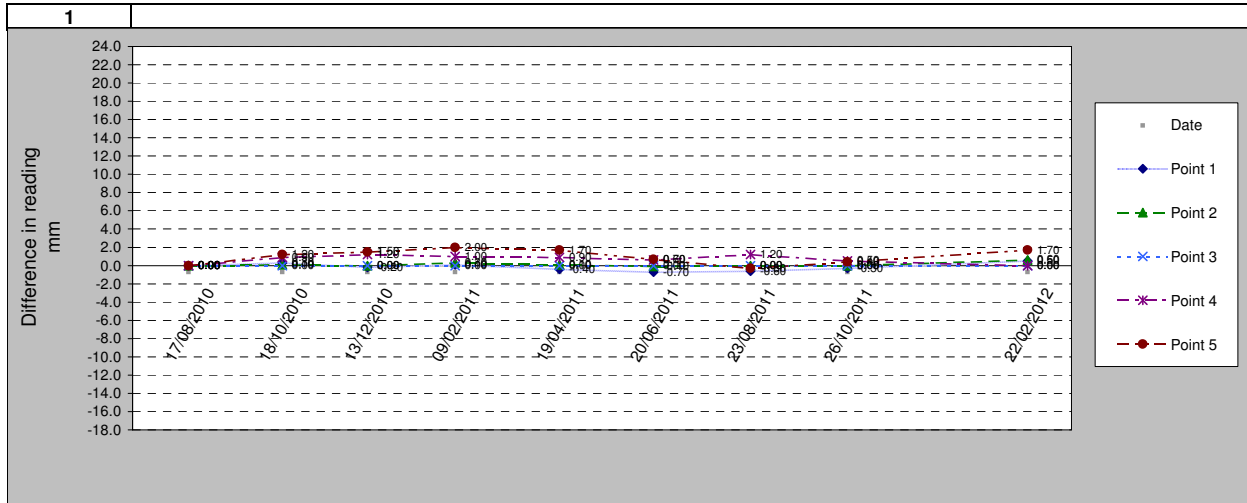
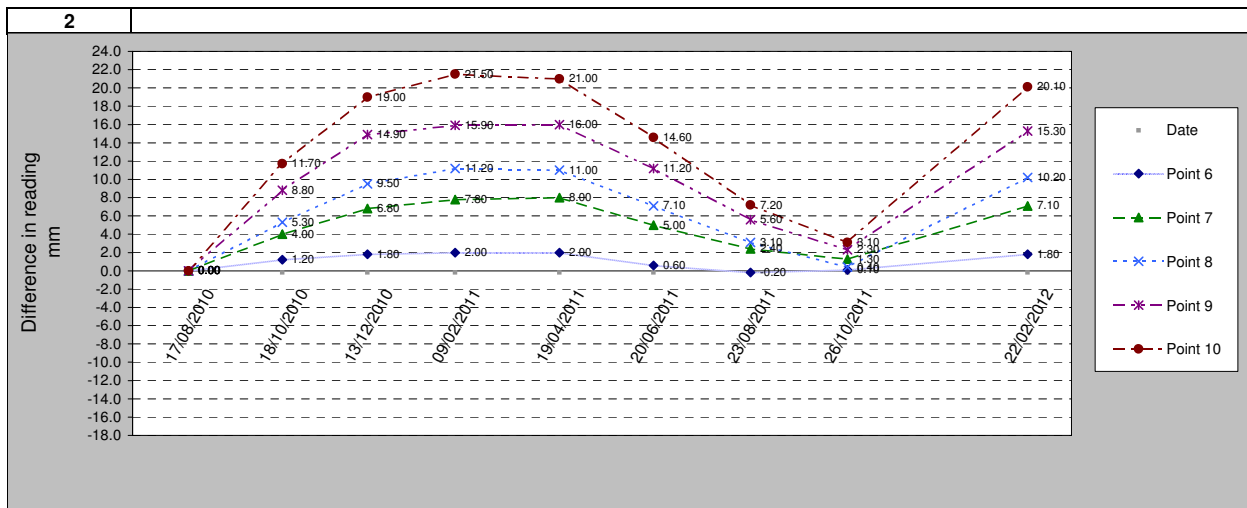
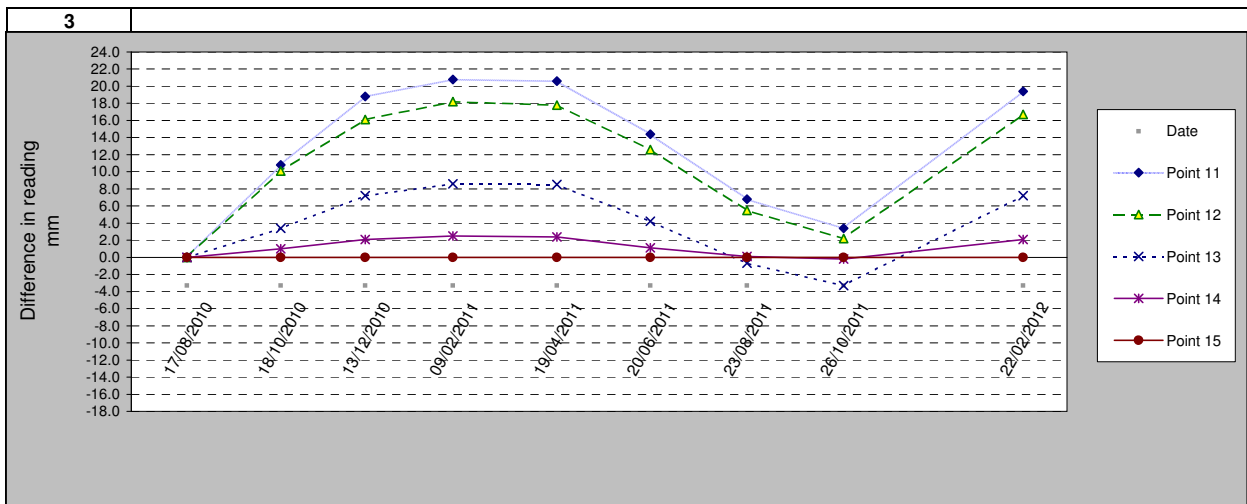
# LEVEL MONITORING - DISTORTION MOVEMENT SKETCH

Point labels give level difference of last reading from original datum in mm.
