# Arboricultural Consultancy for Groupama

| Insured | Mr & Mrs Gruchy | Address | 5 Hitherwood Close, Waterloooville, PO7 8SA | | |

**Scope of Report:** To survey the property and determine significant vegetation contributing to subsidence damage, make recommendation for remedial action, initiate mitigation action and assess recovery prospects. The survey does not make an assessment for decay or hazard evaluation.

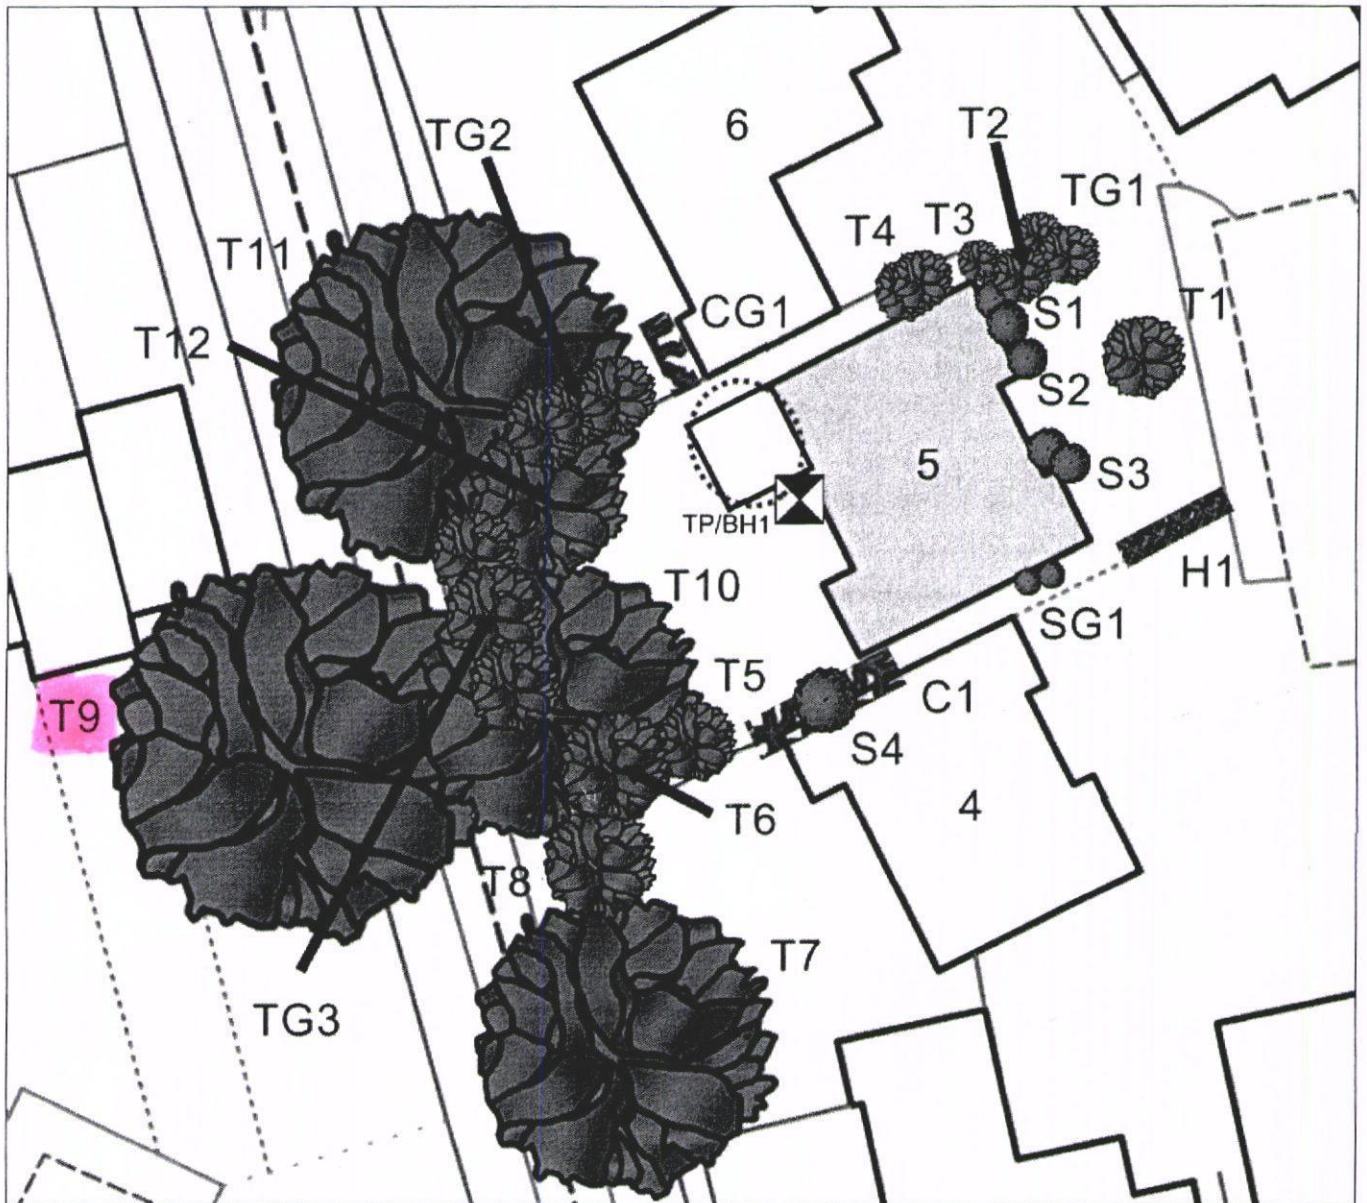
## 7. Site Plan

Based on our site inspection and investigations undertaken by engineers, and taking account of vegetation location, relative to the focal area of damage, it is our opinion that T11 (Oak) will be exerting the principal vegetative influence to the rear extension. It is also our opinion that T9 (Oak), T12 (Willow (Contorted)) and TG2 (Mixed Species Group) are considered to be contributory factors in the damage.
