Our Ref. 2844

Re: **86 West Street, Havant, Hampshire.**  
**Existing Front South Elevation.**

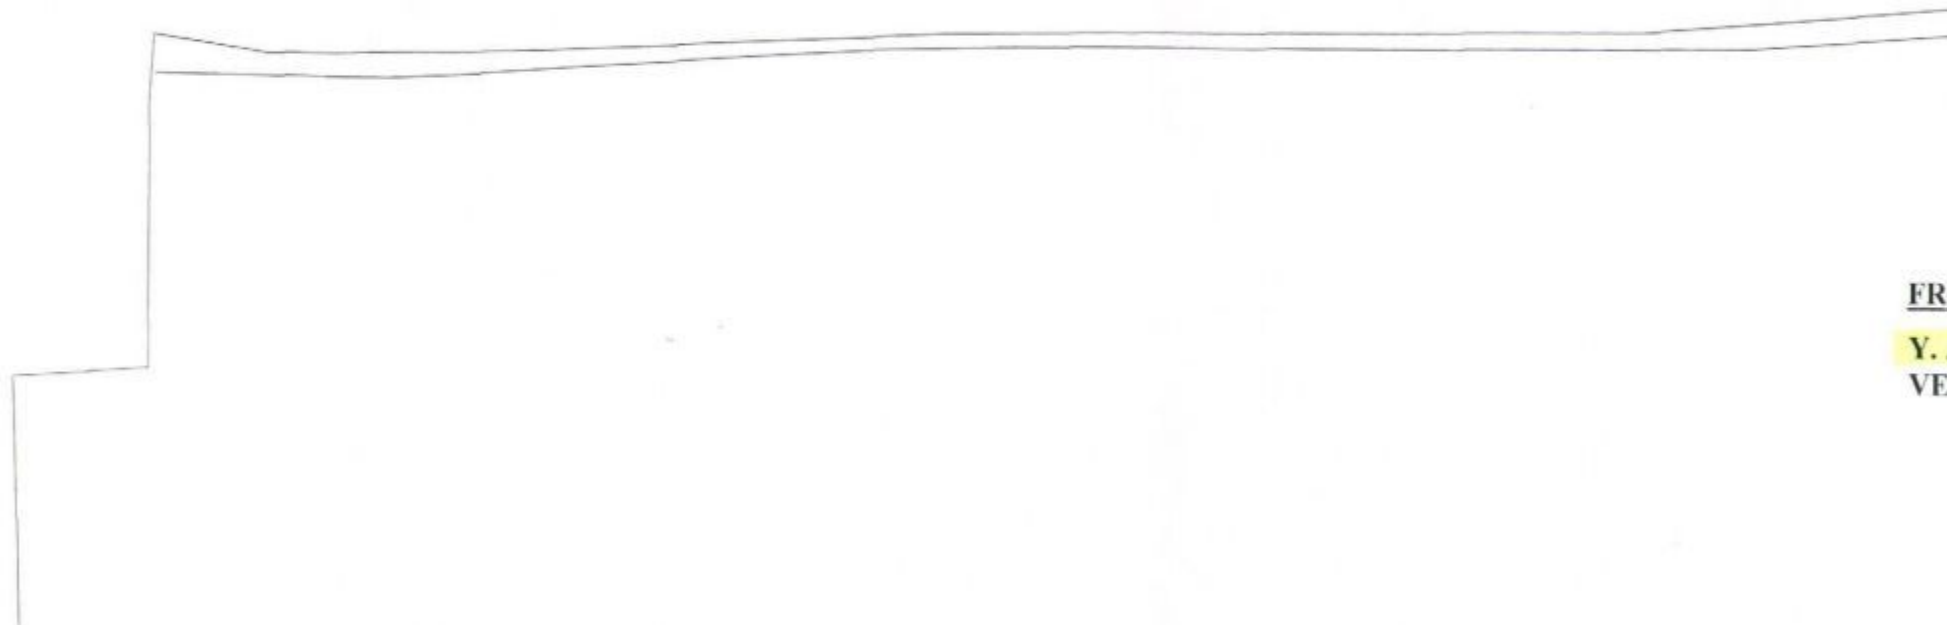
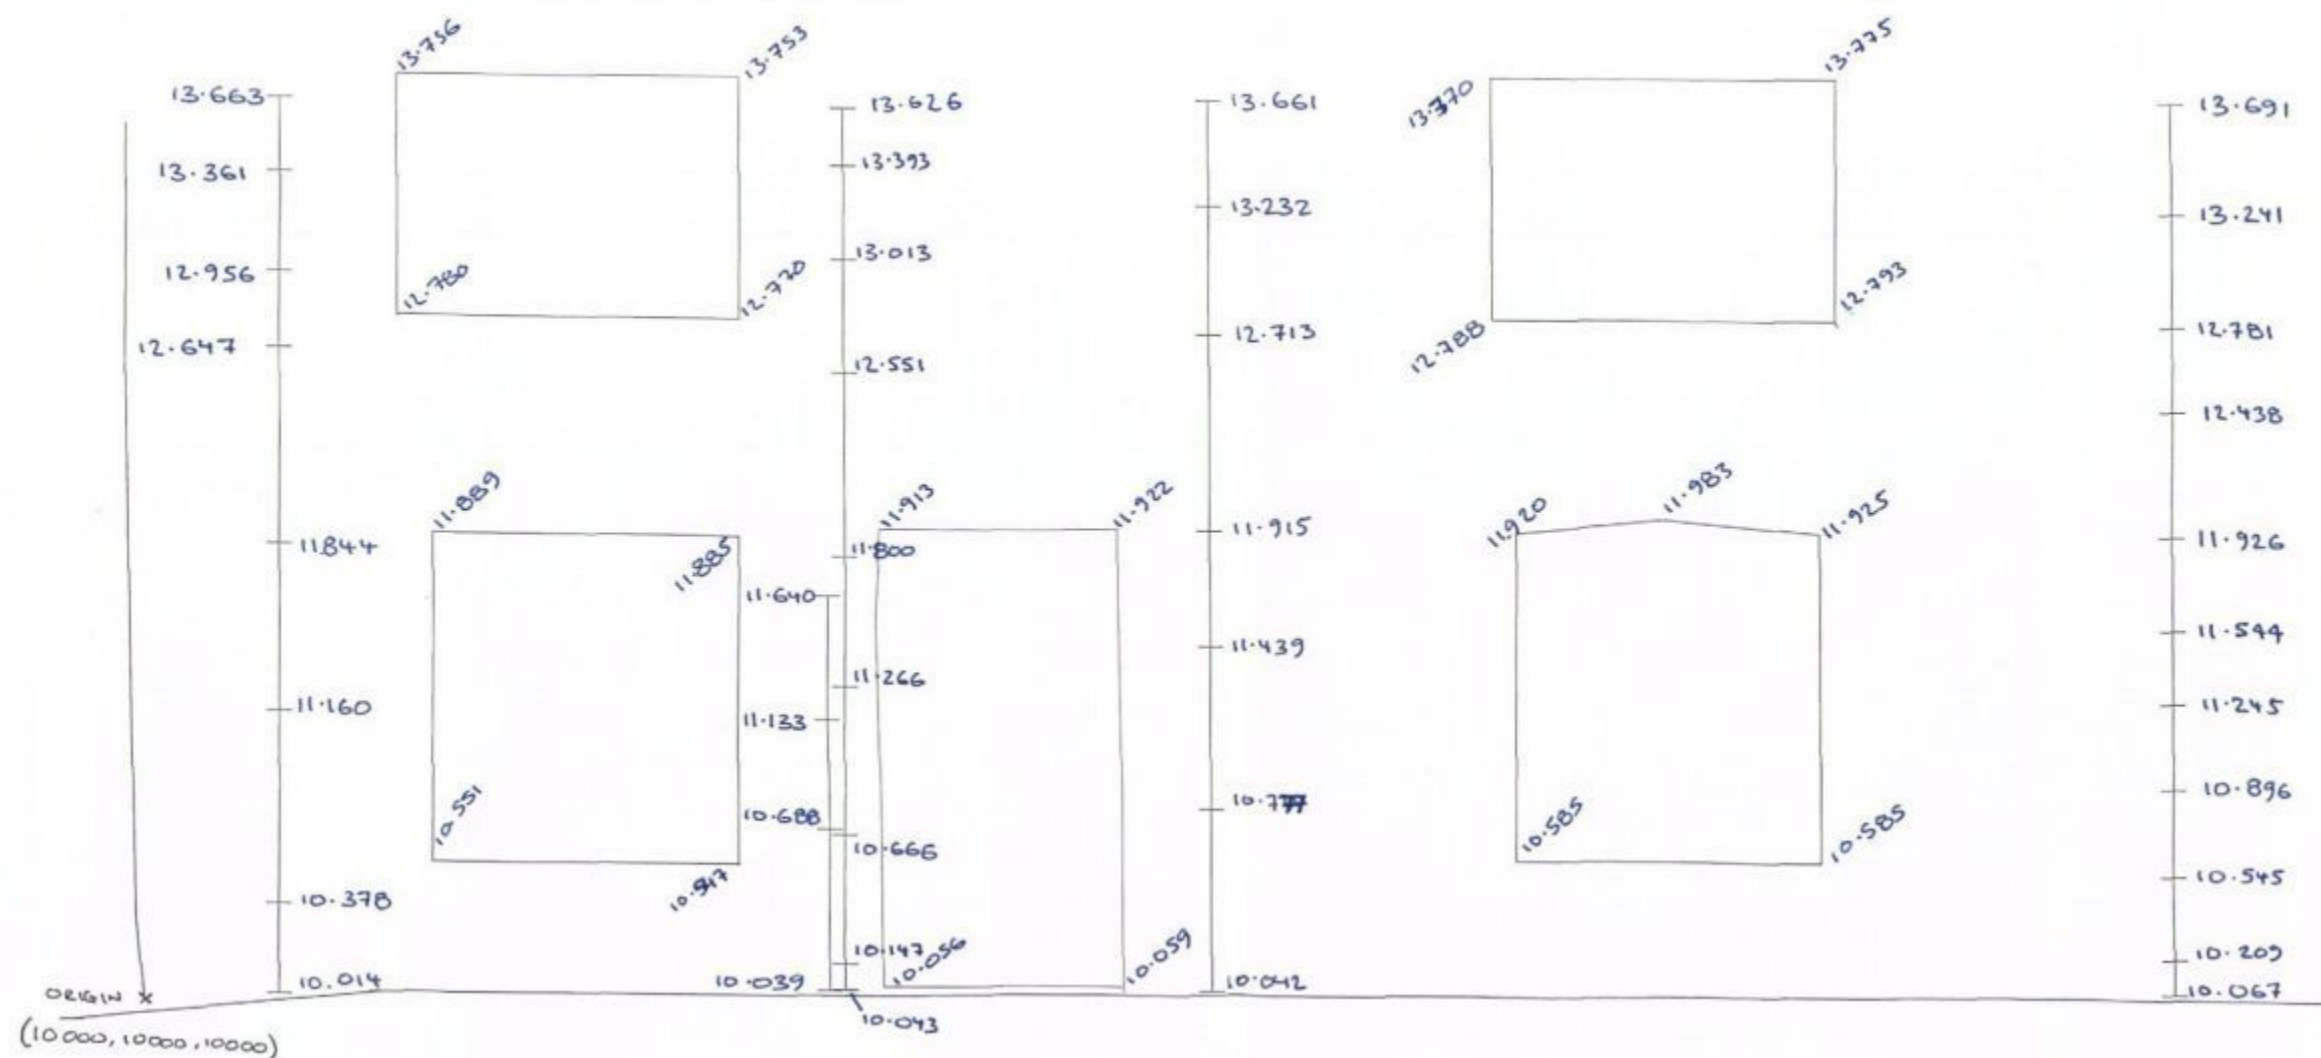
Y. AXIS. EXTERNAL  
VERTICAL DISTORTION

The external distortion over the height in relation to the base of the wall is at its worst at the west, varying from 44mm at the east to 86mm at the western window-head externally and 93mm at plate level, internally at a similar location.
