**FIRST STAGE APPRAISAL**

**86 WEST STREET  
HAVANT  
HAMPSHIRE  
PO9 1LN**

**Job No: 2844**

**Date: 6<sup>th</sup> August 2009**

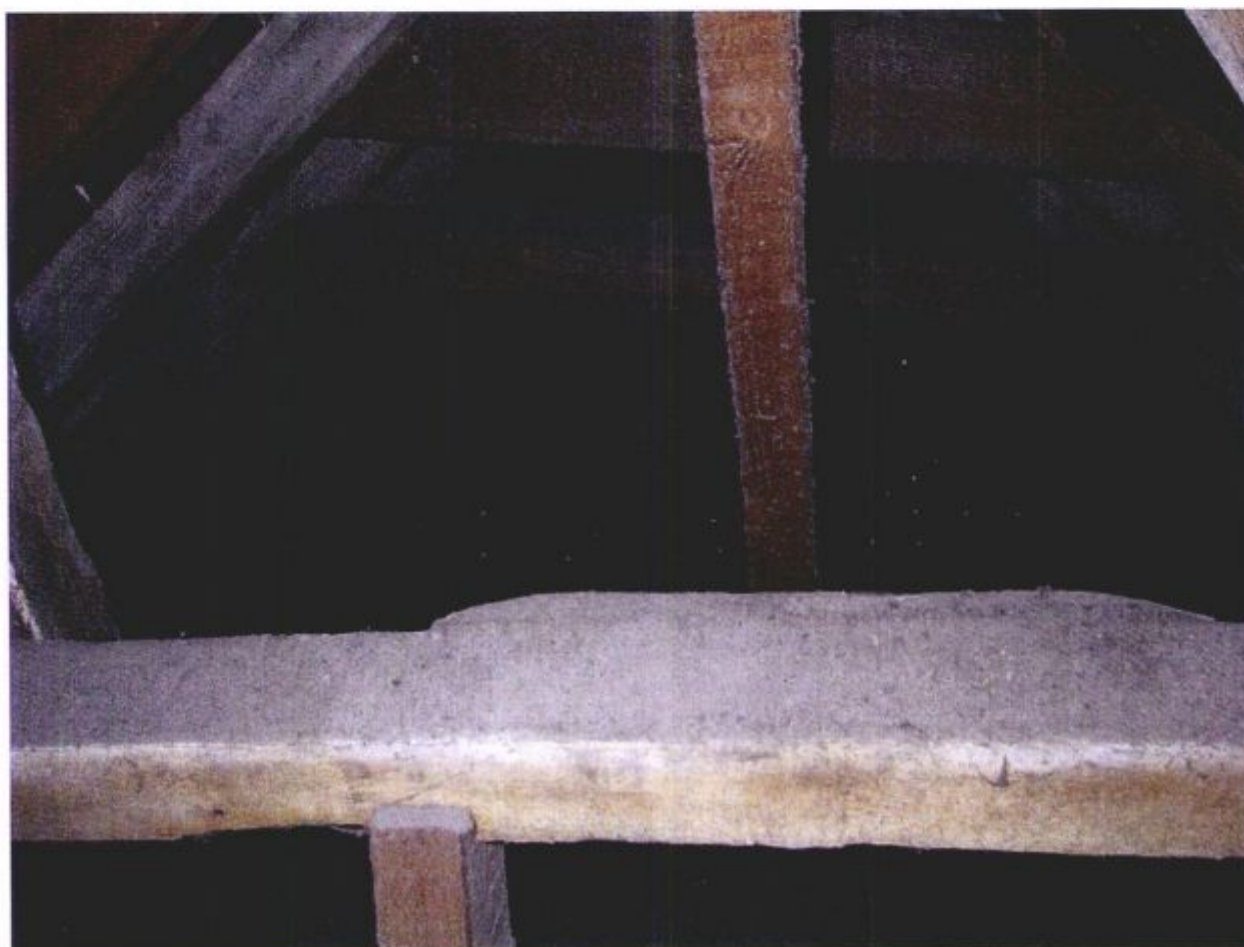
- The front purlin is broken at mid-span and has been diagonally struttled, although there appears to be no loadbearing element below the strut.
- The rear pitch has 2 No. intermediate purlins, both of which are broken at mid-span. (See Photos 014 & 017.)

**Photo 014 – S.W. Roof Space. Rear Pitch. Broken Lower Purlin.**
