**SECOND STAGE APPRAISAL**

**ADDENDUM TO FIRST STAGE APPRAISAL 2844**

**86 WEST STREET**

**Job No: 2844**  
**Dated: 5<sup>th</sup> November 2009**  
**Revised: 30<sup>th</sup> November 2009**

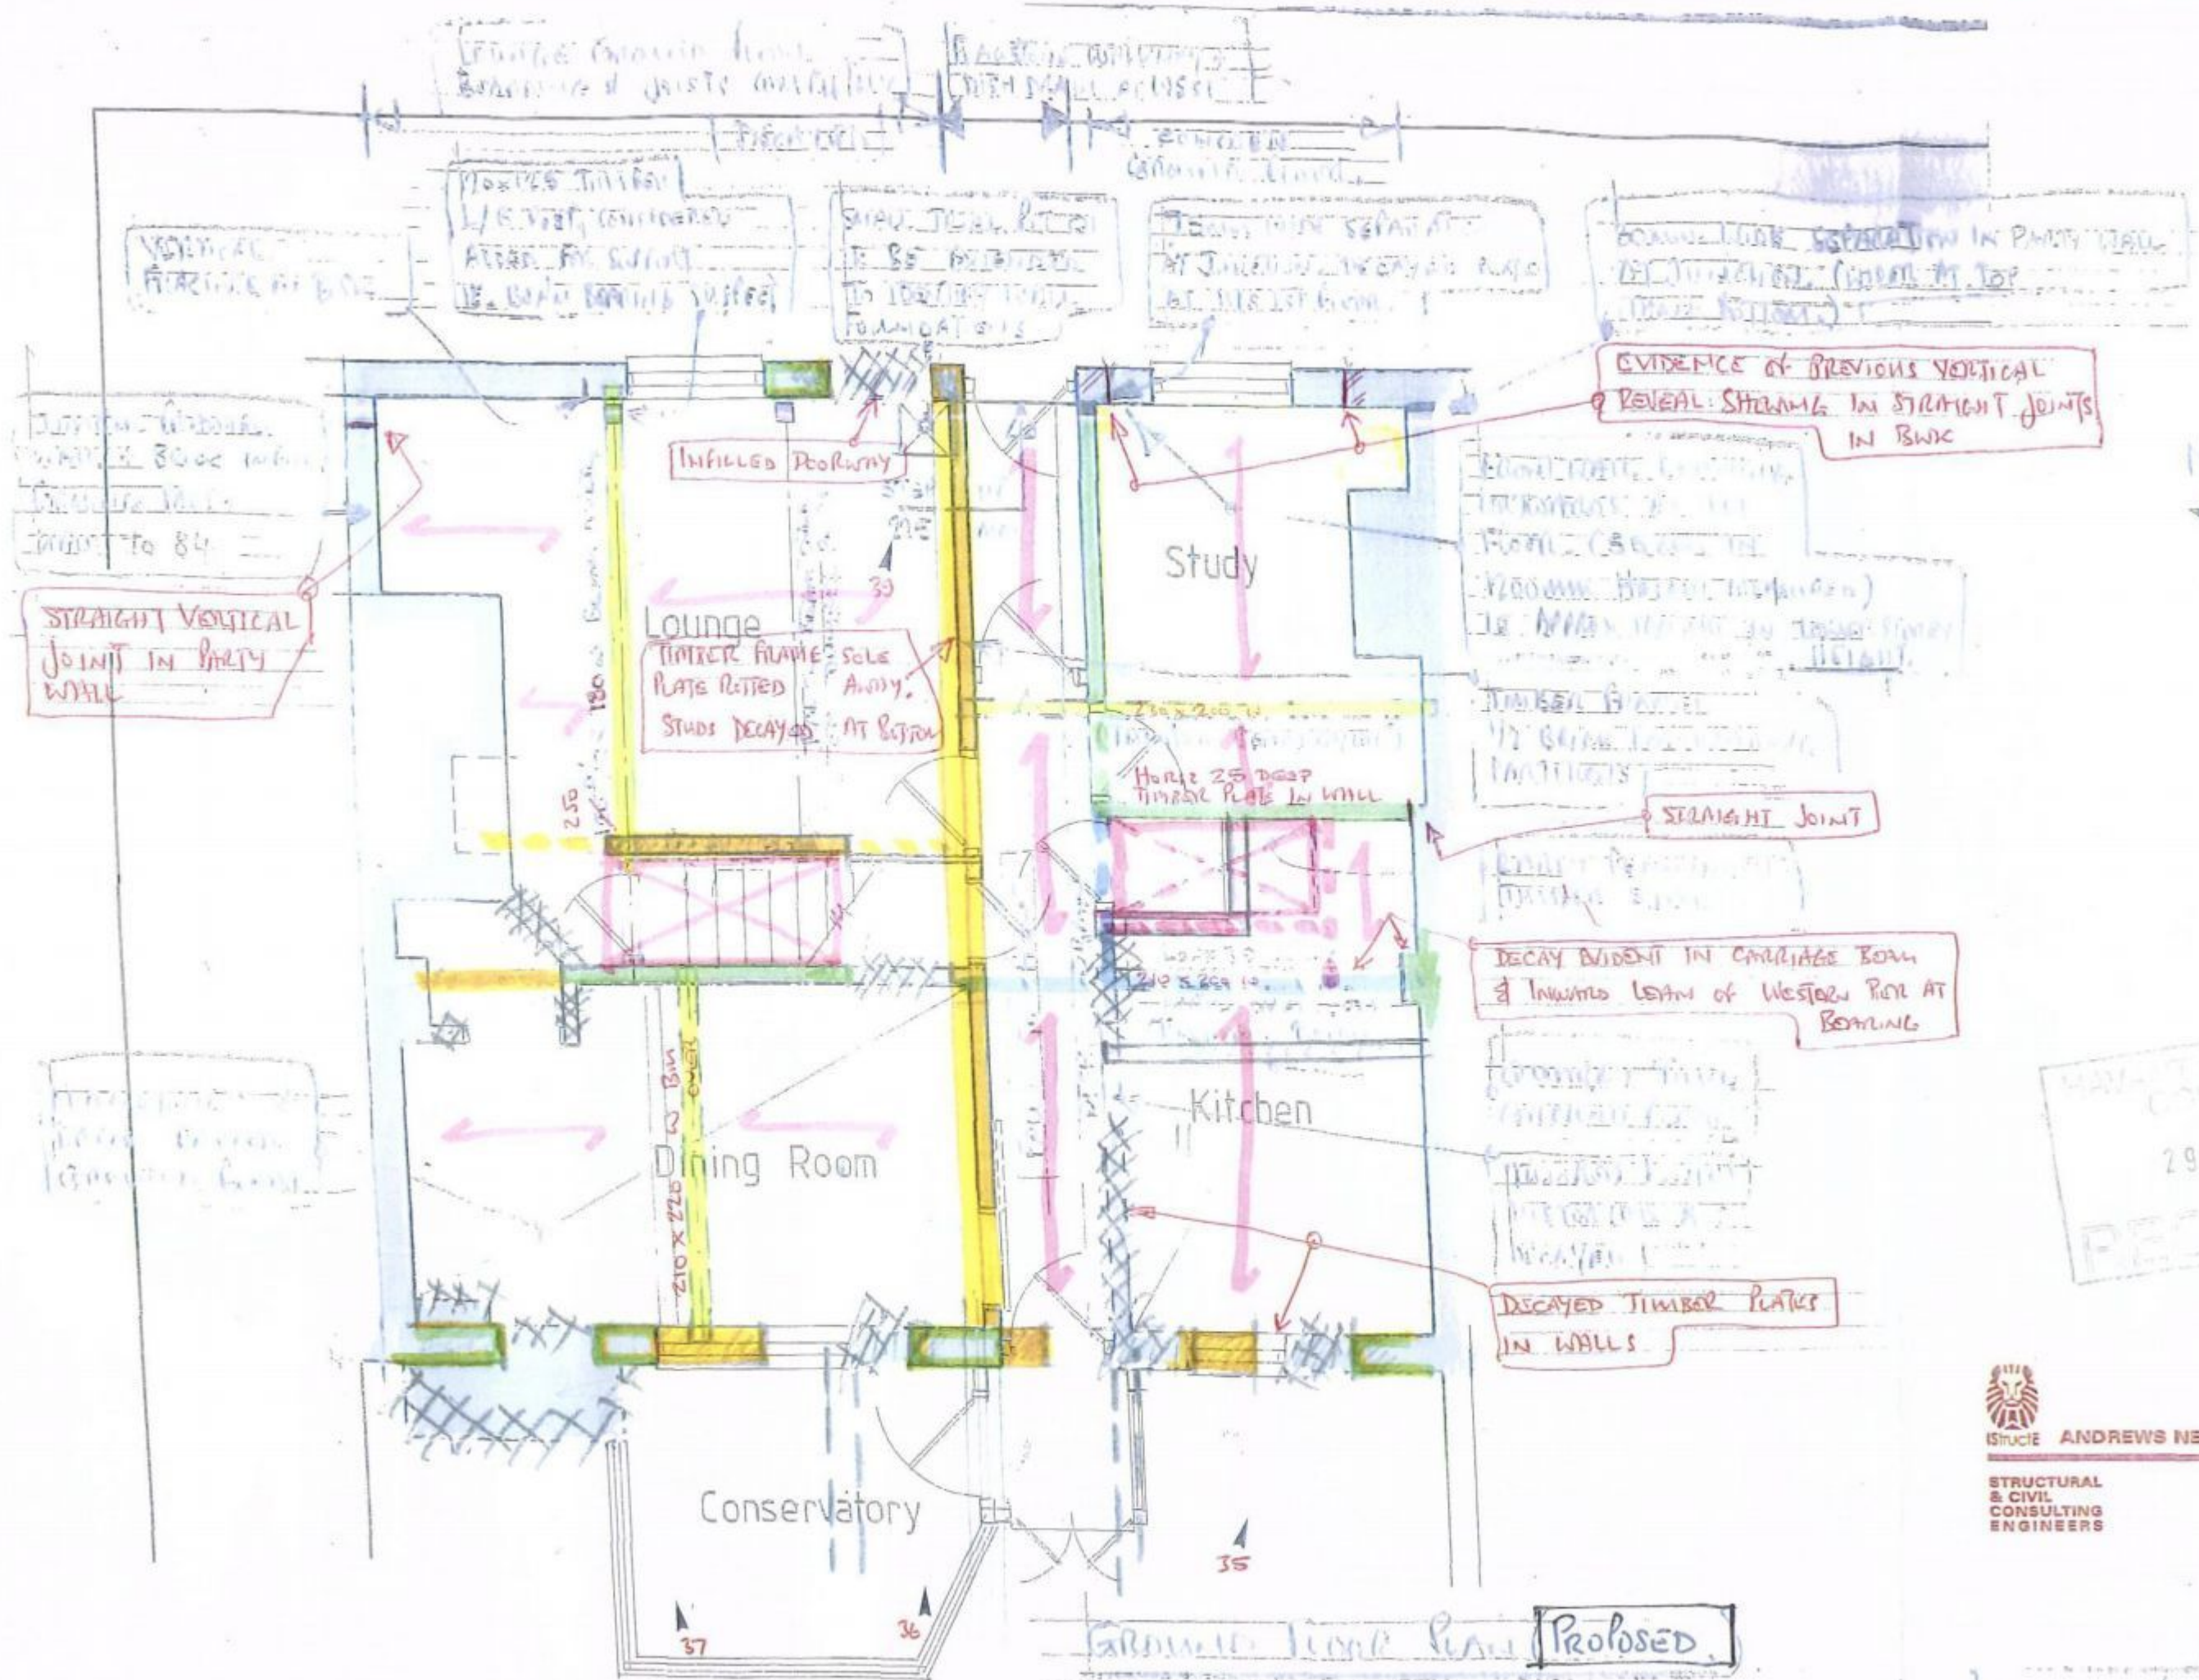
2844/SK/03 A

There is considerable deflection in the south pitch, decay and insect infestation in the timbers, evidence of crude strengthening and badly repaired openings.

The supportwork is totally inadequate and has failed in several places and shows considerable distress.

The new rafters to both pitches are inadequately supported and/or strutted and the ceiling joists are decayed/insect infested and cannot be retained.

The complete roof structure is beyond repair and will require replacement in new works.

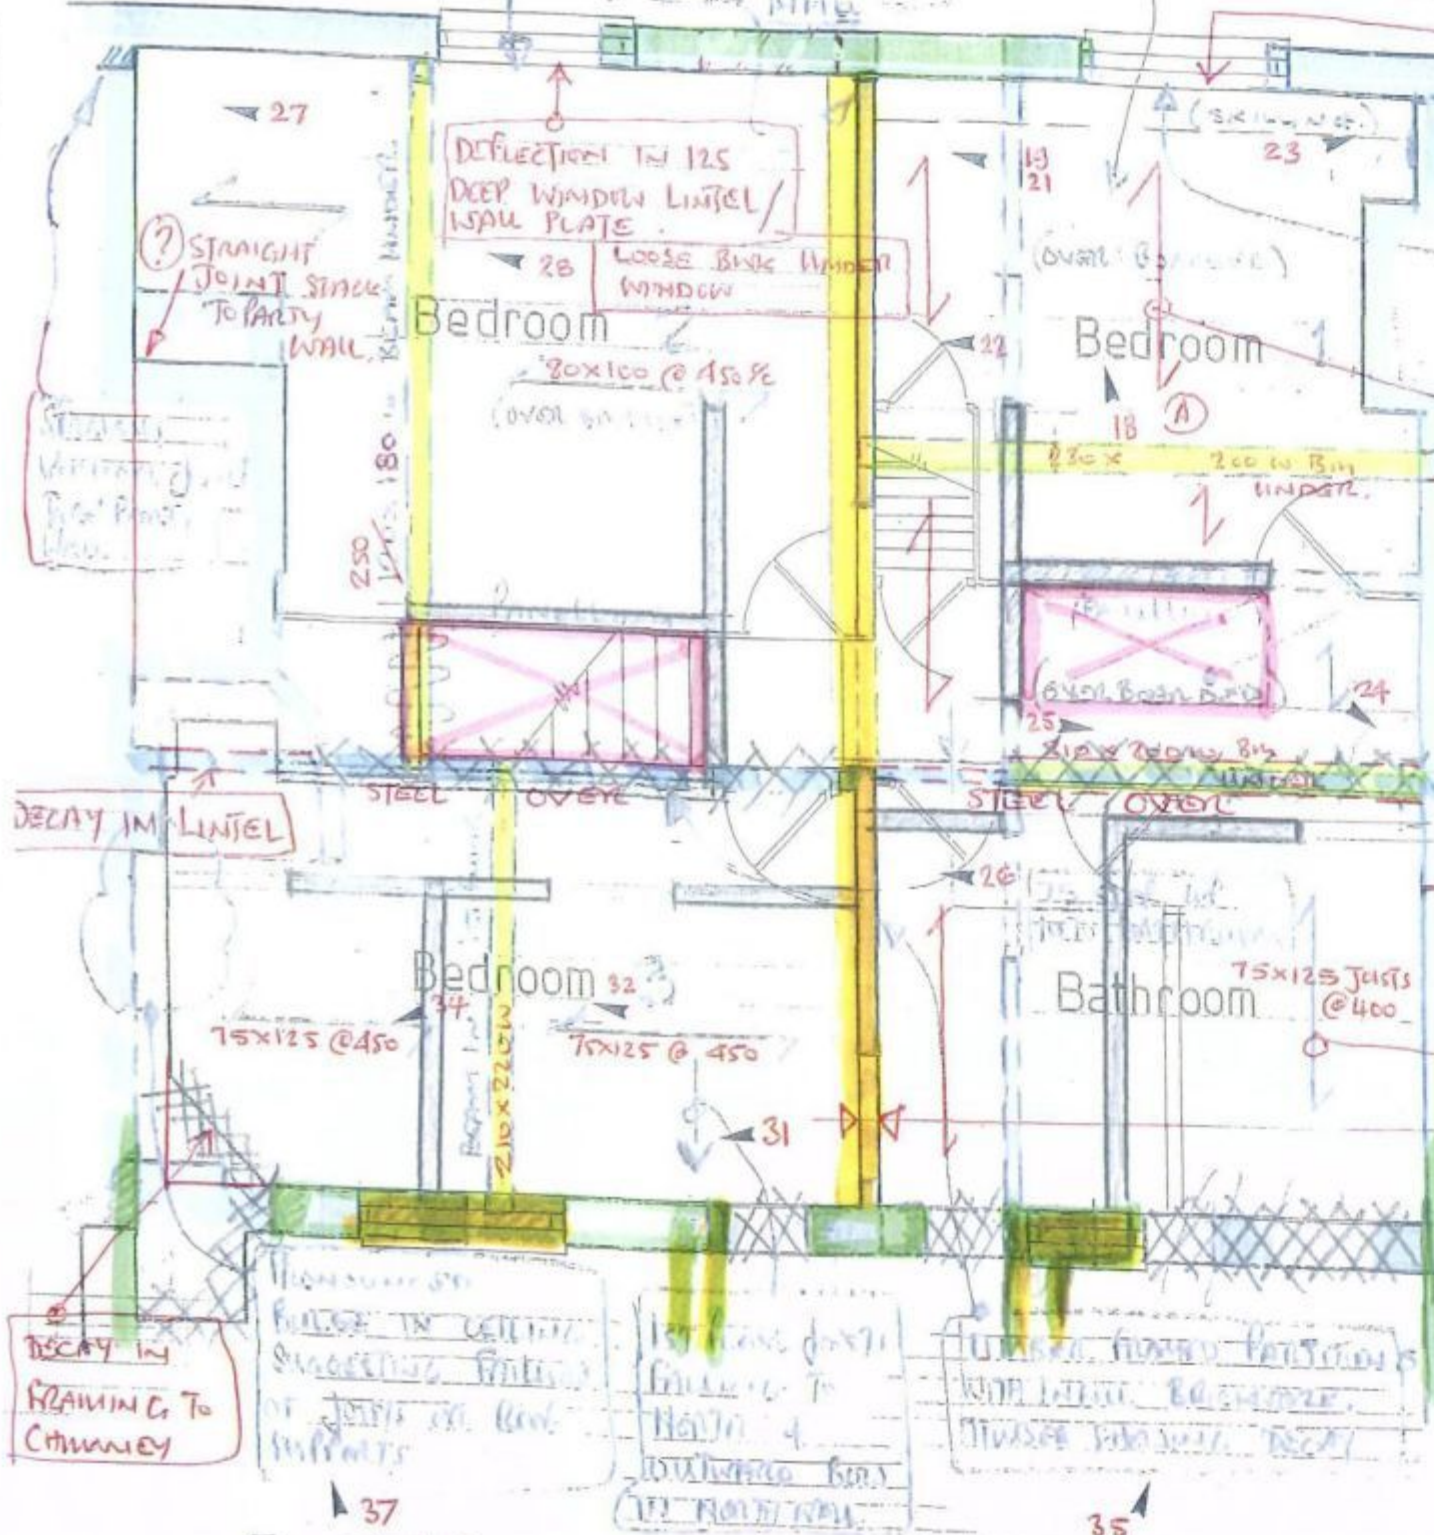
SEVERE DEFLECTION  
IN 1ST FLOOR ON  
CORNER

VERTICAL SEPARATION  
AT 1ST FLOOR / FRONT  
WALL

Pronounced Deflection of 125 DEEP  
WINDOW LINTEL ON CENTRE

1ST FLOOR JOIST SPAN M-S  
AND HAVE NO BEARING  
AT FRONT WALL
