Meadowsweet Grant  
Application  
(Original)

1st March 2012

Meadowsweet comprises two separate buildings, joined together at one corner for internal access. The older cottage shown on the left in Fig 1, is located adjacent to St Peters Road and is believed to date from AD 1530. The newer 'added-on' cottage on the right in Fig. 1 is partly constructed in a 'Mock Tudor' type style; it is located adjacent to Clovelly Road and dates from AD1920. This application concerns changes to the older cottage, (i) renovation of the southern and western elevations and (ii) installation of stainless steel liners inside the chimney stacks.

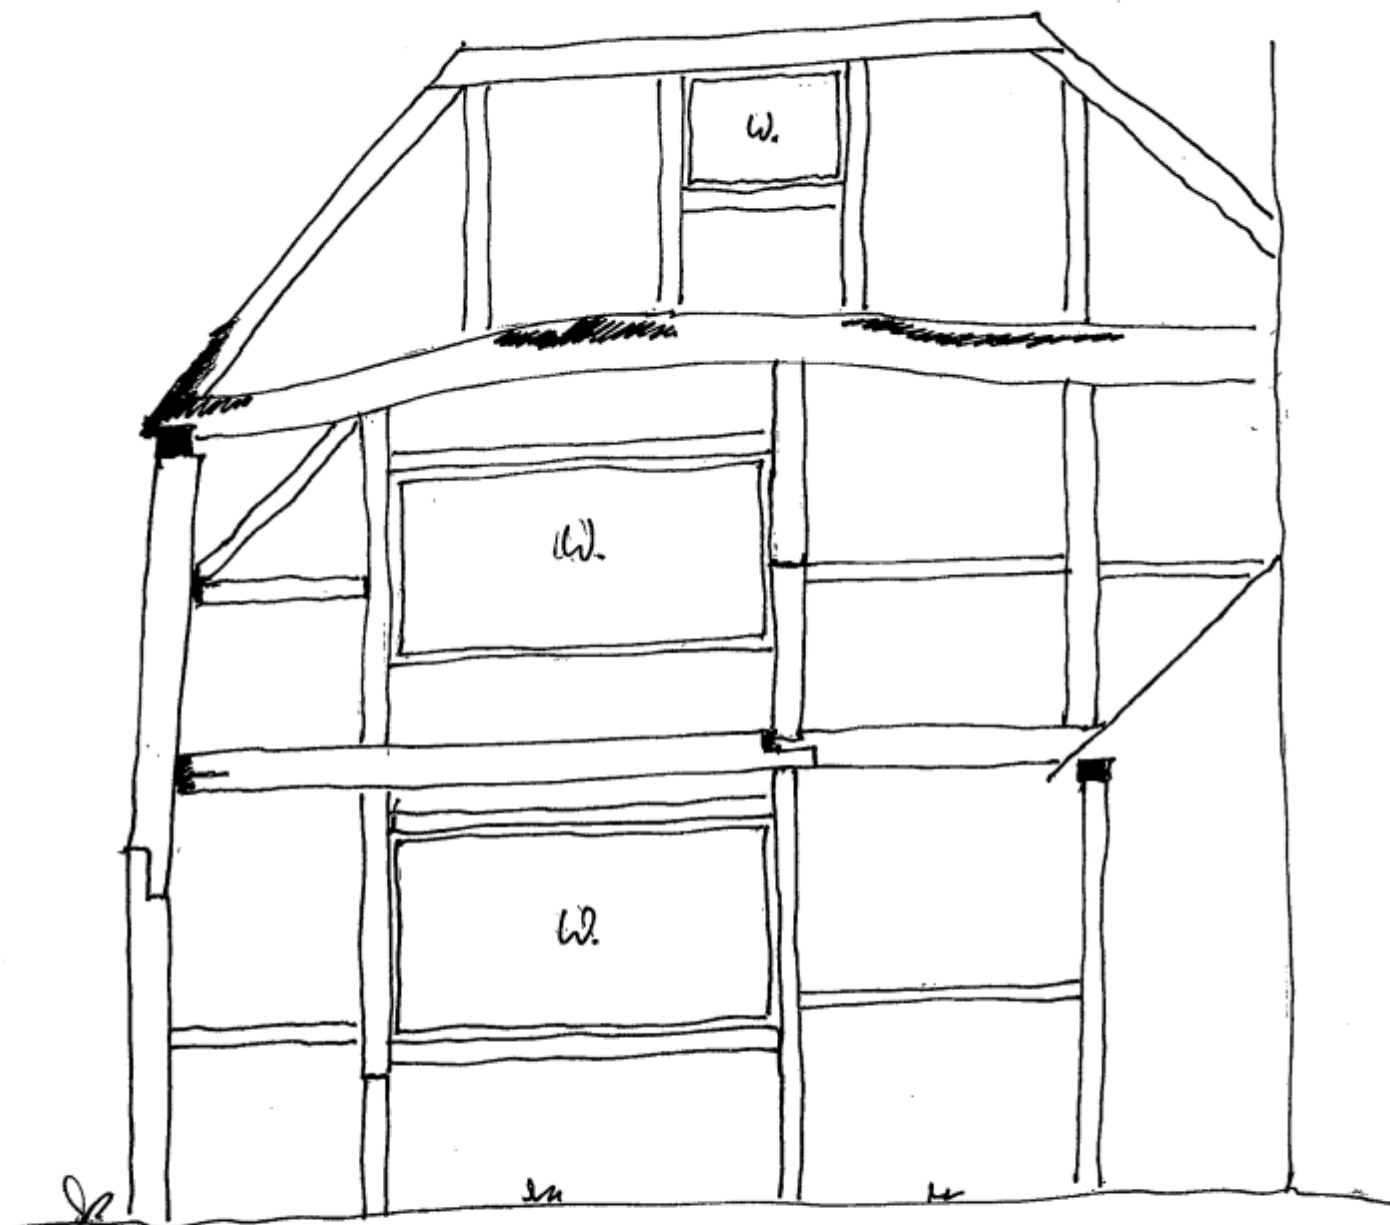
Meadowsweet Existing  
Southern Elevation

The wall shown in Fig 2 is in presently in a very precarious state, with some loose brickwork panels in danger of falling outwards, potentially endangering people who pass below. The oak frame has lost its structural integrity, due to serious decay and attack by wood-boring beetles. Both horizontal tie beams are badly affected by this, and have become disjointed from the upright corner post. Many of the smaller beams are not keyed into the surrounding wood frame, thus further destabilising the wall and its individual masonry panels. The lower part of the vertical corner post was replaced using soft wood some time ago, and the resulting joint between these sections has caused the corner to buckle outwards; see Fig 2. In turn, this movement has caused the lower two brick panels on the west-facing corner wall to buckle inwards.
