# Arboricultural Consultancy for Churchill Building Insurance

| <b>Insured</b> | Mr Philip Wakeford | <b>Address</b> | 21 Cavendish Drive, Waterlooville, Hampshire, PO7 7PJ | | |
| <b>Report Date</b> | 02/03/2012 | | | | |

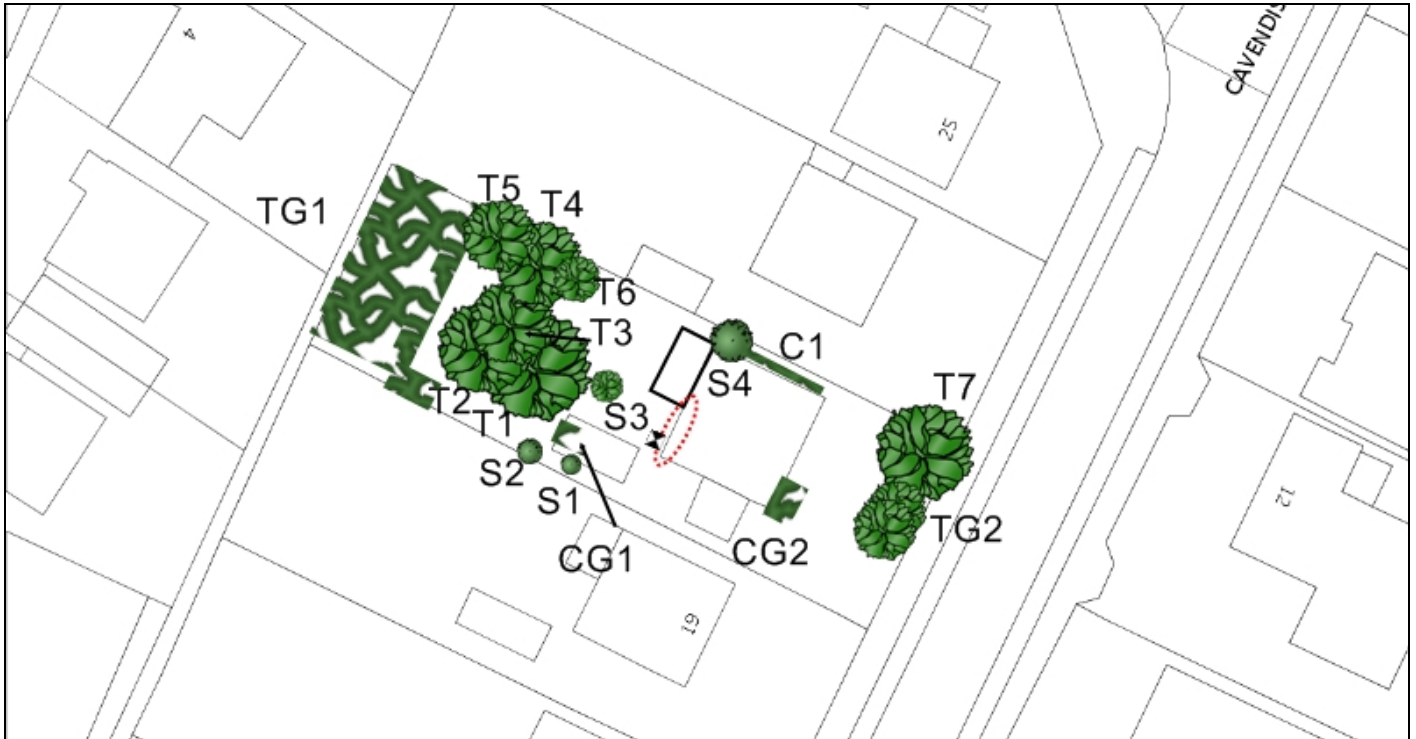
## 7. Site Plan

Based on our site investigations, and taking account of vegetation location, relative to the focal area of movement/ damage, it is our opinion that T1 (Oak) will be exerting the principal vegetative influence. This influence is determined by moisture content of soil in the locality of the area of damage combined with the above site investigations. This tree is also the largest one, closest to the property with the highest leaf area/ canopy size.
