# Arboricultural Consultancy for Royal & Sun Alliance

## 1. Case Details

| <b>Insured</b> | Mr James Grattan | <b>Address</b> | 4 Hermitage Gardens, Waterlooville, Hampshire, PO7 7PR | | |

**Scope of Report:** To survey the property and determine significant vegetation contributing to subsidence damage, make recommendation for remedial action and assess initial mitigation and recovery prospects. The survey does not make an assessment for decay or hazard evaluation.

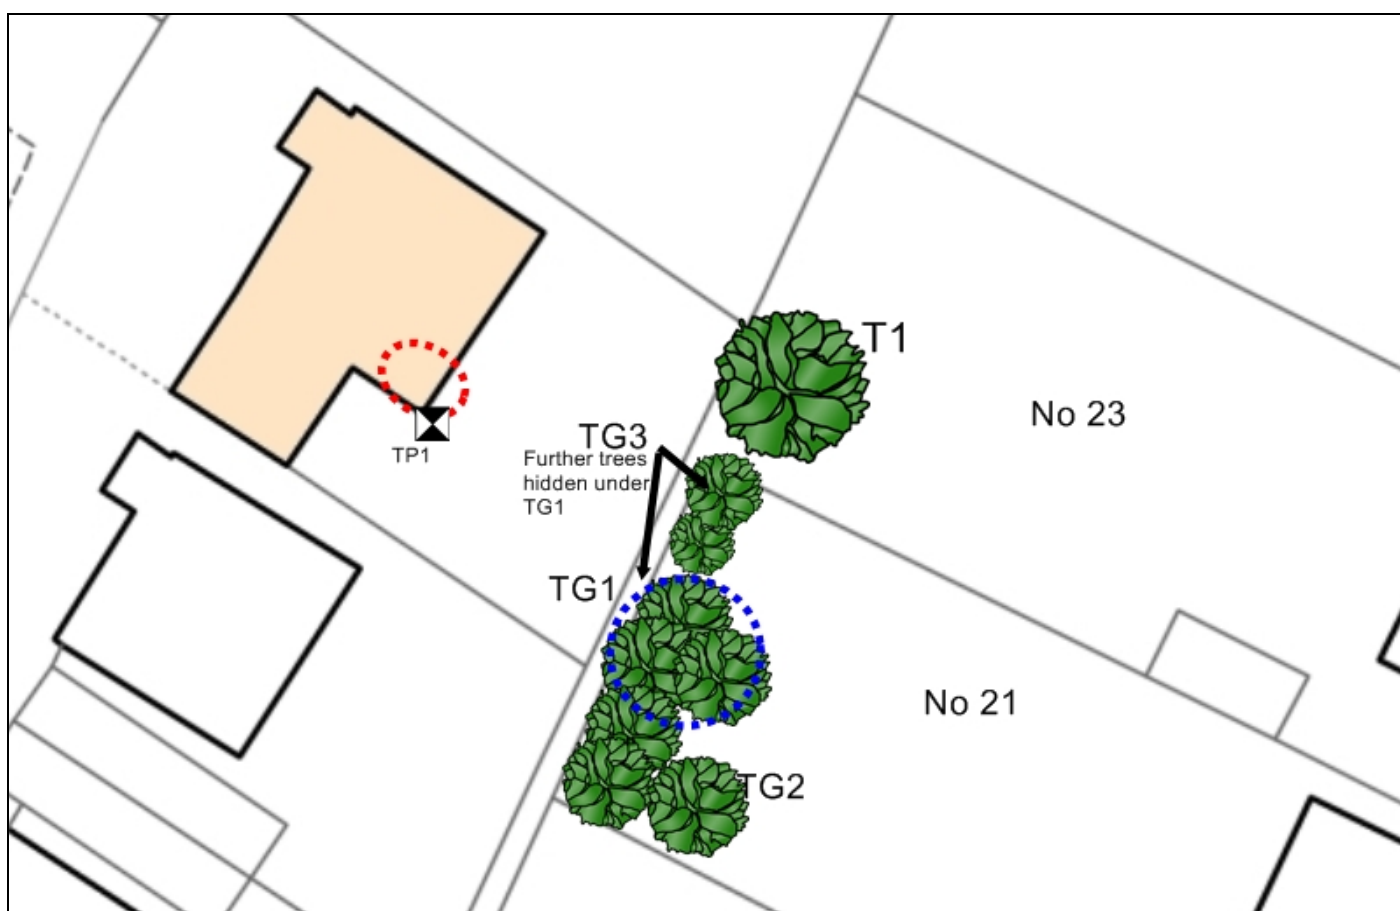
## 7. Site Plan

Based on our site investigations, and taking account of vegetation location, relative to the focal area of movement / damage, it is our opinion that TG1 (Oak) will be exerting the principal vegetative influence. This influence is determined by the moisture content of soil in the locality of the area(s) of damage and recovery of *Quercus* roots.
