## **Subsidence Claim**

# **Engineer's Report**

| Report Date | <b>19 July 2010</b> |
| Claim address | <b>4 Hermitage Gardens, Waterlooville,<br/>Hampshire, PO7 7PR</b> |

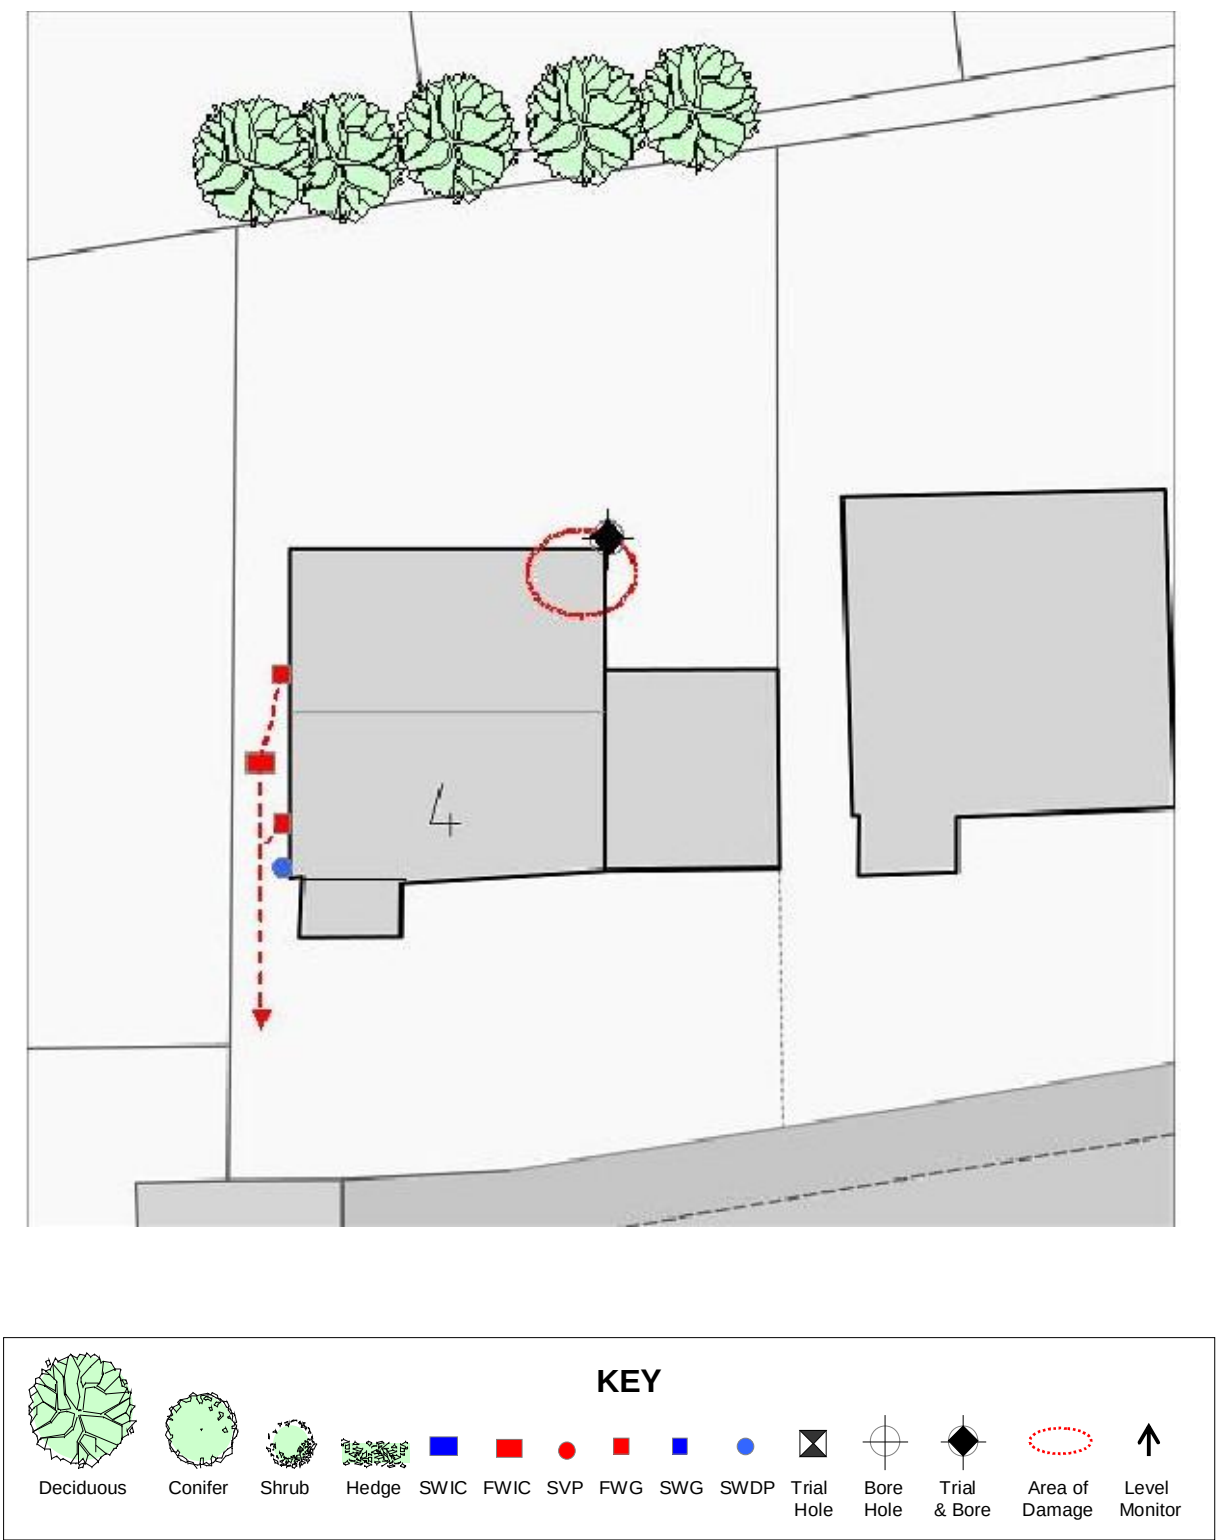
FIGURE 1 - Site Plan

The property is situated on a level within an established residential suburb of Waterloooville surrounded by properties of similar age and style. Mature oak trees mark an original field beyond the rear boundary fence. Drainage is along the left flank to the main sewer and remote from the damage.
