# PERMIT

The Flint Barn, Old Barn Gardens, Lovedean, Waterloooville. PO8 9XL

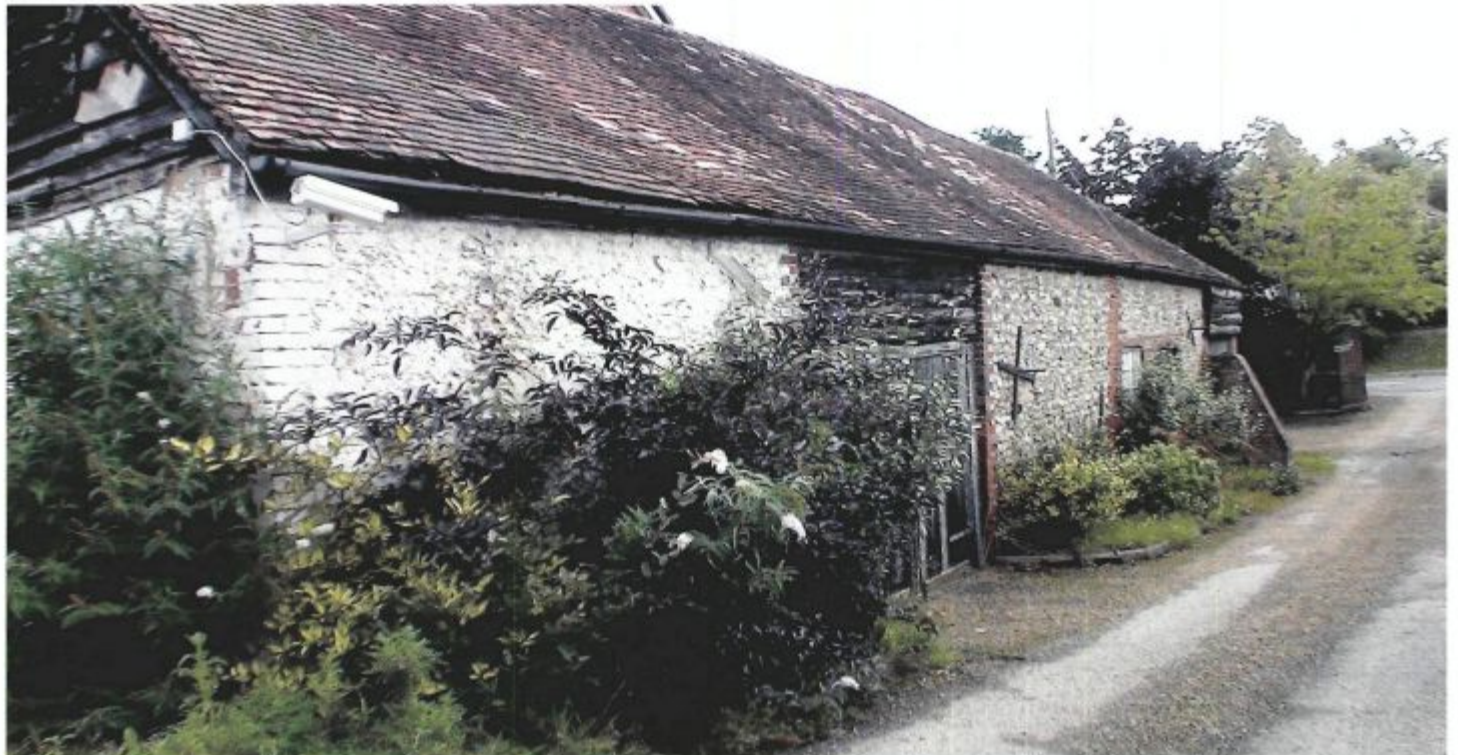
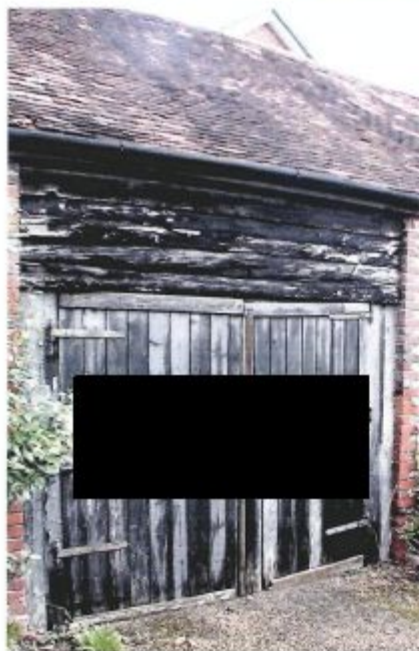
The barn was constructed in three separate areas each with exterior doors but not interconnecting.

Roof tiles were missing or broken, all the doors and the wooden cladding were rotten. The left hand end, which is the largest space, had had a problem with roof tiles falling off the back of the roof into the garden of the house behind. The previous owner hired a company to spray liquid foam onto the underside of the tiles to stick them in place.

The two trusses were not supported by the wall or the plate.

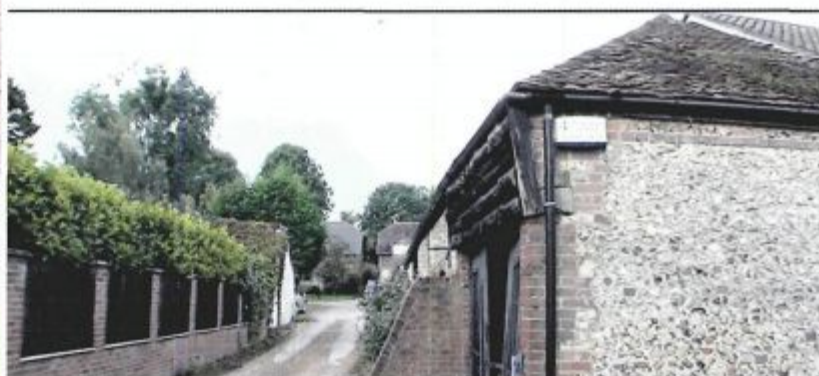
The guttering here did not connect with the down pipe, causing silt to build up over the years and the walls to be damp. There was no guttering at all on the rear of the roof, causing problems for the neighbour in the house behind.

The entire building had an ongoing problem with rats, the Council's pest control officer has made a number of visits.

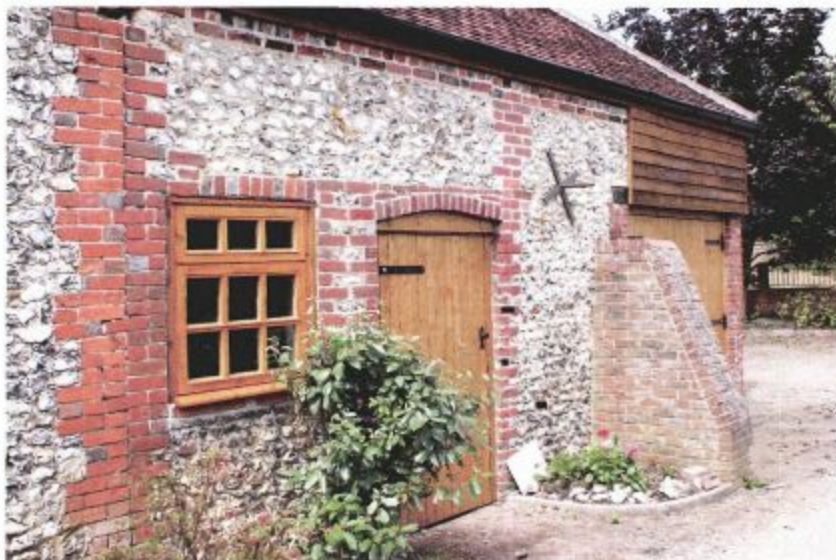
The right hand end is painted white, and if this could be removed and taken back to the original flint and brick it would be in keeping with the rest.

Parts of the flint work need to be re-pointed and this is intended to be undertaken in the future.
