**BRIAN EYLEY PARTNERSHIP**  
CHARTERED BUILDING SURVEYORS

**MEADOWSWEET, ST PETERS ROAD, HAYLING ISLAND**

Decadet Timber Frame Surveys  
Unit 3, Roses Farm  
Gallants Lane, East Farleigh, Kent ME15 0LG  
Tel: 07836 746520

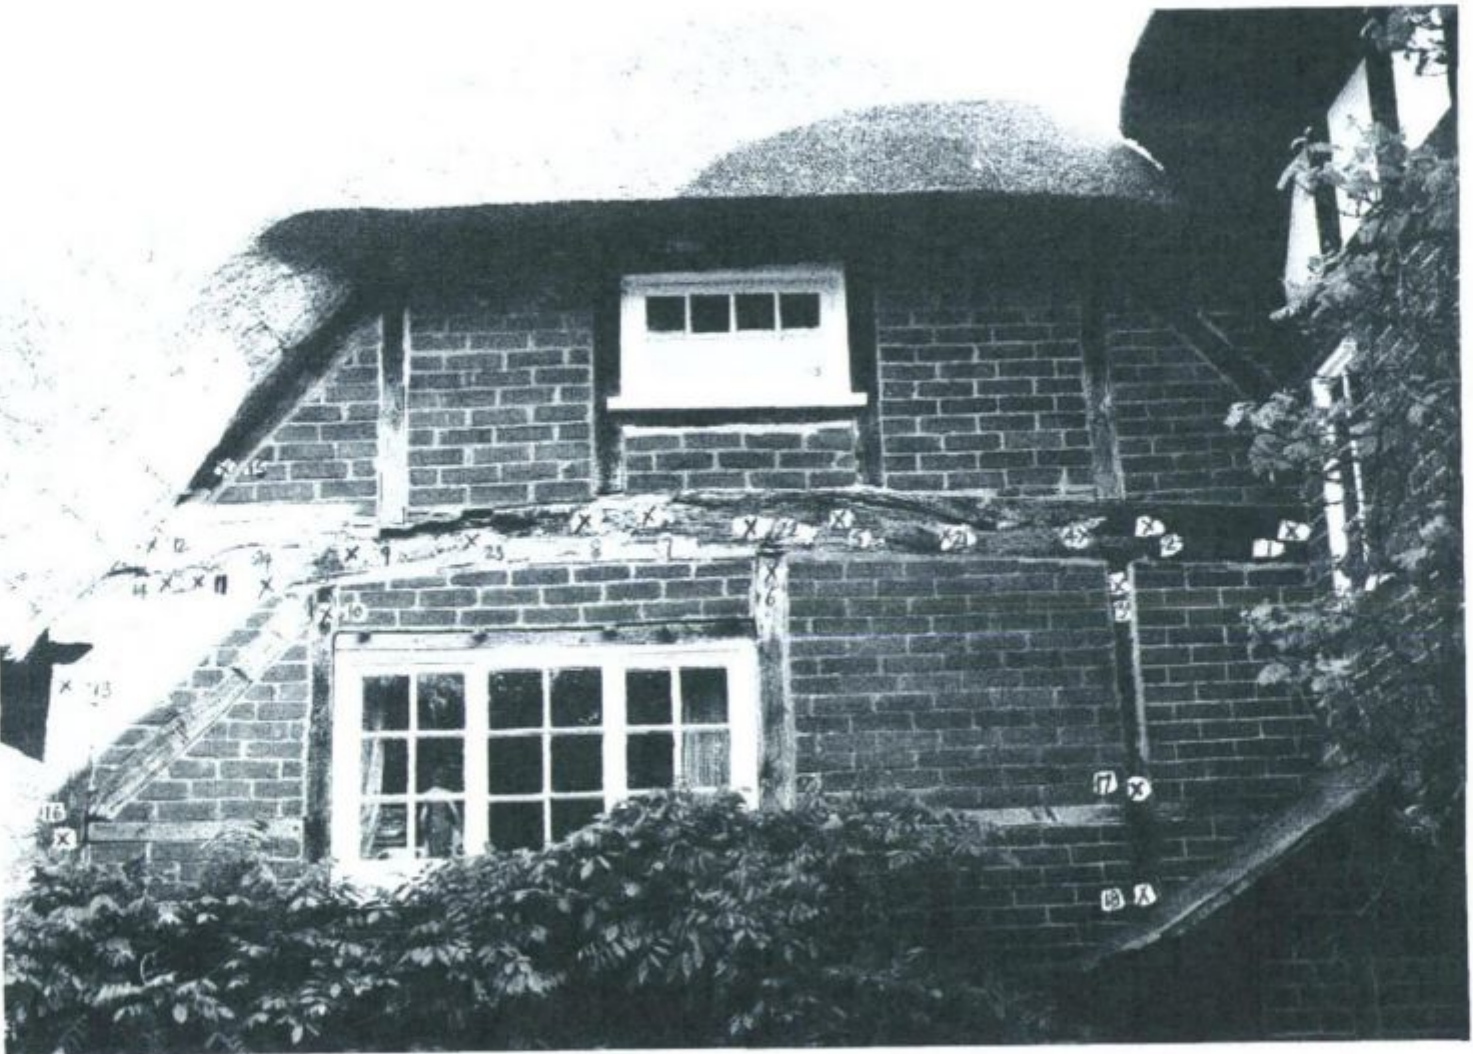
South Elevation

Probe inspections have highlighted problems to the South elevation roof tie beam, general jointing and members as noted.
