**St Mary's Church,  
Church Road  
Hayling Island  
Application for reduction of Yew**

This document supports a Planning Application submitted by Andrew Skeet ONDipArb for reduction of ancient yew "11" in TPO 1615 at St Mary's churchyard.

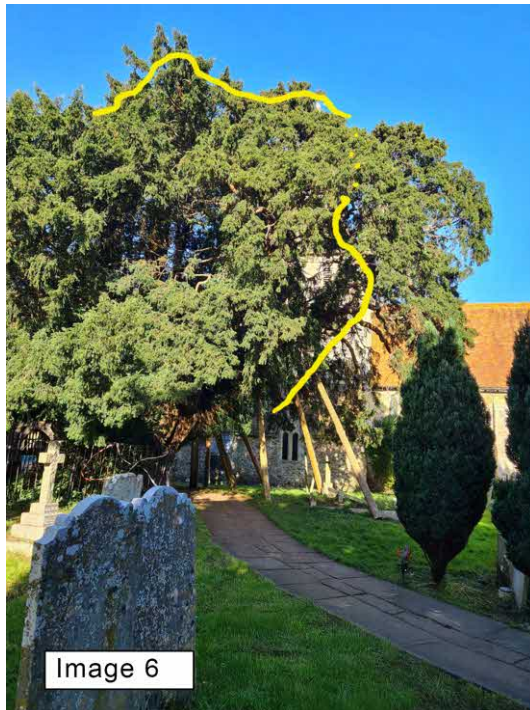
**Image 6** - new crown profile viewed from S

The following images illustrate the envisaged crown profile after work is complete

My recommendation is that reduction work to lower the tree's centre of gravity, reduce its wind resistance (sail area) and start moving to a smaller lower and denser crown, should be carried out. Light reduction work on the east side was carried out when the props were fitted in 2016 with the intention further reduction would follow. This work will inevitably diminish the tree's appearance somewhat but is the best way of ensuring the welfare and maximum longevity of the most important and interesting ancient lower structure. As viewed principally from the east, it can be seen that the tree has already made good progress on forming a smaller lower crown which the proposed reduction work will be using as a guide
