# BS 5837:2012 Arboricultural Survey

Stanton's Yard, Havant

Issued: October 2018

Delta-Simons Project No. 18-0609.02

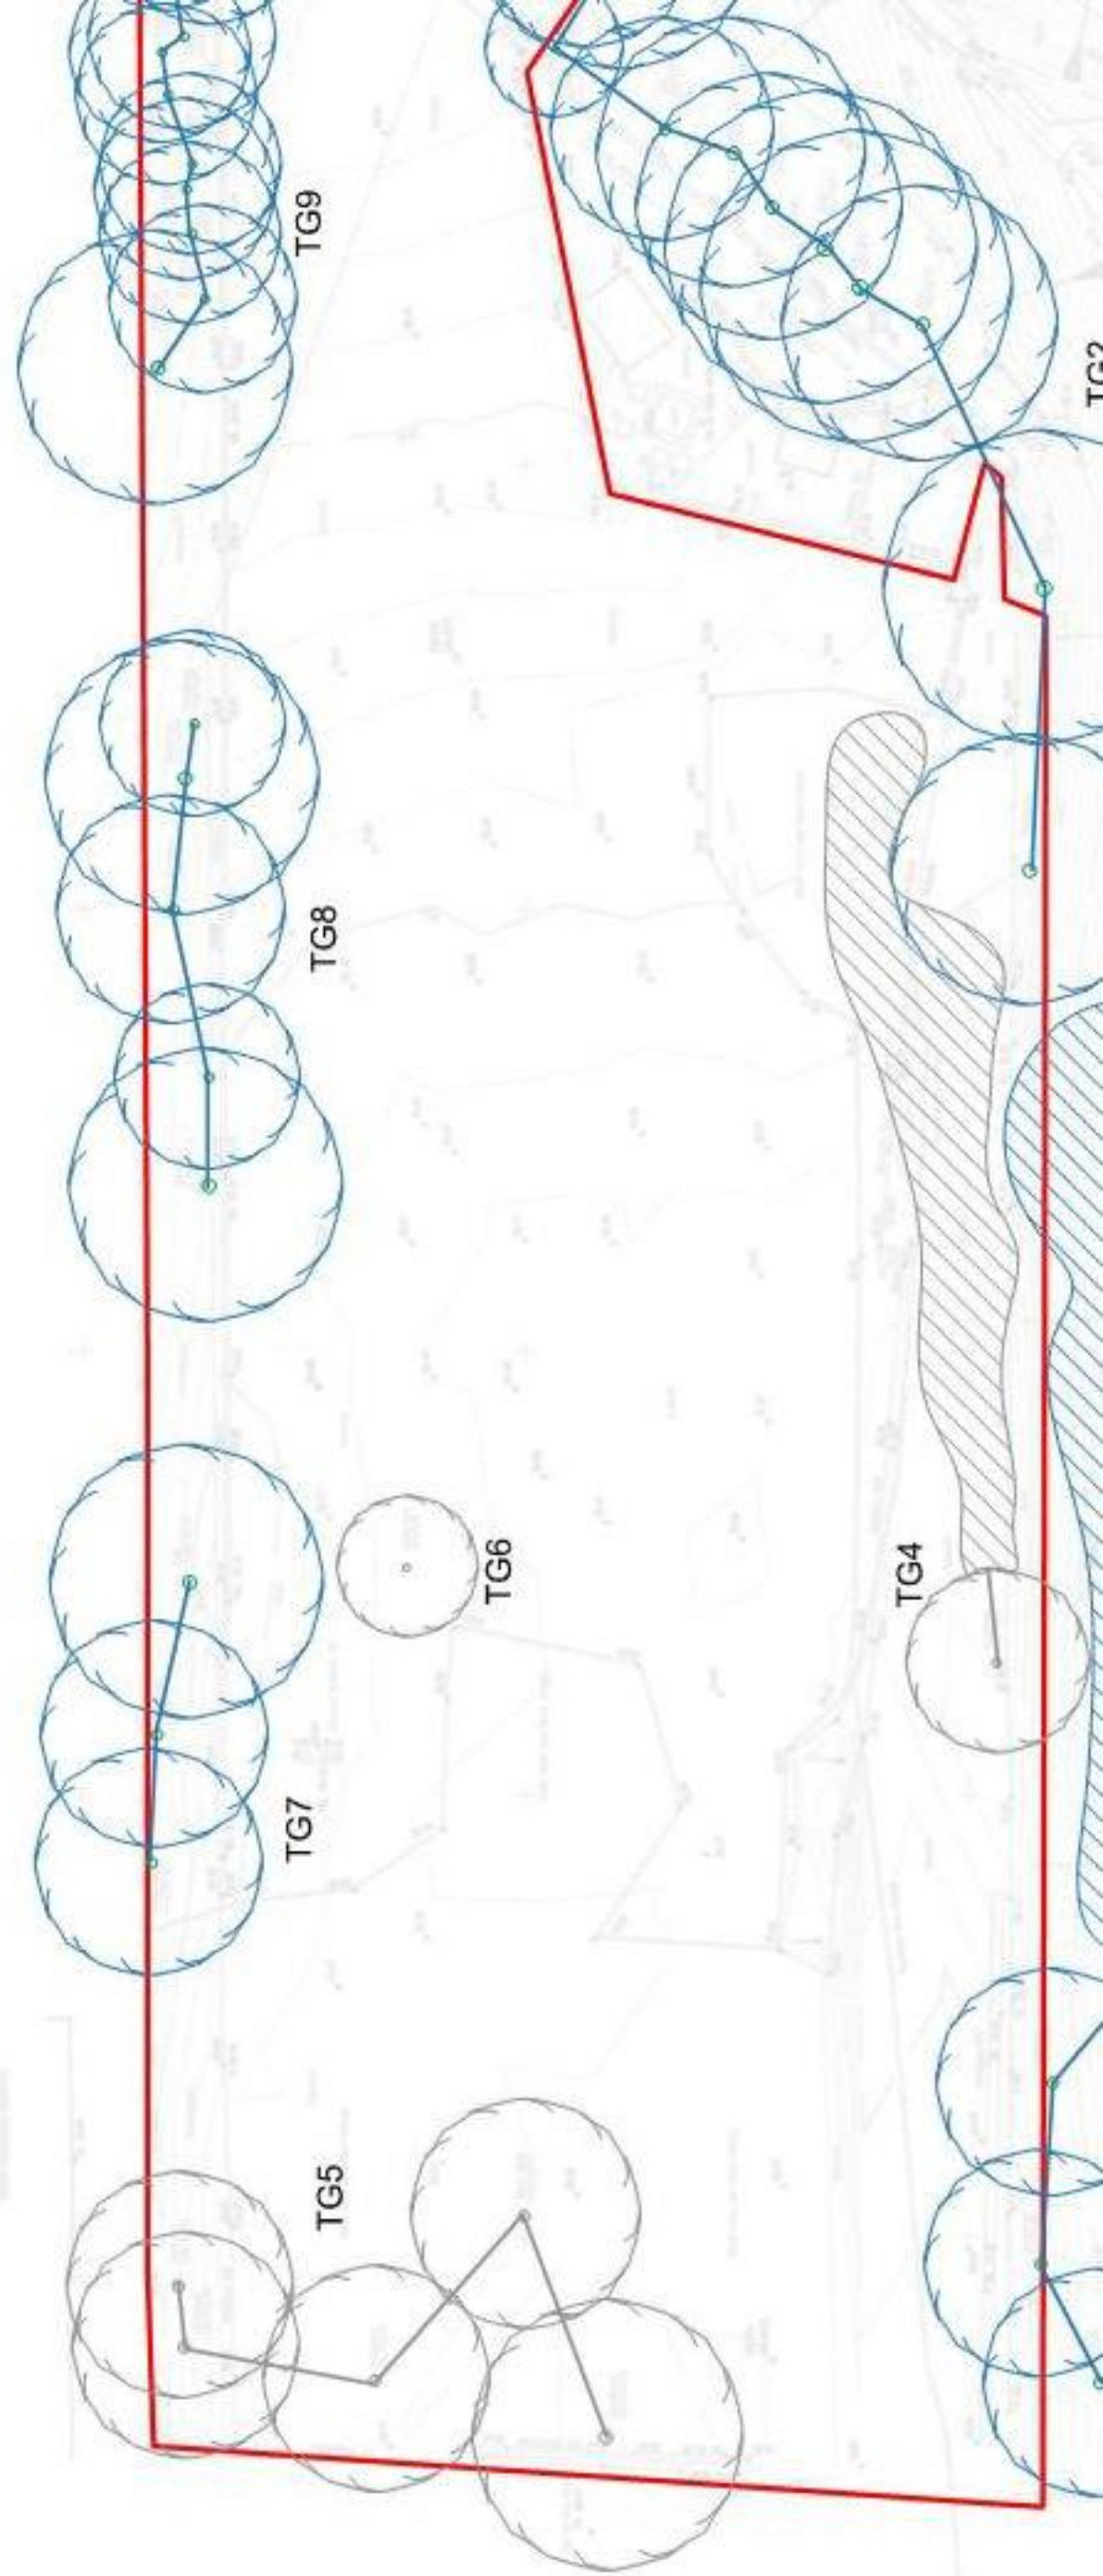
## Figure 2 - Tree Survey

The extent and positions of significant individual trees or groups of trees close to the Site are shown on the Arboricultural Survey Plan (Figure 2). The Root Protection Areas (RPA) of the key trees of value identified for, or recommend for retention have been marked within the Constraints Plan (Figure 4) using the RPAs provided in the Tree Schedule within Table 1.

The tree inspection took the form of a walkover inspection completed by Steven Kemp NDFarb TechArborA on 1<sup>st</sup> May 2018. Each individual semi-mature or young tree of significance that could be impacted upon by any proposed development was identified and visually inspected and classified. The trees identified during the survey at the Site have been individually noted and identified within this Report and are shown in the Tree Survey Plan within Figure 2, and within the Photograph Section of this Report (Appendix III).
