CCTV REPORT FOR: 28 DAMASK GARDENS  
WATERLOOVILLE  
PO7 8QZ

Insured: Mrs. Hayley Psaila  
Reference: LIV-SN-23-006703 Ins Ref: 800-16-008022

2nd Site Visit: 21-Aug-23  
2nd Report Date: 31-Aug-23

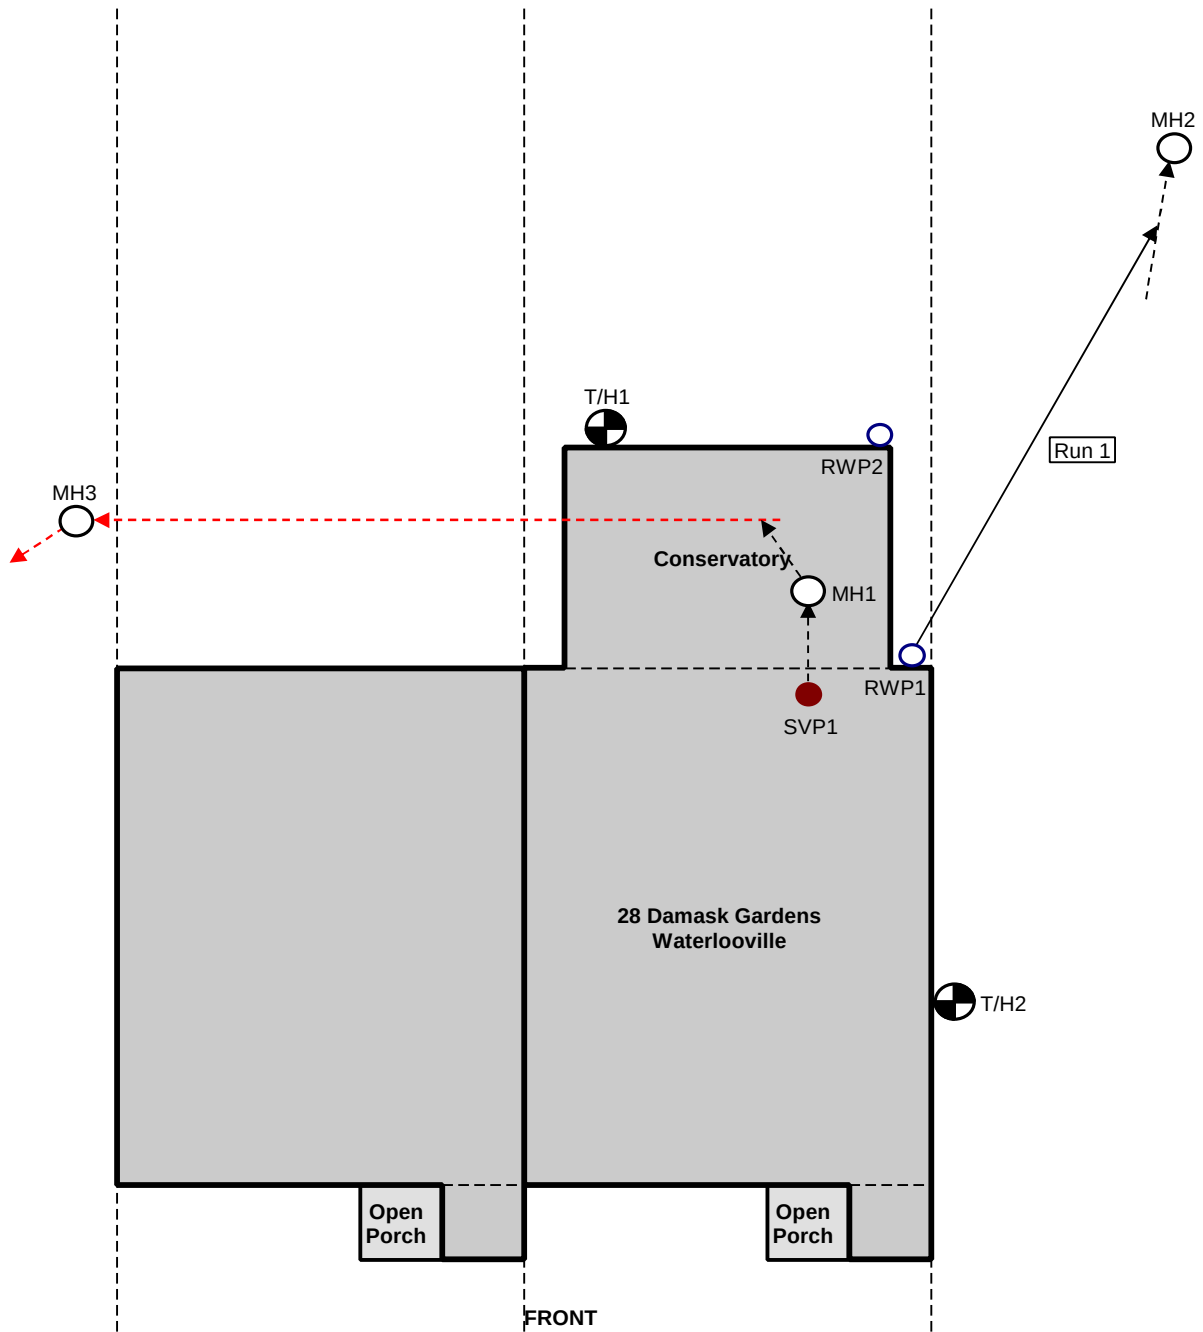
Tracing the pipework downstream we located a chamber (MH3) set in the grass verge to the left of the neighbouring property. When we lifted the cover to this we found that this was also holding water backing up from pipework further downstream. We attempted to jet from the chamber but were still not able to clear the debris and water.

There are high levels of debris and standing water in the shared pipework serving MH3. As this pipework is believed to be the responsibility of the local water authority we recommend that they are contacted so that they may clear the blockages from the pipework.

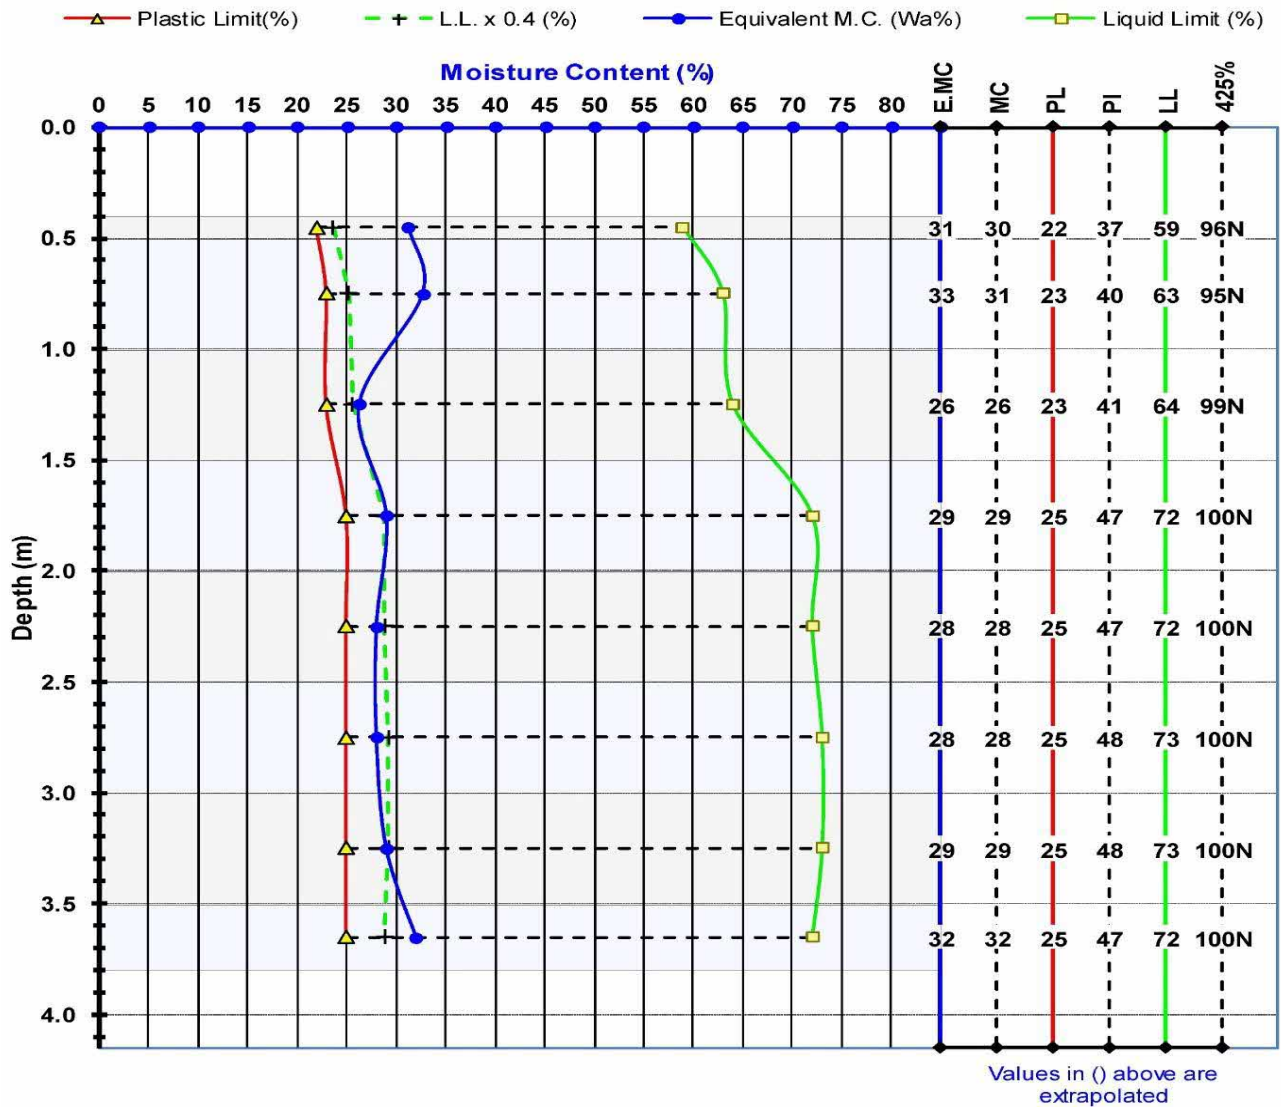
**Drainage**  
 Repair Company  
**LABORATORY TESTING RESULTS**

| Depth<br>T (m) | Depth<br>B (m) | 1 - Rear LHC of conservatory<br>Brief Soil Description | Plasticity<br>(BS 5930) | Volume Change<br>M.PI (BRE 240) |
|---|---|---|---|---|
| 3 | 3.5 | Firm/stiff grey/brown CLAY with rare medium gravel | V. high CV | 48% High |
| 3.5 | 3.8 | Firm/stiff grey/brown CLAY with rare medium gravel | V. high CV | 47% High |

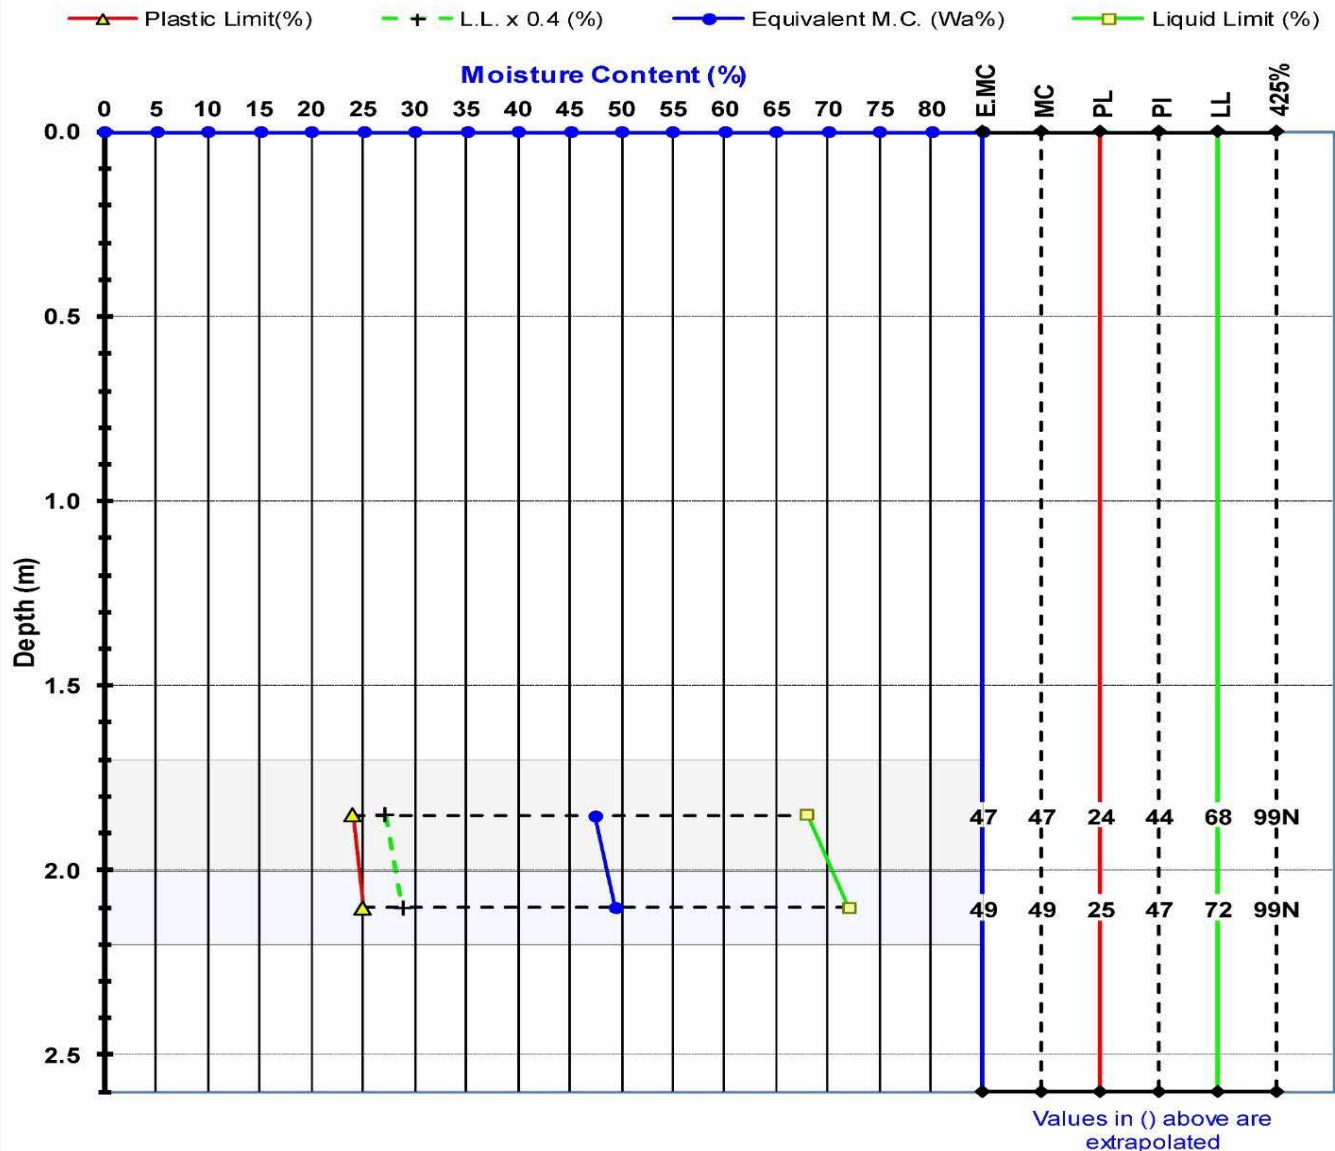
**Drainage**  
 Repair Company  
**LABORATORY TESTING RESULTS**

| Depth<br>T (m) | Depth<br>B (m) | 2 - R/H side of property | Plasticity<br>(BS 5930) | Volume Change | |
|---|---|---|---|---|---|
| 1.7 | 2 | Soft brown CLAY with rare medium gravel | High CH | 44% | High |
| 2 | 2.2 | Soft brown CLAY with rare medium gravel | V. high CV | 47% | High |
