CCTV REPORT FOR: 28 DAMASK GARDENS  
WATERLOOVILLE  
PO7 8QZ

Site Visit: 25-May-23  
Report Date: 28-Jun-23

Address: 28 DAMASK GARDENS, WATERLOOVILLE, PO7 8QZ

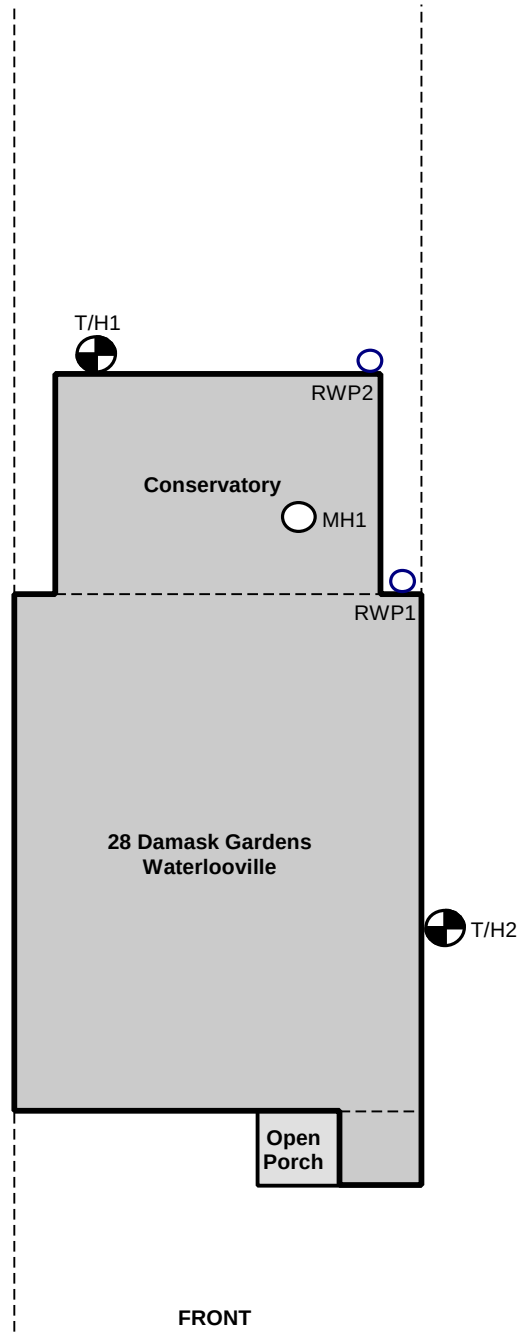
## SITE LAYOUT

Note: Runs shown in red have been adopted by the local water authority.

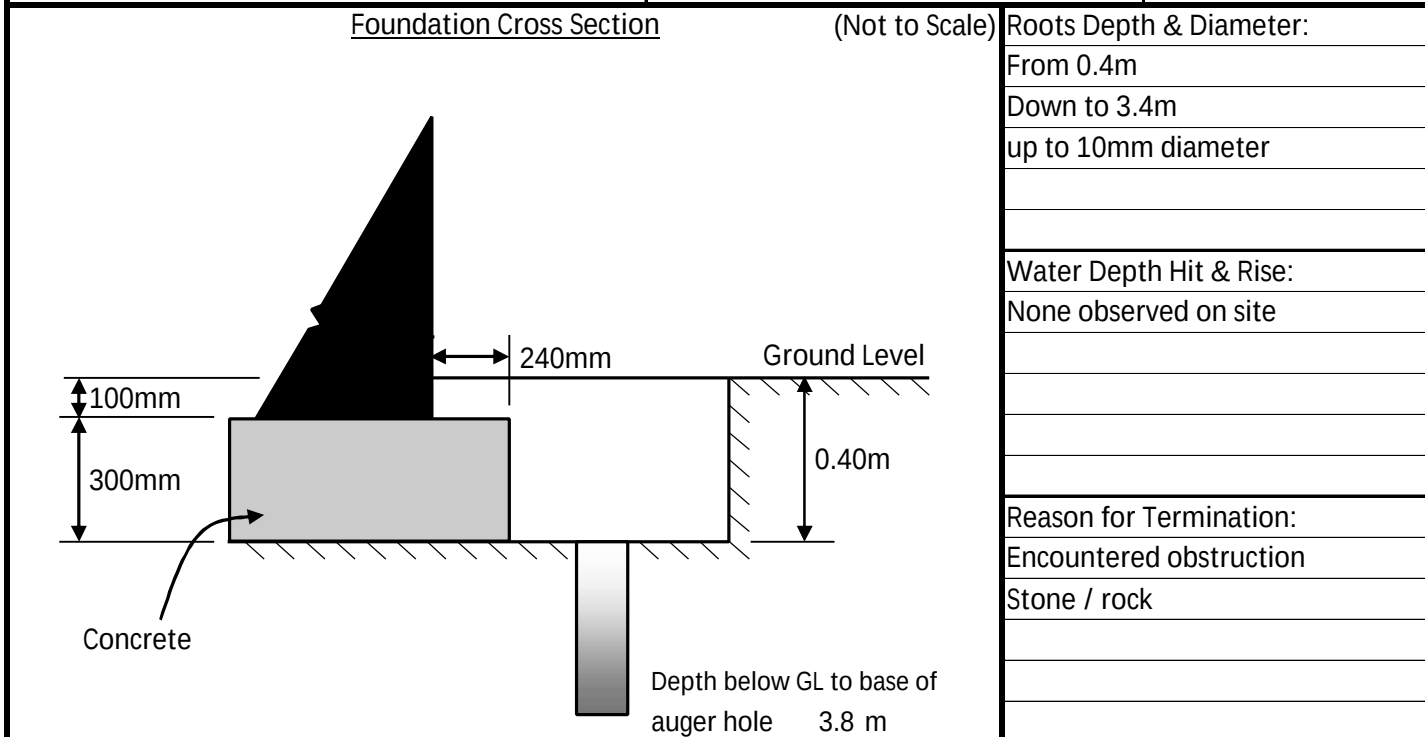
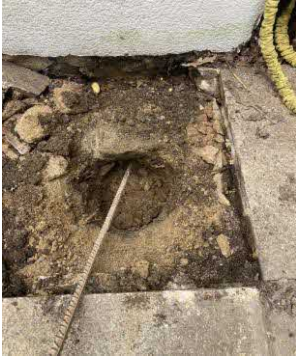
| Location: Rear Left Corner of Conservatory | T/H No. 1 |

| Depth<br>(m) | Soil Descriptions<br>(NB: Field crew description only) | Test<br>Type | Depth (m) | |
|---|---|---|---|---|
| 0.40 | Soft/firm brown CLAY with rare medium gravel (inc. brick) & roots | V(n) 34 | 0.400 | |
| 1.00 | Soft/firm brown CLAY with rare medium gravel & roots | V(n) 52 | 0.500 | |
| 1.50 | Soft/firm light grey/brown CLAY with rare medium gravel & rootlets | V(n) 70 | 1.000 | |
| 2.00 | Firm/stiff grey/brown CLAY with rare medium gravel & rootlets | V(n) 88 | 1.500 | |
| 3.00 | Firm/stiff grey/brown CLAY with rare medium gravel | V(n) 126 | 2.000 | |
| 3.80 | End of Borehole | V(n) 140+ | 2.500 | |
