Site: No.25-27  
Woodcroft Lane,  
Waterlooville,  
Hampshire, PO8 9QG

Site Visit Date: 11<sup>th</sup> July 2023

Client: Vivid Housing Association

**Prepared by  
Richard Daubeney  
Our Ref 0723-RD  
12th of July 2023**

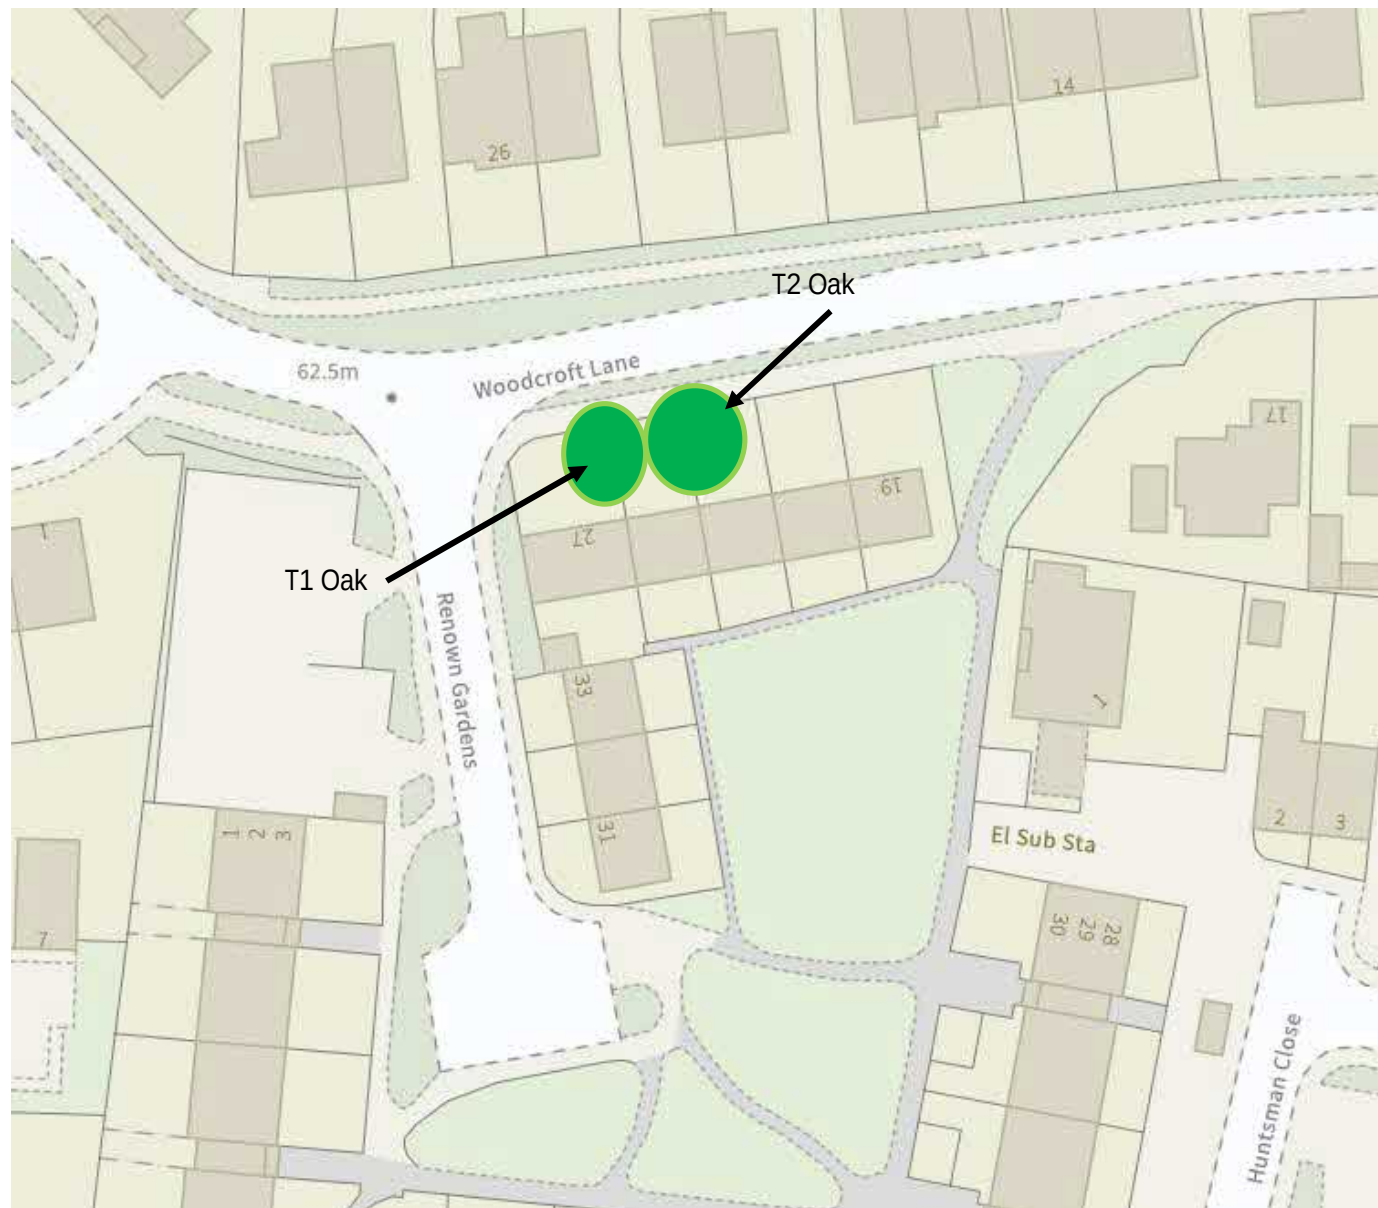
## T2 Measurement 3

T2 English Oak held no gross defect upon resistograph inspection with a T/R ratio of over the industry recommended 30% point. Based on the readings provided it would suggest that the likelihood of failure at test point is not significant. The testing carried out by the resistograph shows that the tree had very minor areas of decay within the stem, which would indicate that the tree is showing good areas of live holding wood throughout the stem.
