# Arboricultural Consultancy for Lloyds Bank

| Insured | Mr Andrew Hunnibal | Address | Longacre, Emsworth, PO10 7UR | | |
| ES Ref | SA-247622 | Consultant | Giles Mercer | Contact No. | 0330 380 1036 |
| Report Date | 09/02/2021 | | | | |

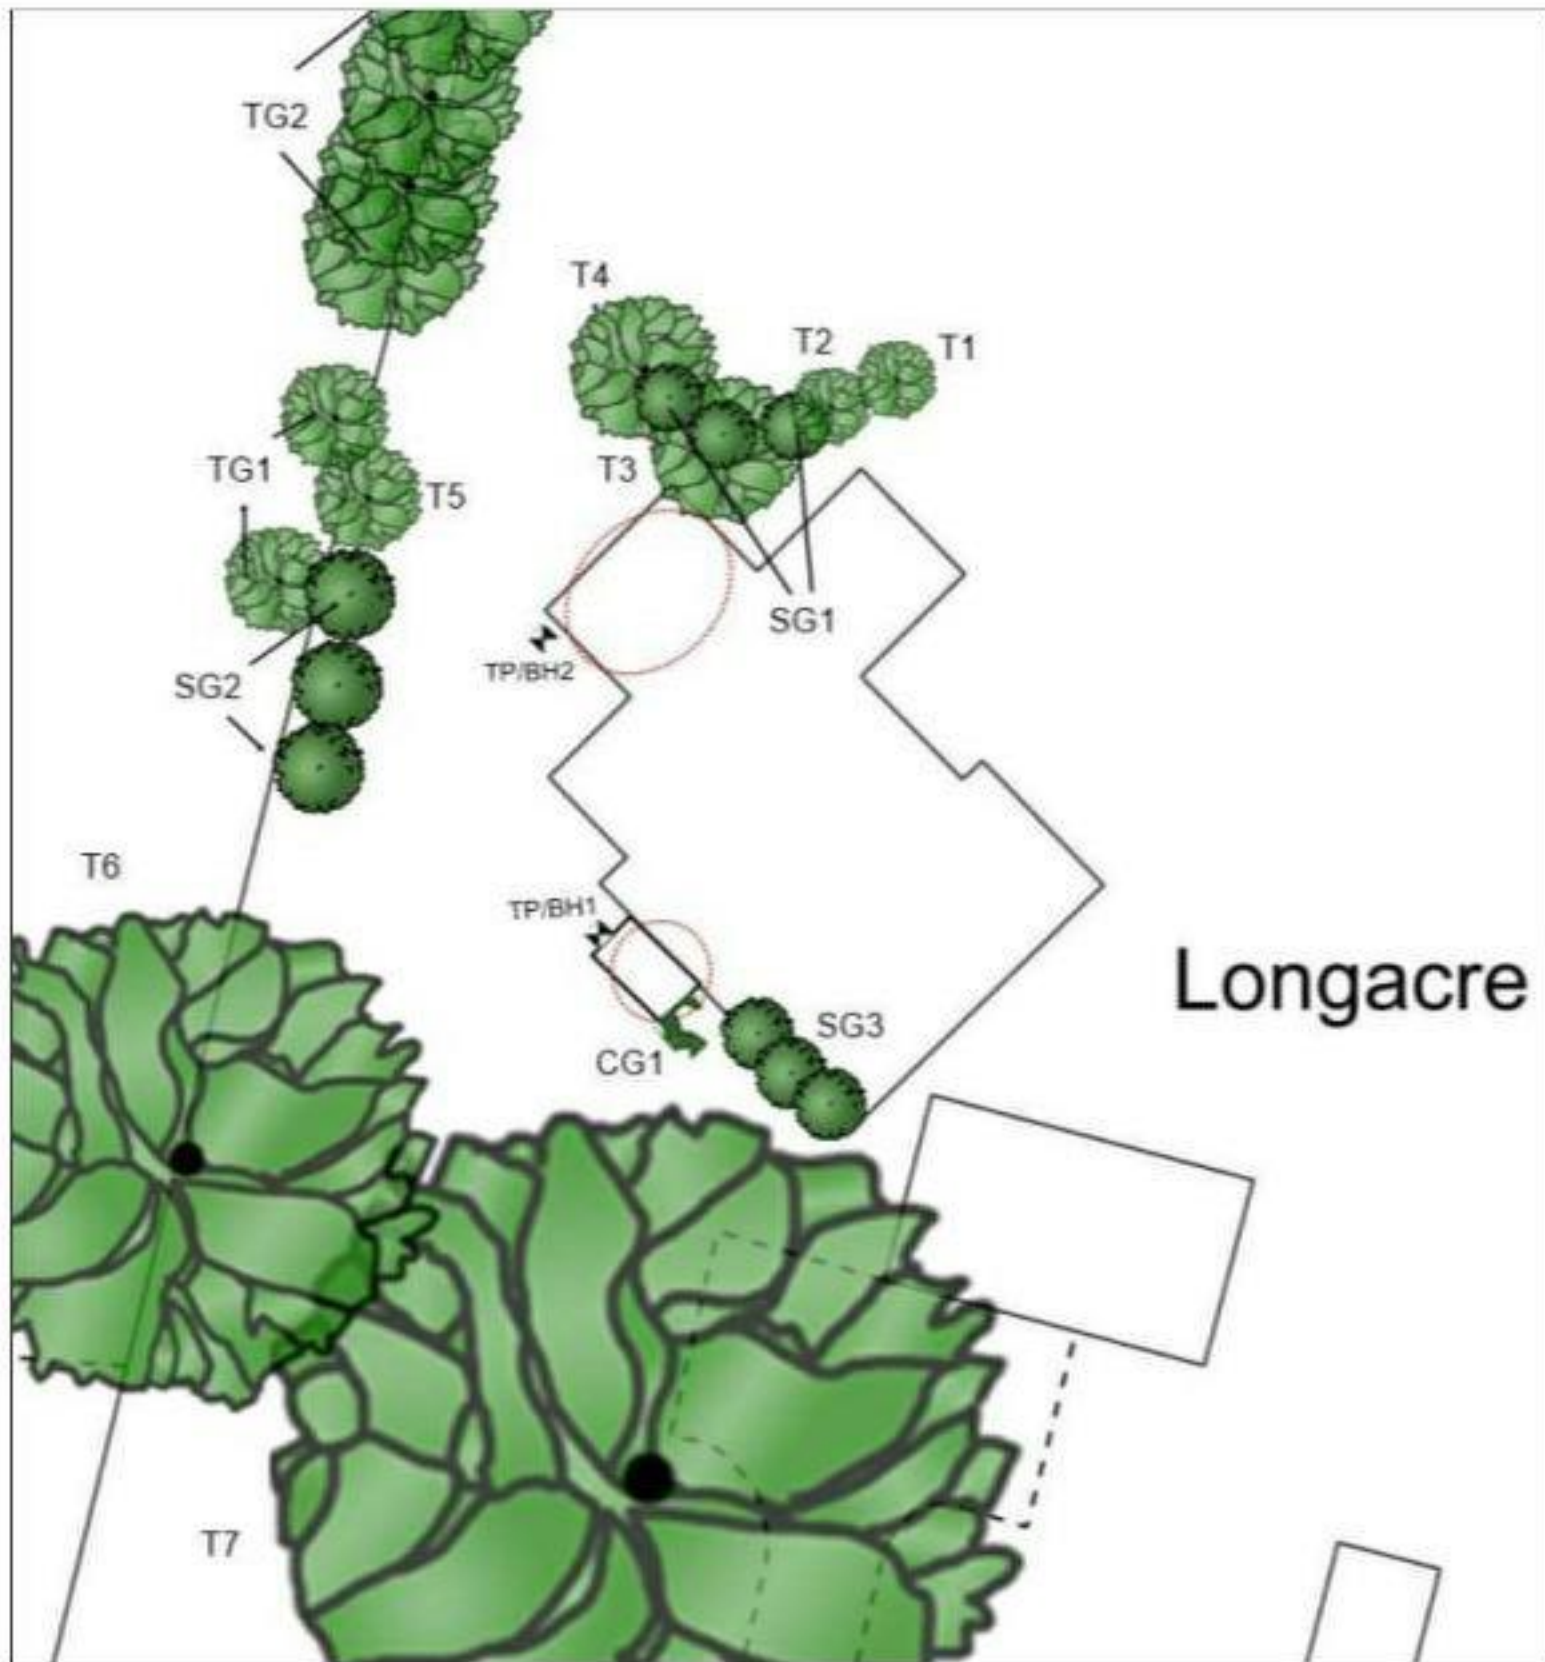
7. Site Plan

Based on our site investigations, and taking account of vegetation location, relative to the focal area of movement/ damage, it is our opinion that, T3 (Prunus), T4 (Poplar) & T7 (Oak) are considered the dominant feature(s) and accordingly we have identified them as the principal cause of the subsidence damage.

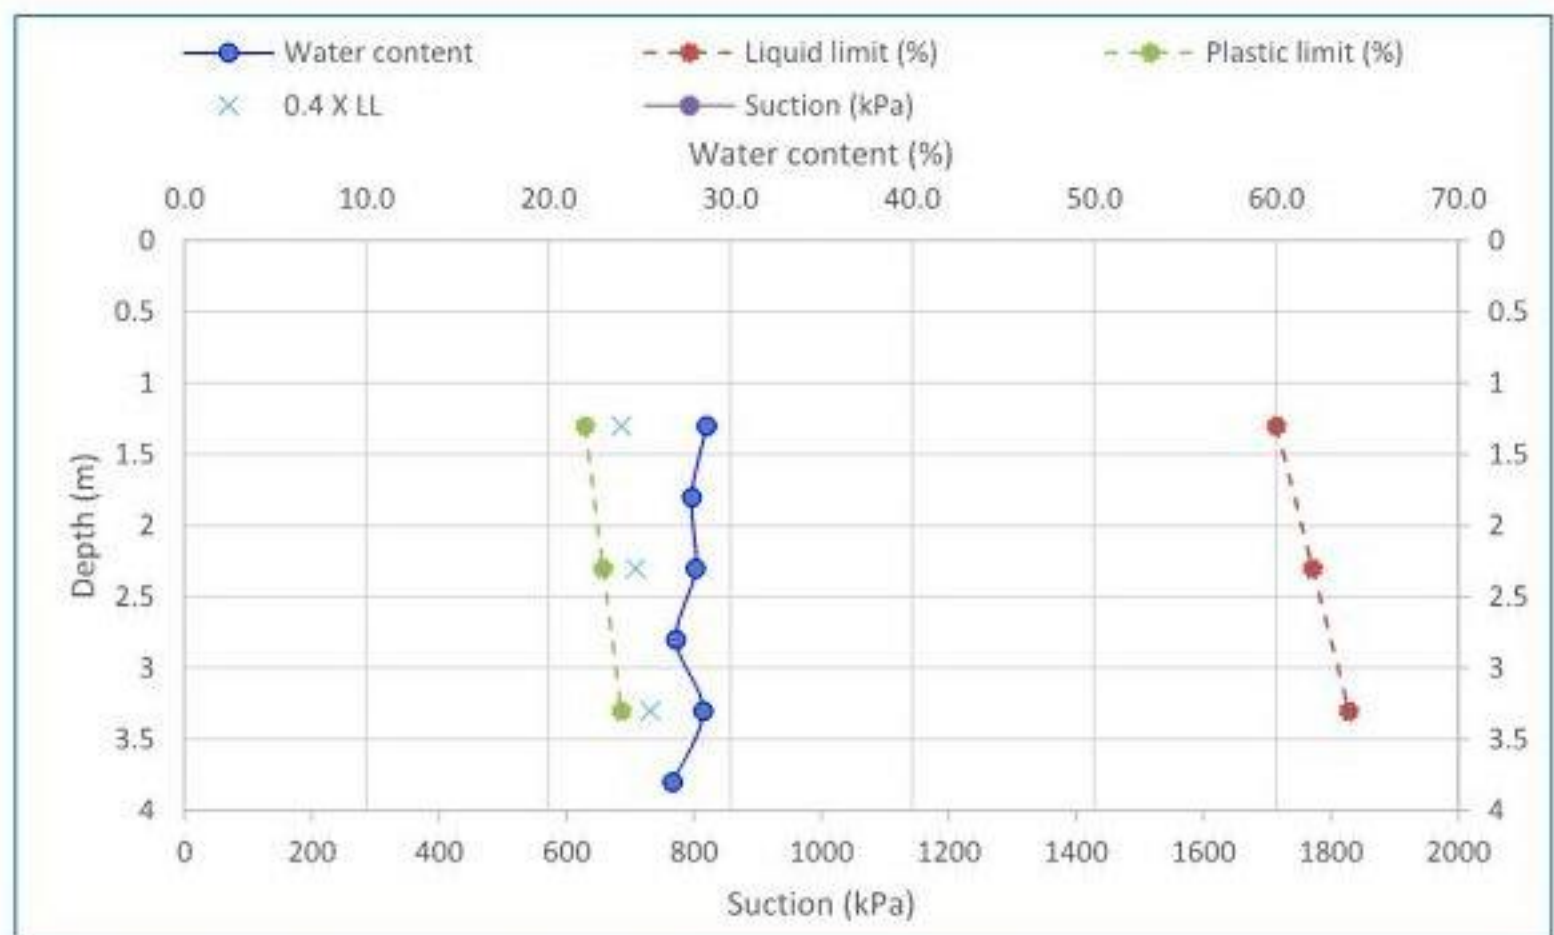
| Lab Ref | Depth (m) | MC (%) | LL (%) | PL (%) | PI (%) | .425 mm(%) | mod. PI (%) | Av. Suc. (kPa) | Description |
|---|---|---|---|---|---|---|---|---|---|
| 5 | 3.3 | 28.5 | 64 | 24 | 40 | 100 | 40 | | Firm brown/orange-brown/light grey veined CLAY with rare gravel and sand. Gravel is fine and medium. |
| 6 | 3.8 | 26.8 | | | | | | | Soft to firm brown/orange-brown/light grey veined CLAY with rare gravel and sand. Gravel is fine and medium. |

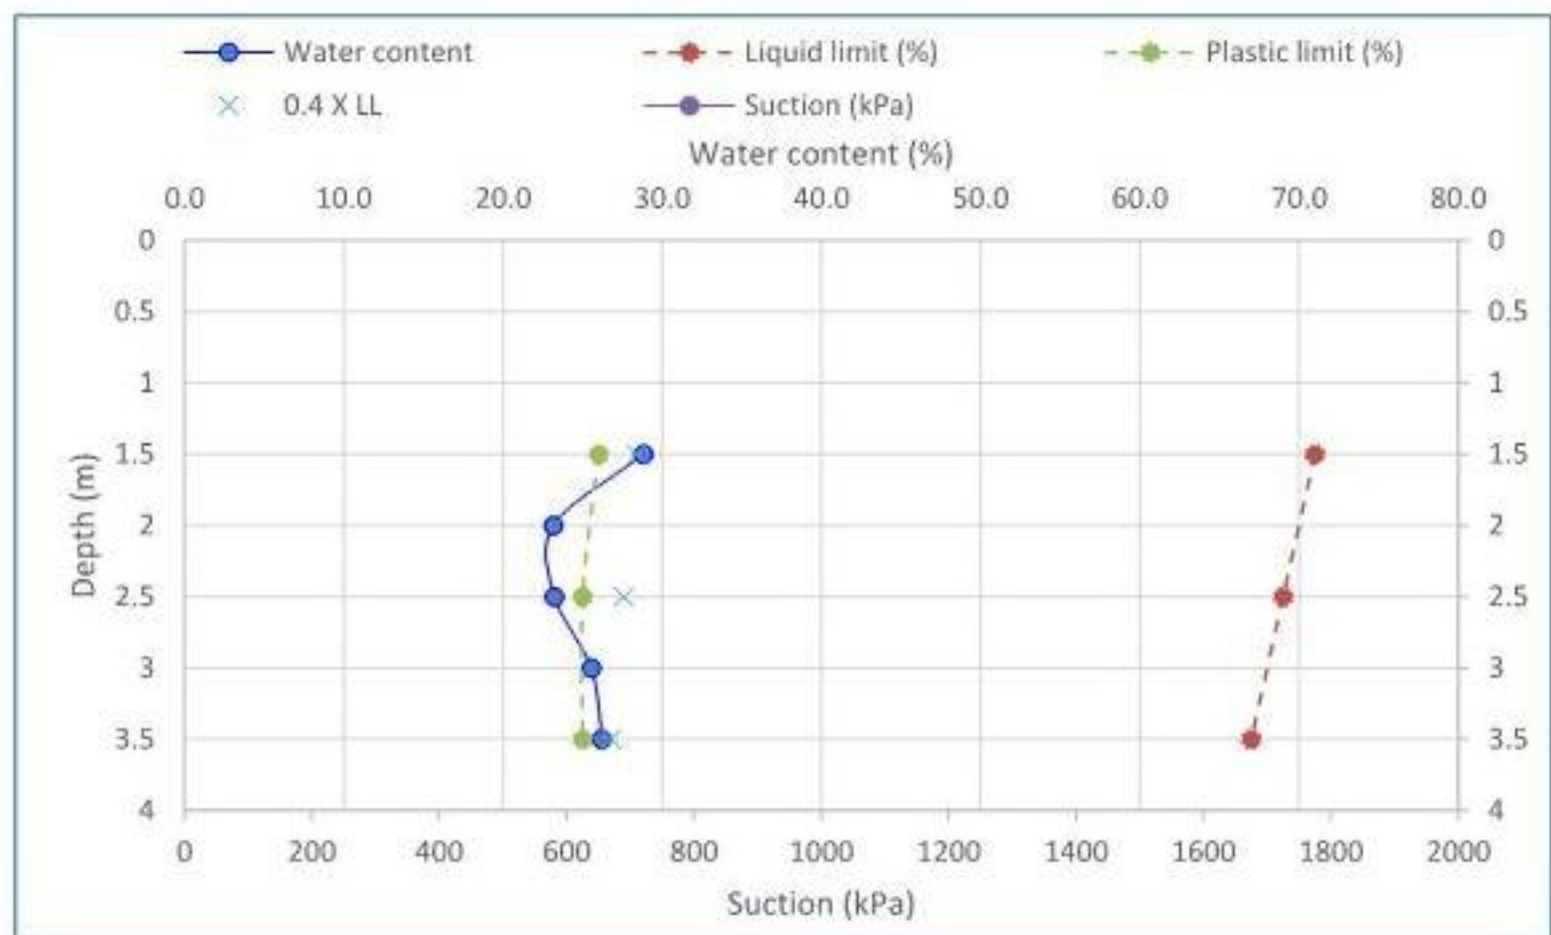
| Lab Ref | Depth (m) | MC (%) | LL (%) | PL (%) | PI (%) | .425 mm(%) | mod. PI (%) | Av. Suc. (kPa) | Description |
|---|---|---|---|---|---|---|---|---|---|
| 10 | 3 | 25.5 | | | | | | | Firm brown/orange-brown/light grey veined CLAY with rare gravel and sand. Gravel is fine |
| 11 | 3.5 | 26.2 | 67 | 25 | 42 | 100 | 42 | | Firm brown/orange-brown/light grey veined CLAY with rare gravel and sand. Gravel is fine |
