# CCTV Inspection Report

Job Number  
**Post Repair Check**

Back To Fitness  
270A London Road  
Waterlooville  
PO7 7HG

A CCTV drainage survey was carried out to ascertain the condition of the existing drainage system and to produce an accurate drawing showing the layout and location of the drainage runs.

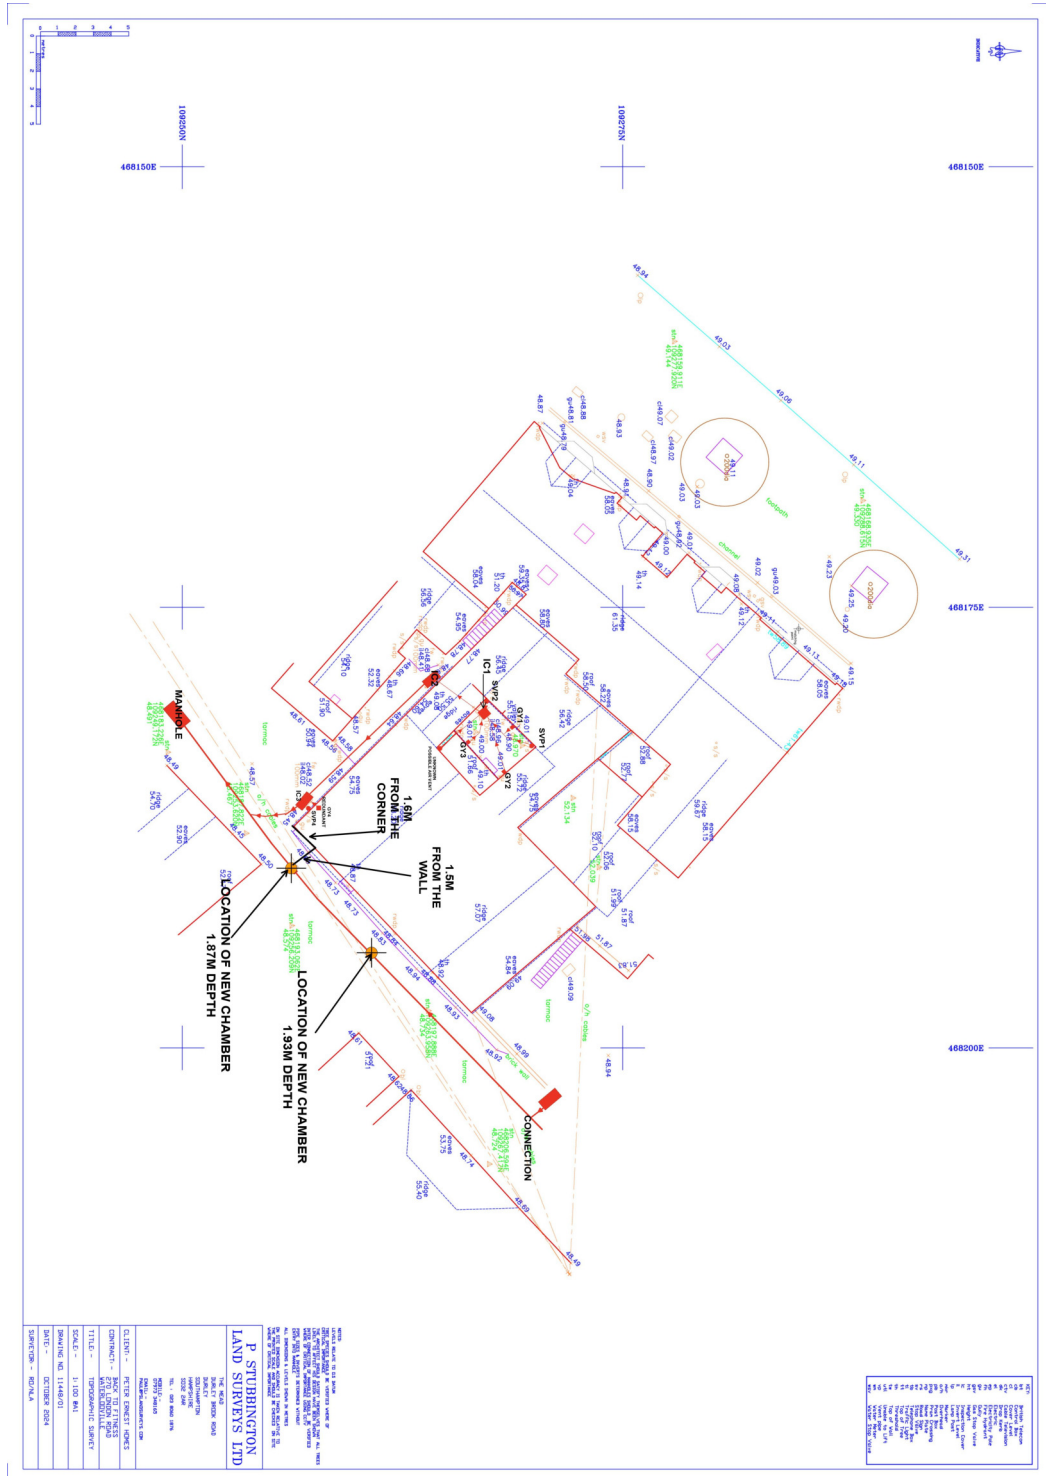
This sketch is not to scale and does not represent the exact routing of the drainage system

- **IC3 upstream GY4 (Redundant):**  
Build-up of **silt** observed within the line.
- **Connection downstream Manhole:**  
Heavy build-up of **scale throughout** the line.  
The main **150mm pipe** has been marked up at **14m** and **20m** (see attached drawing for reference).

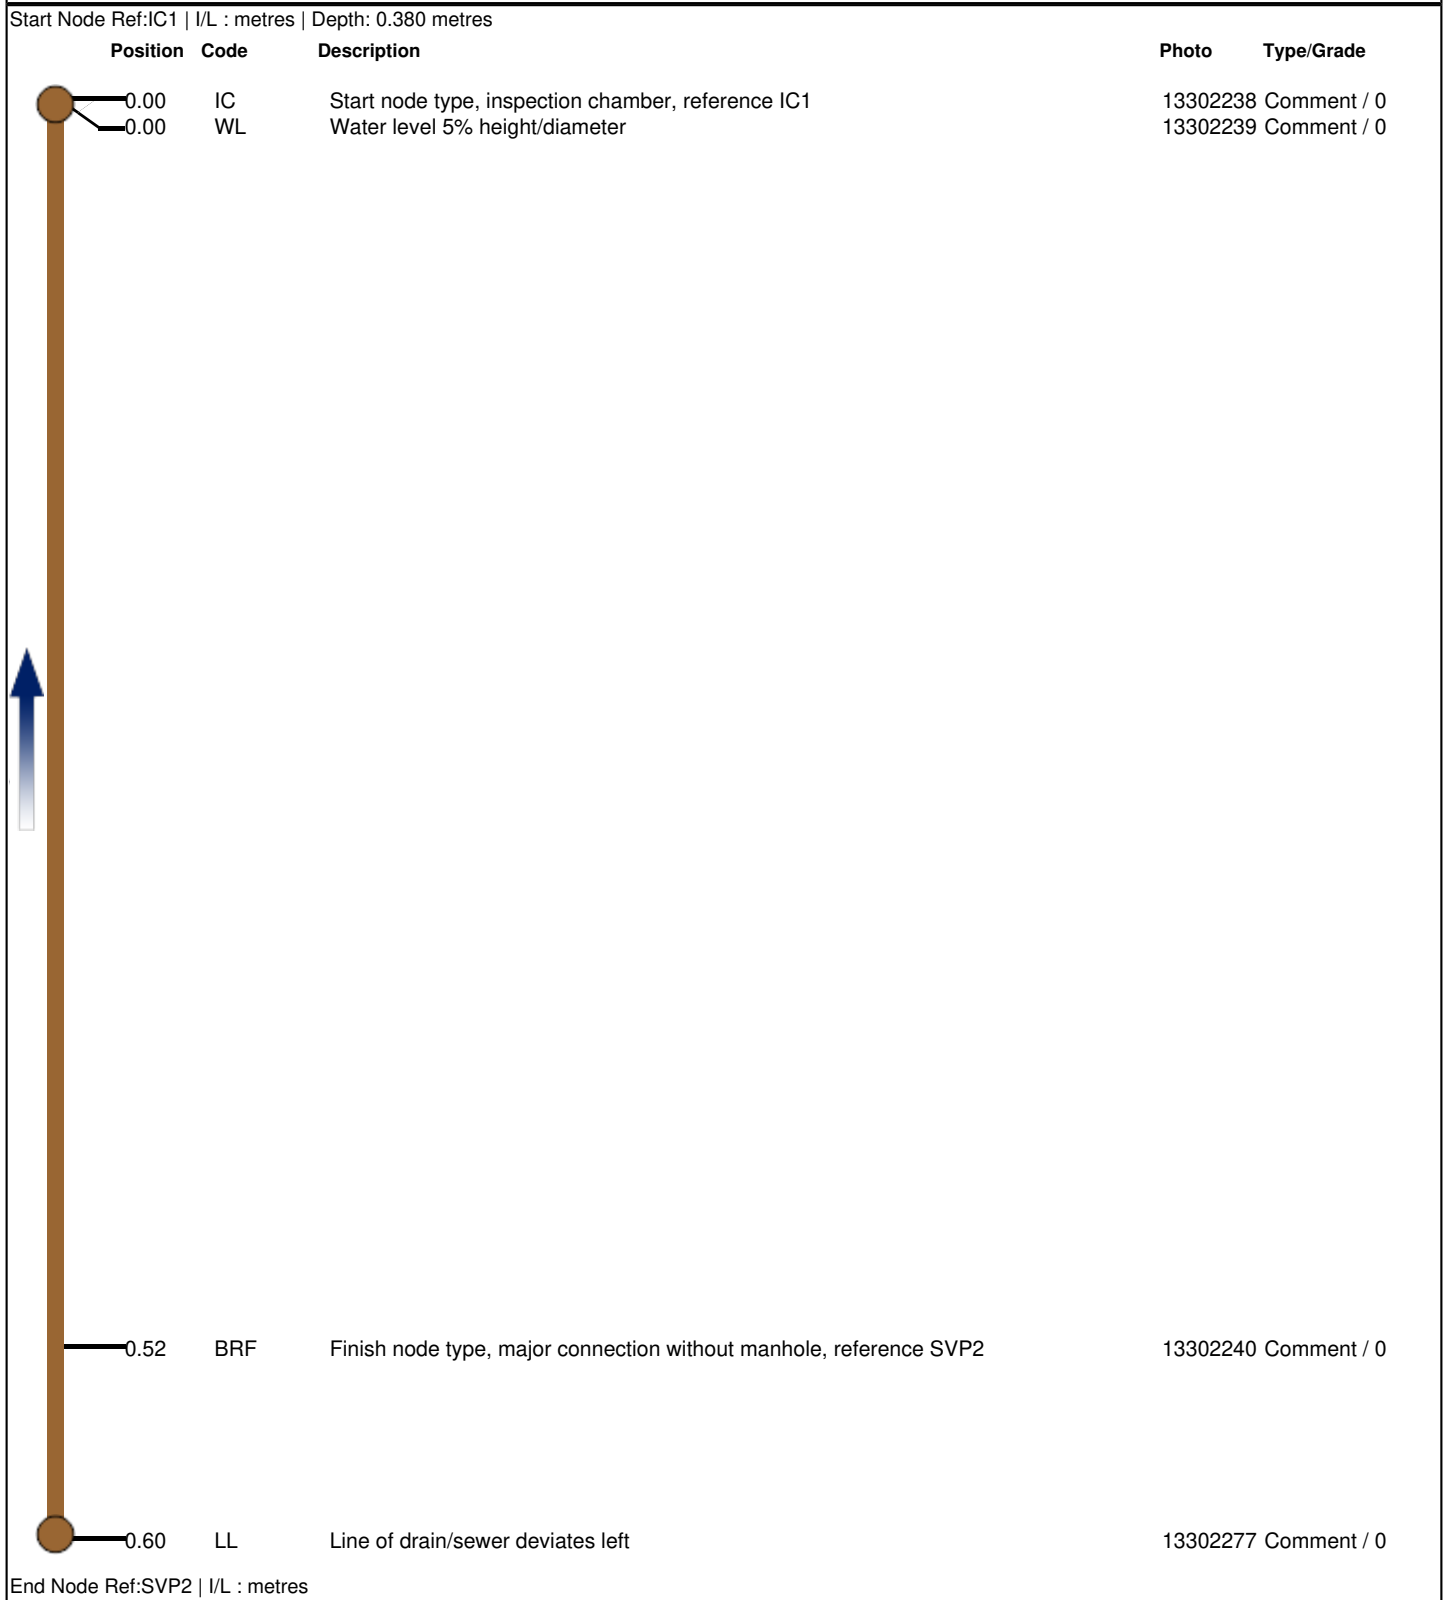
| Surveyed by (Operator)<br><b>BILLY LINK</b> | Job Number<br><b>Post Repair Check</b> | Pipe Length Reference(PLR)<br><b>SVP2</b> | Date<br><b>10/10/2025</b> | Pre Cleaned<br><b>Not Cleaned</b> |

- **IC1 upstream SVP1:**  
A build-up of scale was observed within the line.
- **IC1 upstream SVP2:**  
No defects or issues identified; line is in satisfactory condition.

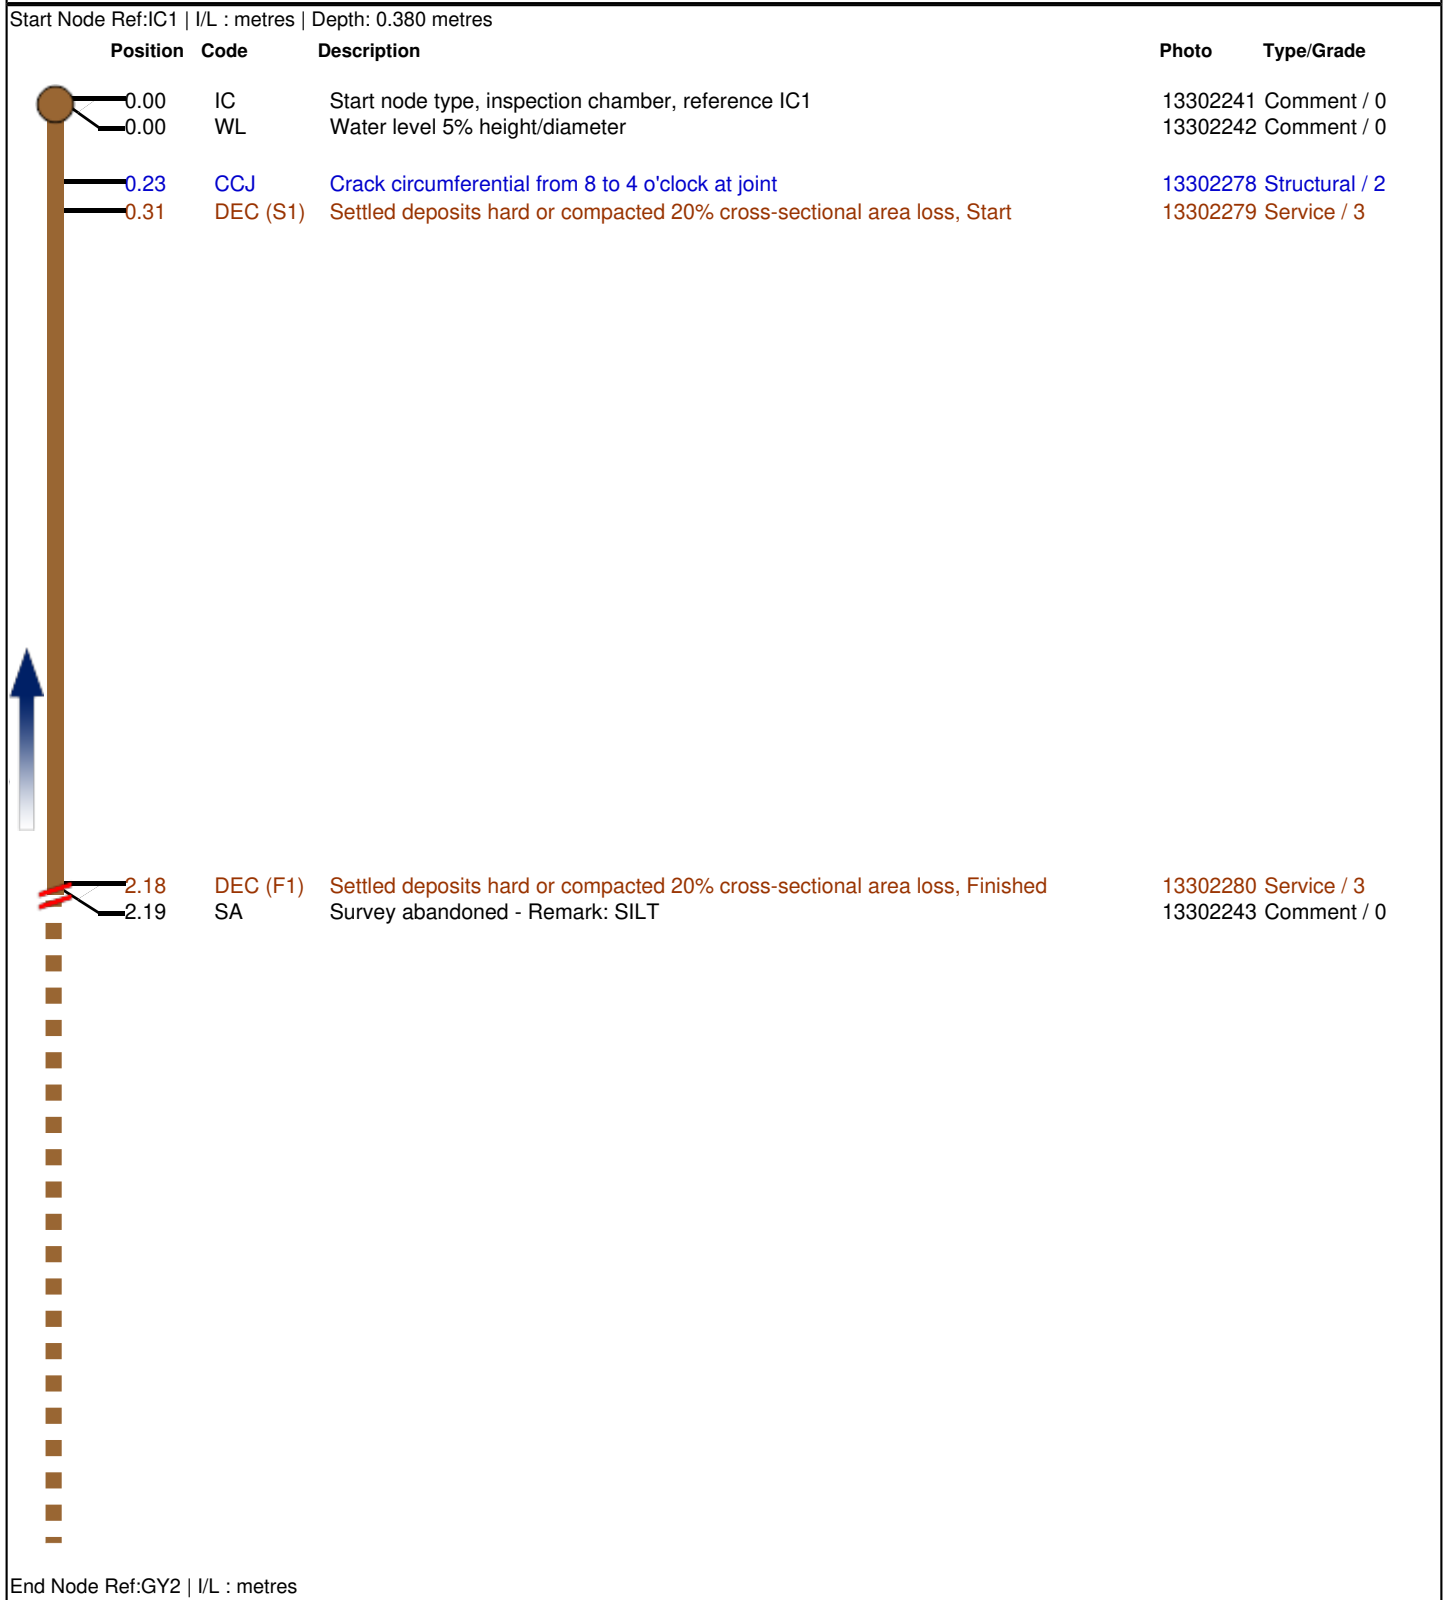
| Surveyed by (Operator)<br><b>BILLY LINK</b> | Job Number<br><b>Post Repair Check</b> | Pipe Length Reference(PLR)<br><b>GY2</b> | Date<br><b>10/10/2025</b> | Pre Cleaned<br><b>Not Cleaned</b> |

- **IC1 upstream GY2:**  
A crack was observed at **0.23m**.  
Build-up of scale noted from **0.31m**, causing the survey to be **abandoned at 2.19m** due to obstruction.

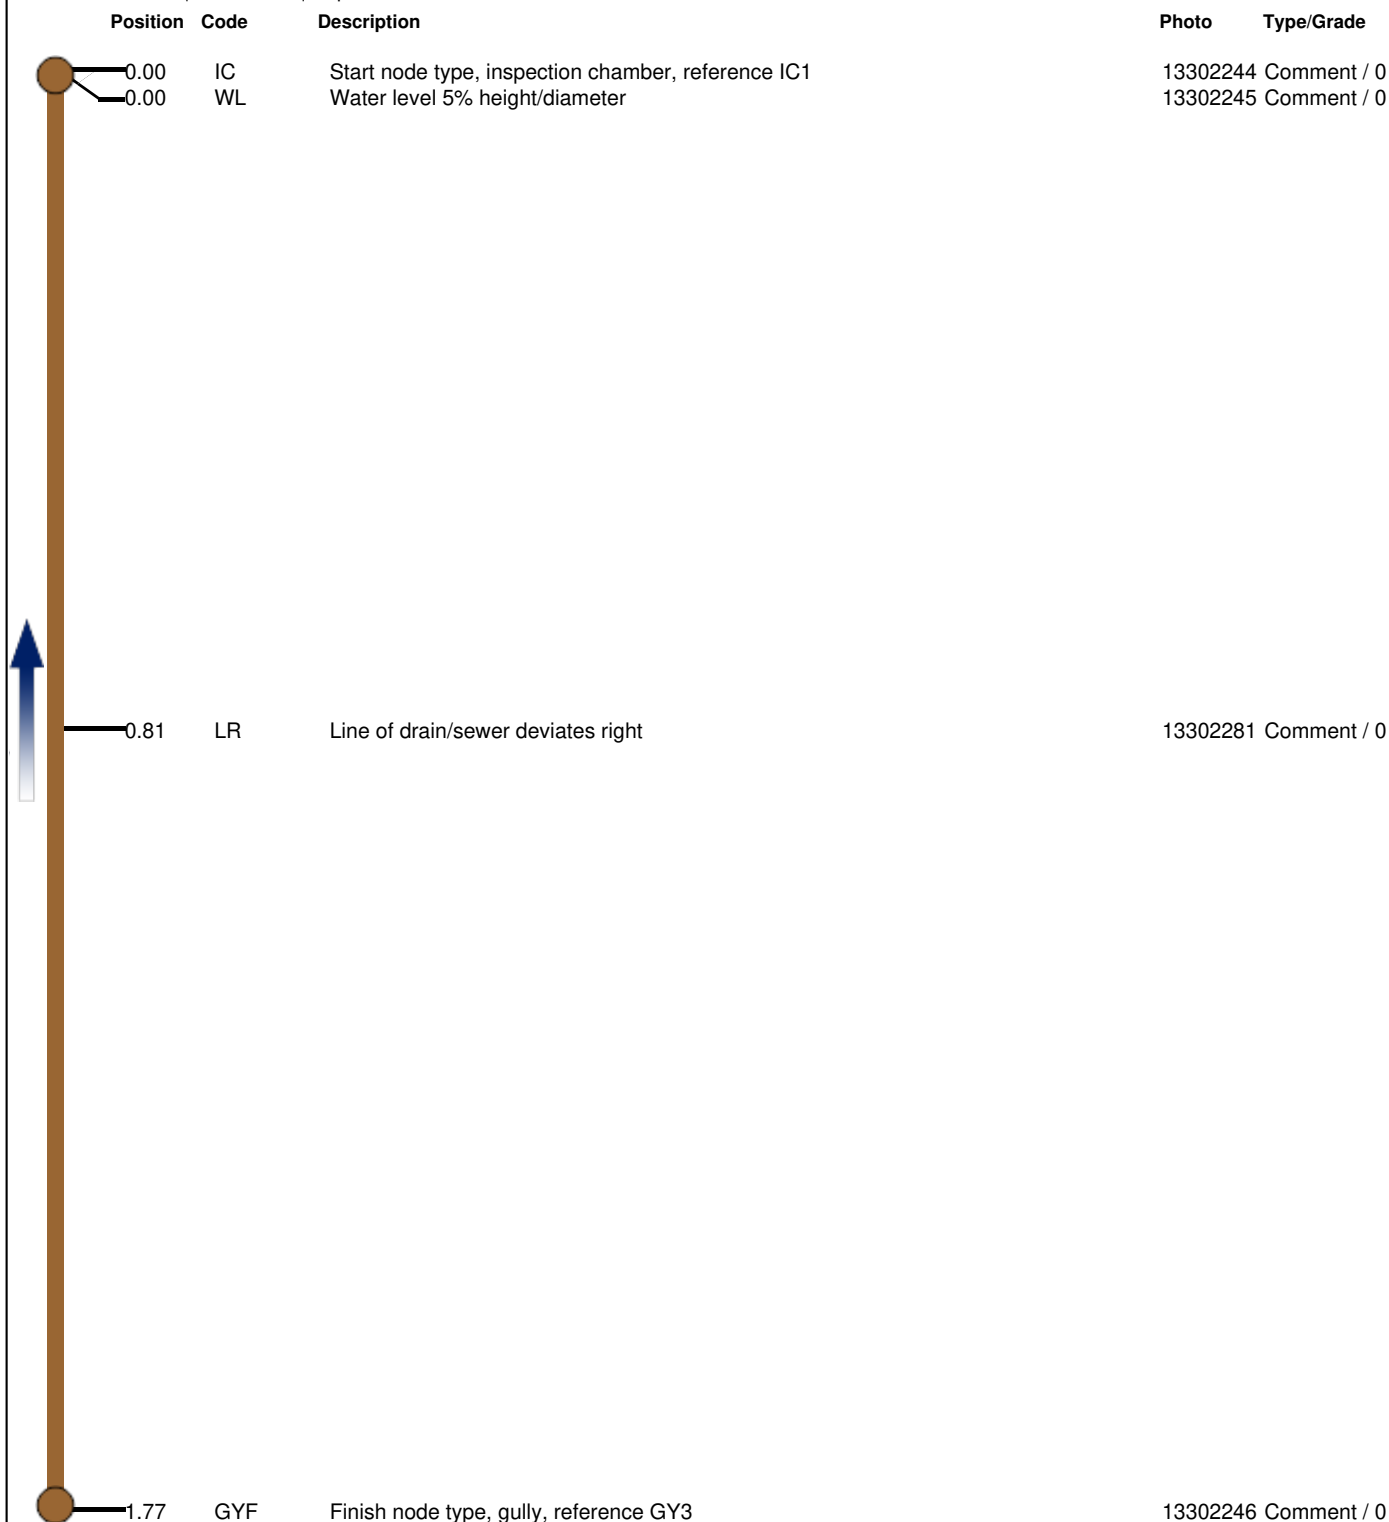
| Surveyed by (Operator)<br><b>BILLY LINK</b> | Job Number<br><b>Post Repair Check</b> | Pipe Length Reference(PLR)<br><b>GY3</b> | Date<br><b>10/10/2025</b> | Pre Cleaned<br><b>Not Cleaned</b> |

- **IC1 upstream GY3:**  
No defects or issues identified; line is in satisfactory condition.
- **IC1 upstream (Unknown):**  
Heavy build-up of scale throughout the line.  
Survey **abandoned at 1.6m** due to blockage caused by scale.

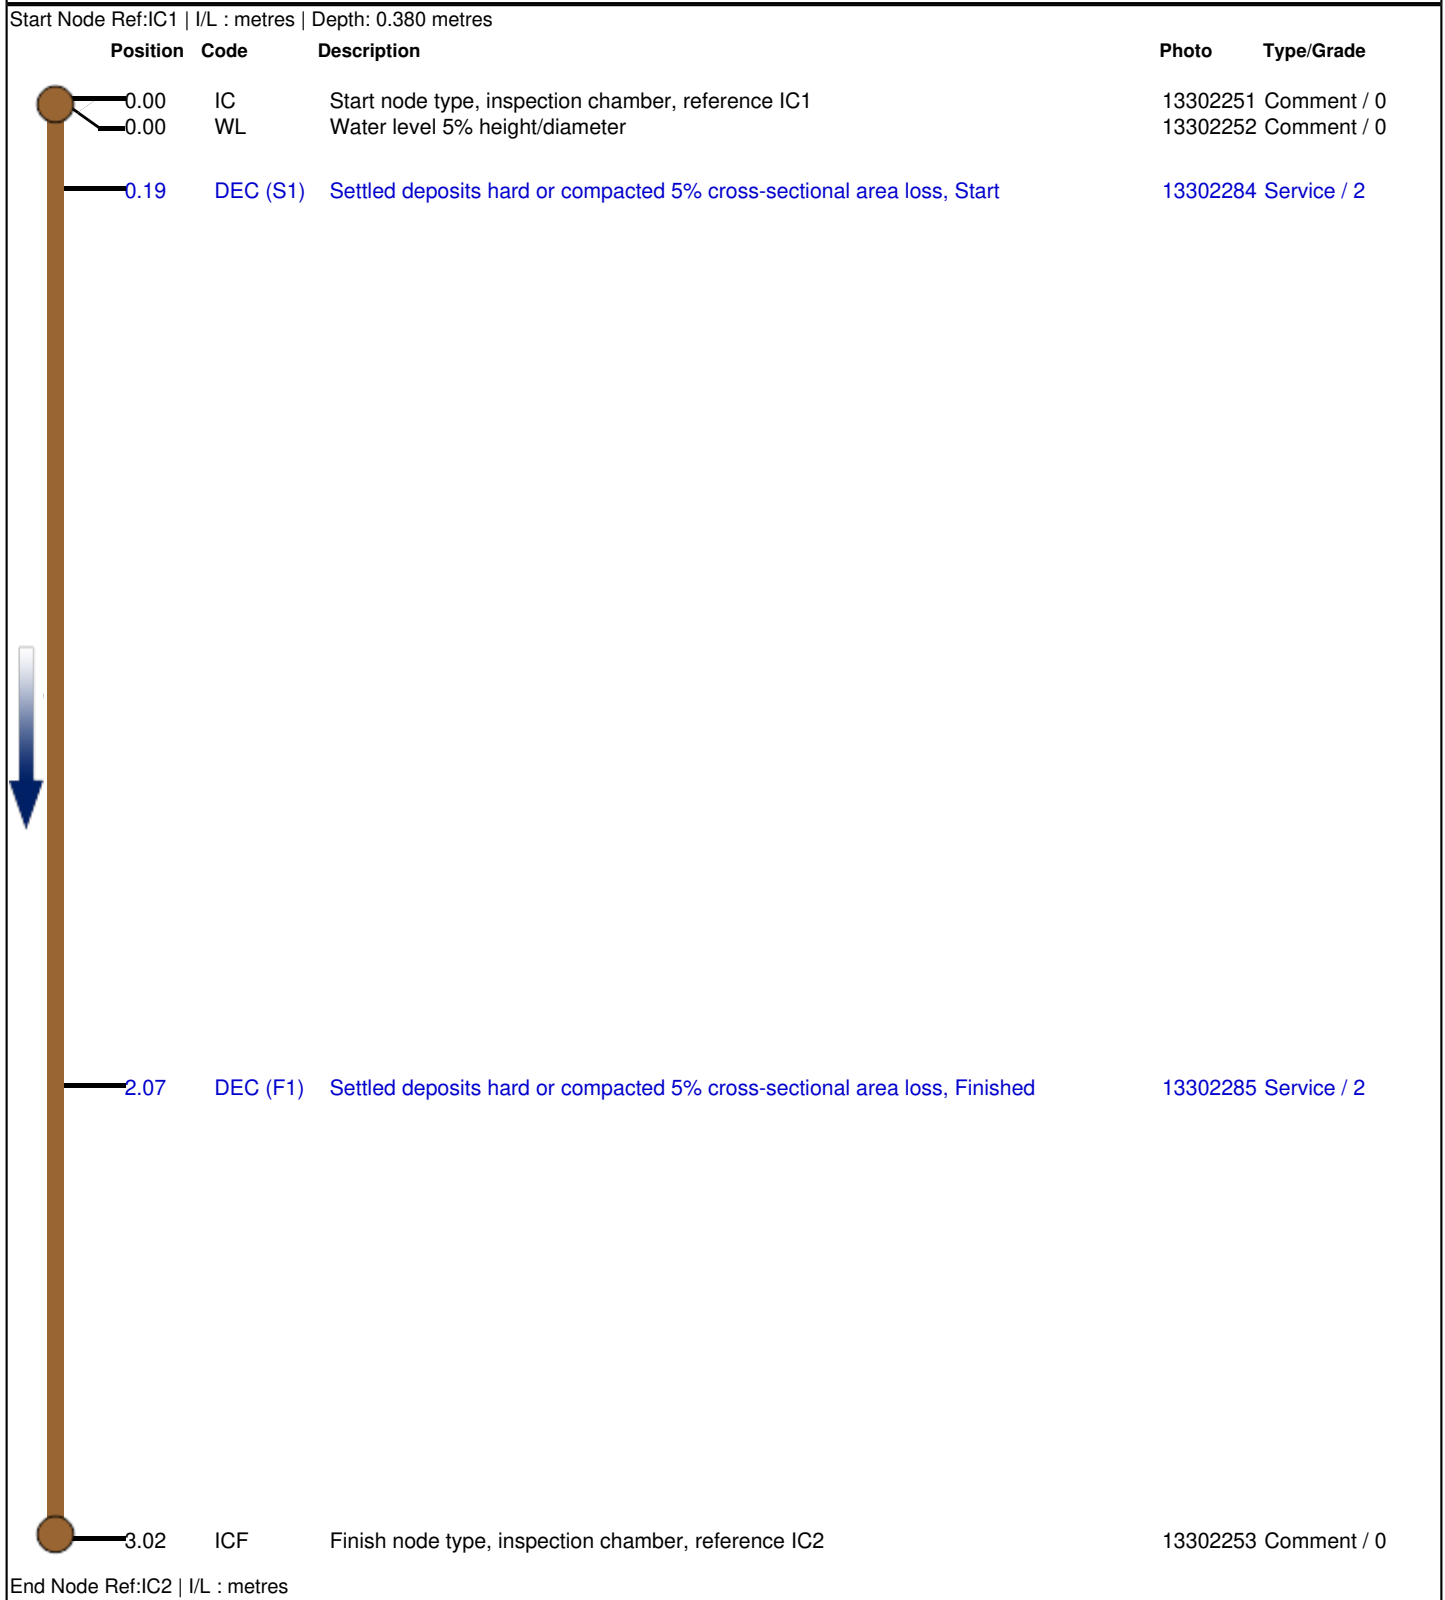
| Surveyed by (Operator)<br><b>BILLY LINK</b> | Job Number<br><b>Post Repair Check</b> | Pipe Length Reference(PLR)<br><b>IC1</b> | Date<br><b>10/10/2025</b> | Pre Cleaned<br><b>Not Cleaned</b> |

- **IC1 downstream IC2:**  
Build-up of scale observed within the line.
- **IC2 to IC3:**  
Unable to complete survey due to the line being **blocked**.
- **IC3 downstream Connection:**  
No defects or issues identified; line is in satisfactory condition.
