# Staunton Country Park

## ‘Lake’ Assessment Technical Note

6 November 2023

**Job Number: P13631**

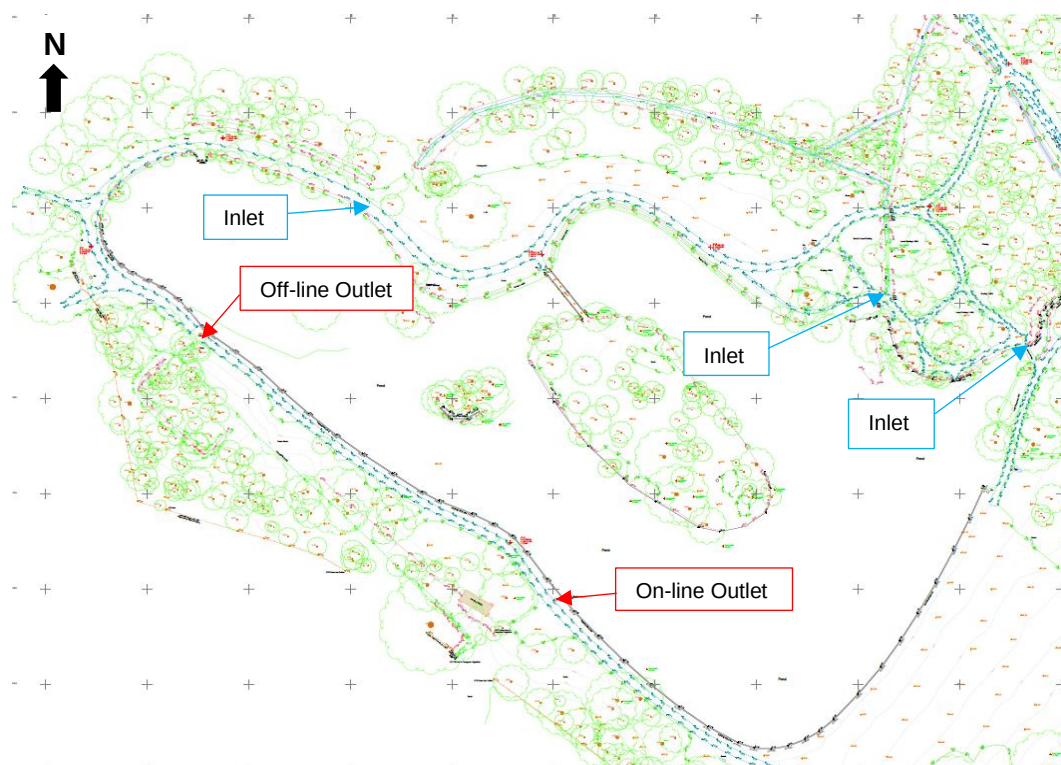
*Figure 2 – Plan showing lake inlets and outlets*

6.2.1 The lake is primarily fed by three known watercourse inlets. For inlet locations refer to Figure 2.

6.2.2 Two watercourses were observed to contribute the majority of flows into the lake, namely the north and north-eastern watercourses. A third watercourse (west of Chinese Bridge) was also observed to contribute flows to the lake. Topographical data suggests this watercourse intercepts runoff from the woodland area to the north-west of the lake, and in addition, has connectivity with the northern watercourse and likely primarily functions as a relief channel by receiving overspill from the northern watercourse in less frequent storm events.

6.2.3 Multiple land drainage outlets were observed to contribute flows into the lake. The outlets were protruding from the wall at intermittent points around the western side of the lake.

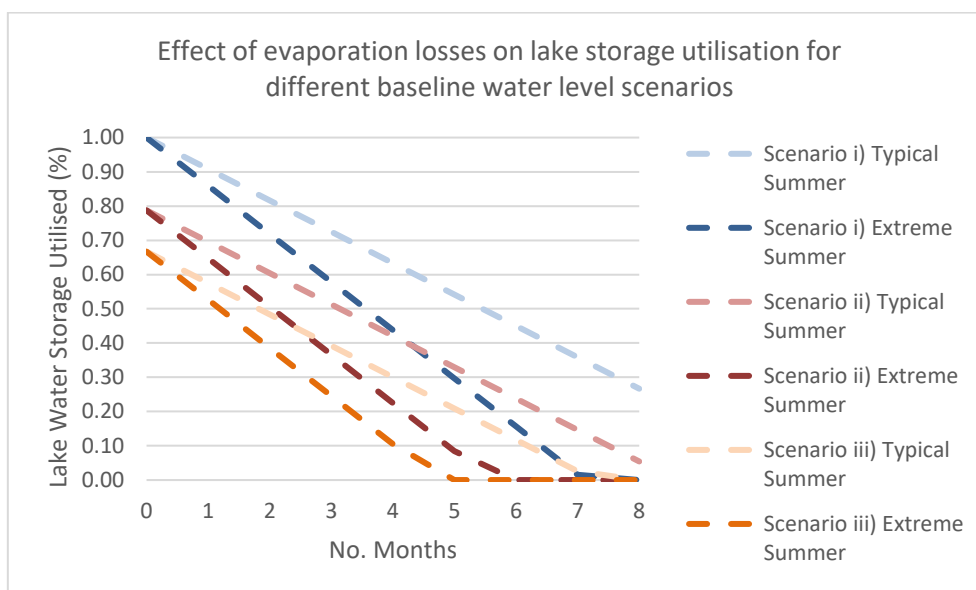
*Figure 6 – Graph showing effects of evaporation loss on the lake*

8.2.5 Referring to Figure 6, taking Scenario iii as a theoretical worst-case baseline, for a typical summer period the lake would lose half its water volume in approximately 3.5 months and its whole water volume in approximately 7 months; for an extreme summer period the lake would lose half its water volume in approximately 2.5 months and its whole water volume in approximately 4.75 months. While these are hypothetical situations based on conservative assumptions, they are possible, and given the likely impacts of climate change on future weather patterns, the extreme situation tests may well become the future norm.

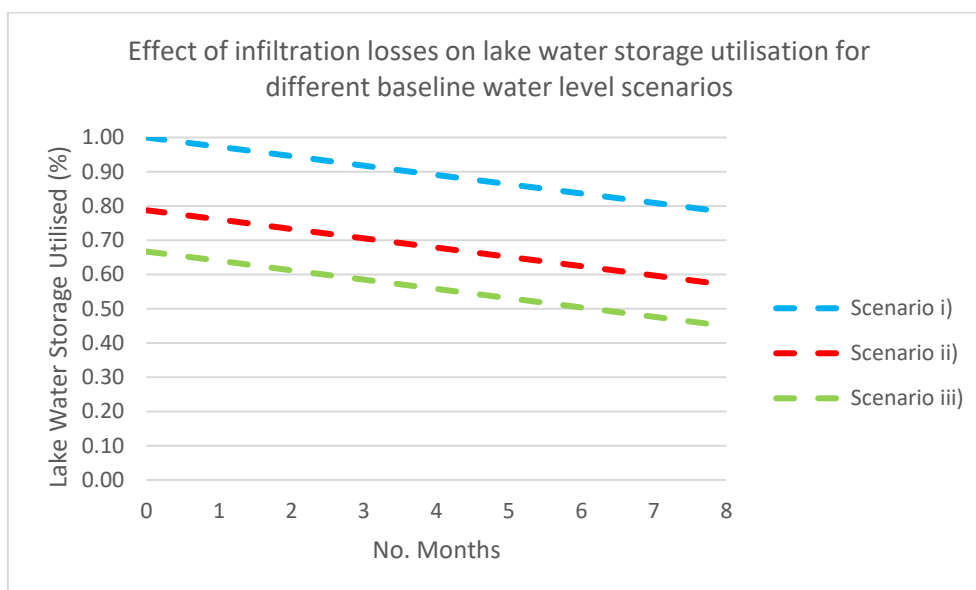
Figure 7 – Graph showing effects of infiltration loss on the lake

- 8.3.4 Referring to Figure 7, taking Scenario iii as a theoretical worst-case baseline, the lake would lose approximately a fifth of its water volume within a 6-month period. This is a relatively small loss, but compounded with other water loss mechanism would not be an insignificant factor.

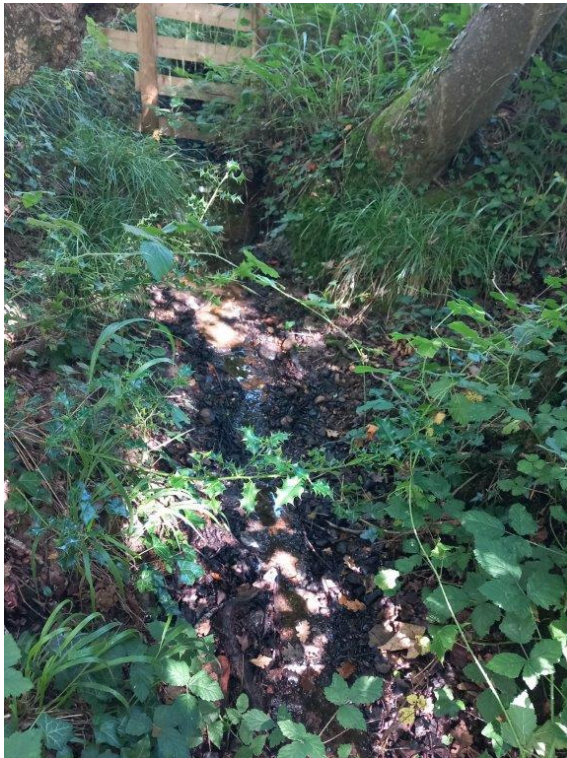
1) Watercourse immediately upstream and north-east of the lake [Report Section 5.2, a)]

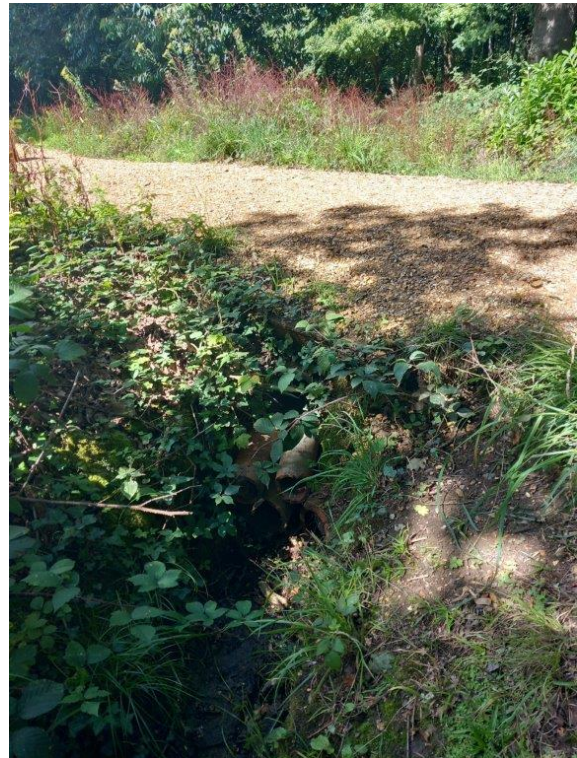
2) Watercourse immediately upstream and north of the lake [Report Section 5.2, b)]

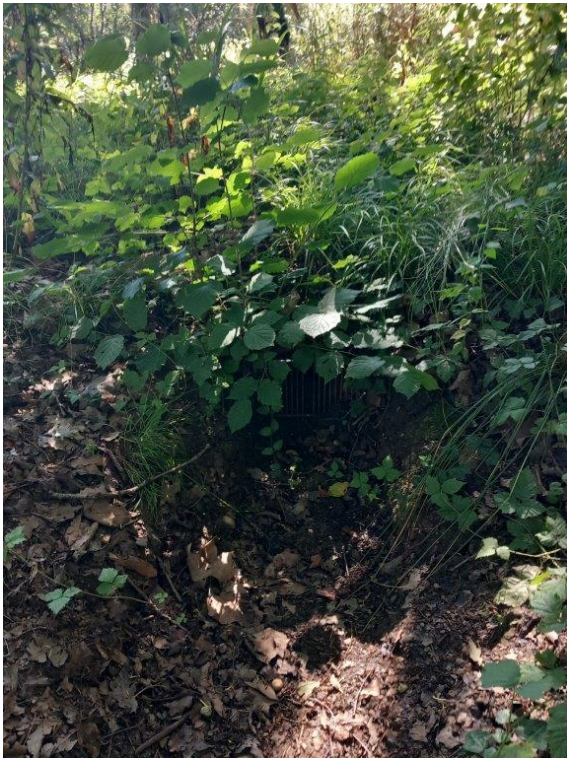
4.3.4 The findings from OS mapping are broadly consistent with topographical survey data and observations from site reconnaissance. However, a third watercourse was observed upstream and north-west of the lake (west of Chinese Bridge), flowing in a southerly direction into the lake via pipe outlet; this is also shown on topographical survey data.

3) Watercourse immediately upstream and north-west of the lake (west of Chinese Bridge) [Report Section 5.2, c)]

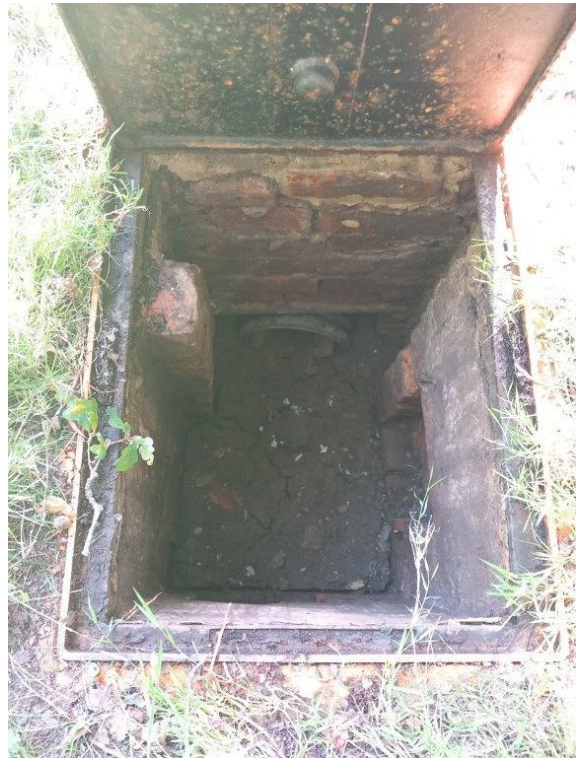
4) Chamber on watercourse immediately upstream and north-west of the lake [Report Section 5.2, c)]

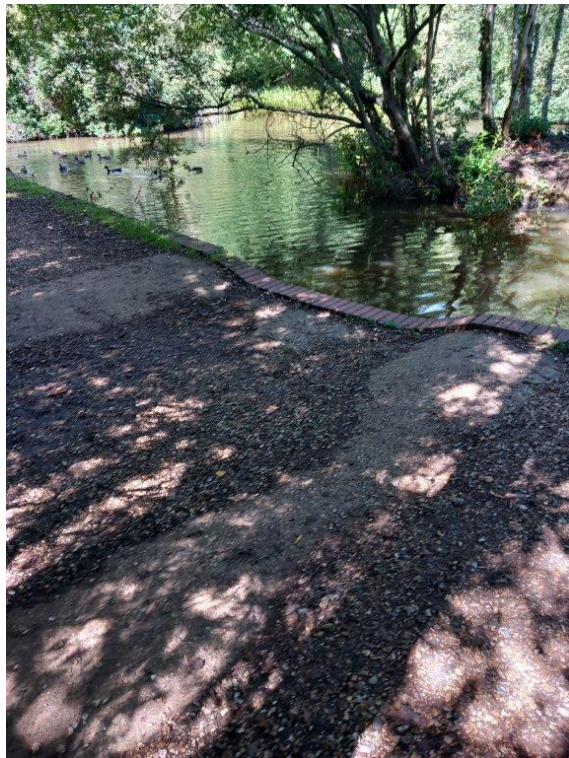
11) Off-line outlet spillway [Report Section 5.2, i)]

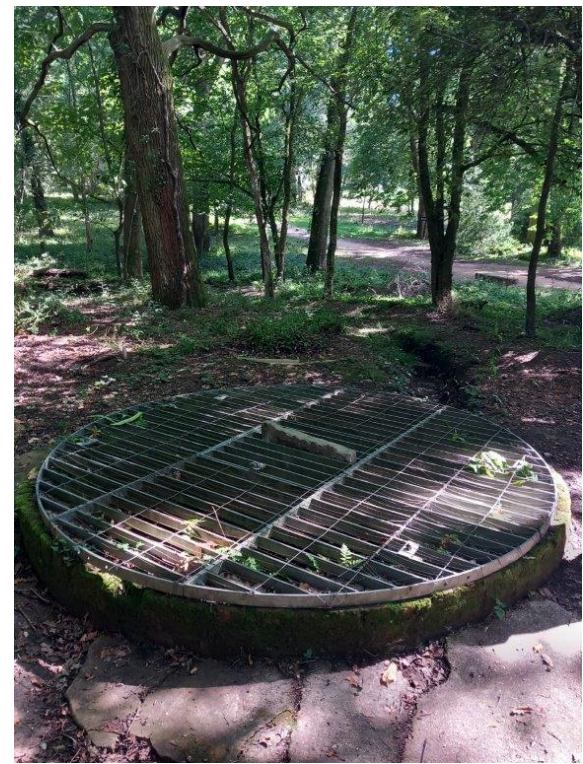
- l) A 'Well House' chamber structure is located approximately 50m north of lake. Anecdotally, this provided water supply to the house. The 'Well House' has an overflow channel which has connectivity with the north-east watercourse upstream of the lake. The chamber structure is covered with a grating; water was observed within the chamber, but no water was observed flowing from the chamber, hence the overflow channel was dry.
- m) A spring-like feature was observed in the field approximately 200m north-west of the lake; the water source is unknown. Water was observed overtopping an above ground trough feature and flowing overland and downhill towards the watercourse immediately upstream and north-east of the lake. Also, iron staining was observed at ground level local to the trough and in the overland flow route downstream.

16) 'Well House' chamber structure [Report Section 5.2, l)]
