# Gas Membrane Verification Report

**Lidl, Havant**  
**Somborne Drive**  
**Havant**  
**PO9 5AN**

# GeoShield Verification Report 1

PROJECT: Lidl, Havant

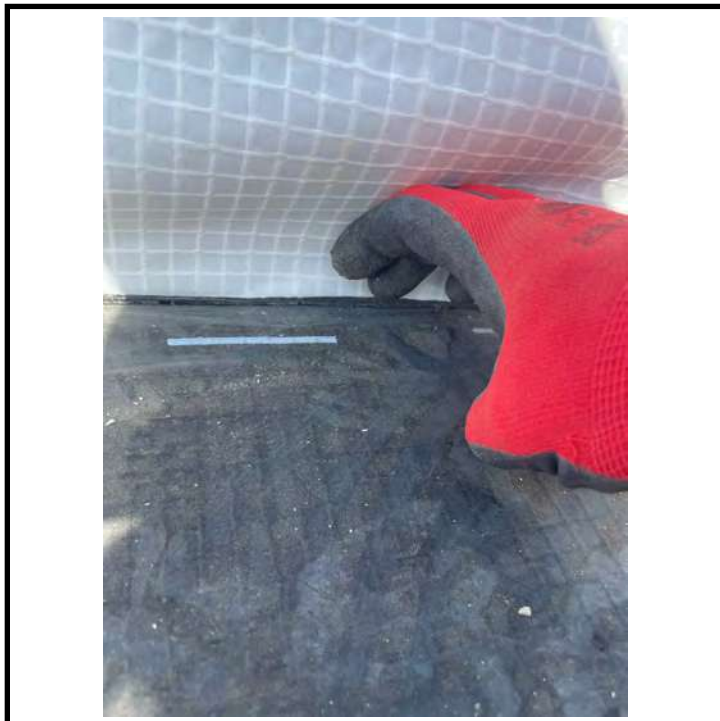
LOCATION/GRID LINE: Hashed black line area

Today's verification visit was inspect the installation of the Corden EPS total gas barrier. Each lap has been sealed firstly with the Corden EPS double sided butyl tape, pressure has been applied to ensure a continuous seal has been achieved.

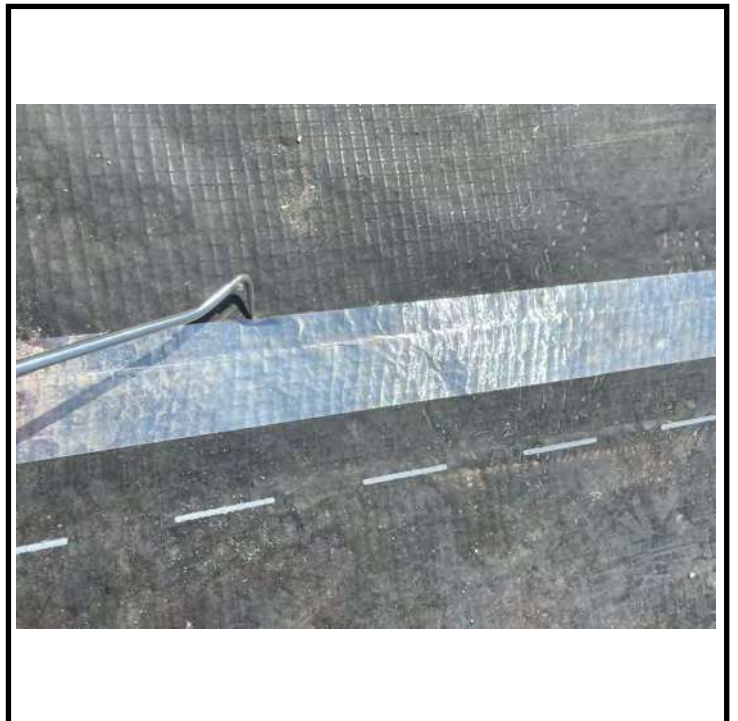
Further to this the installation team have then sealed each lap using the Corden EPS aluminium lap tape. Each lap was successfully sealed ensuring the continuity of the membrane.

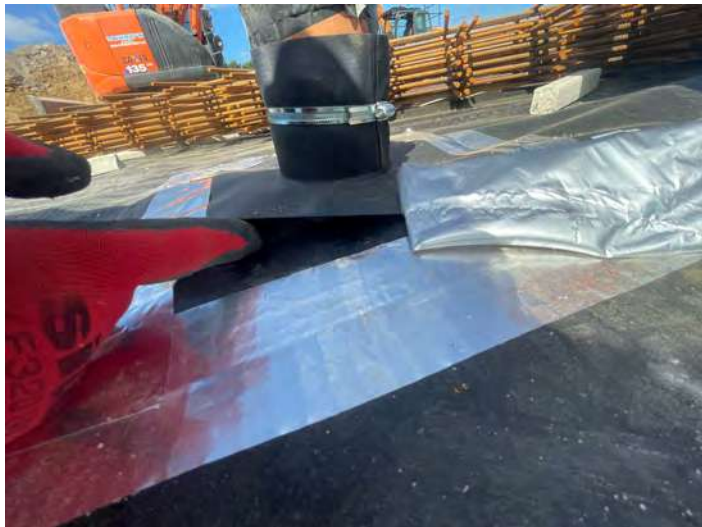
Pipe penetrations

As can be seen from the above photograph all the pipe penetration were firstly sealed using a cordon top hat preformed detail. Each top hat was sealed using the cord EPS double sided tape.

In addition to this or lapse were further sealed using the cordon EPS aluminium lap tape. A jubilee lip was then used to seal the top section to the pipe penetration however as no double sided tape was noted these pipe penetration is require remediation.

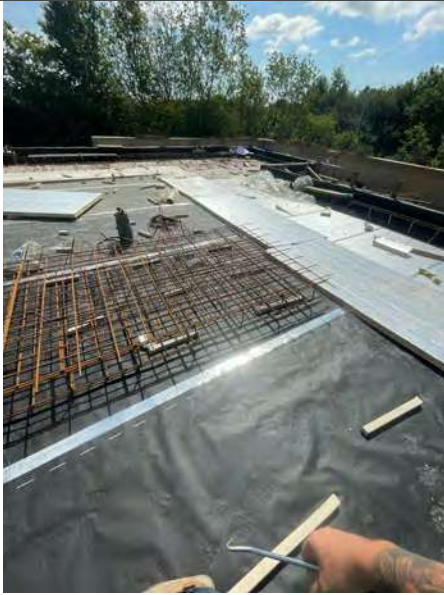
Additional photo of area where verification inspection took place.

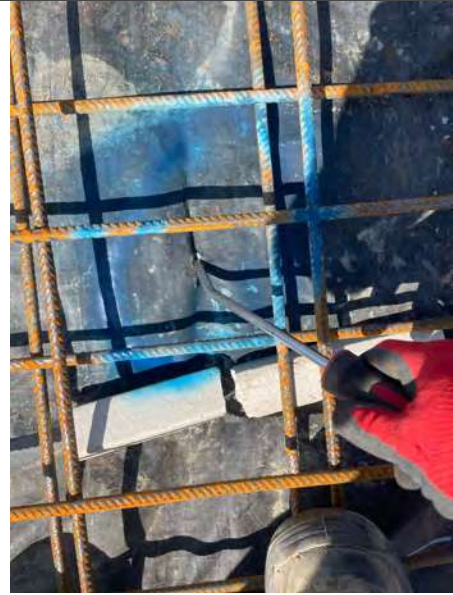
Additional image of identified fault

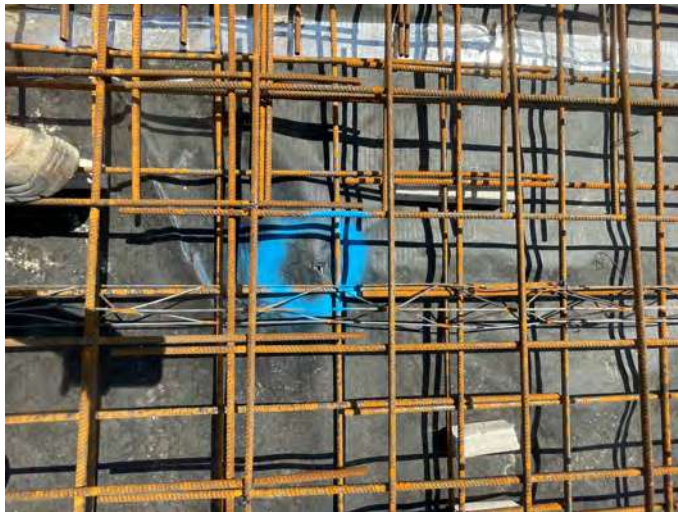
Additional image of identified fault

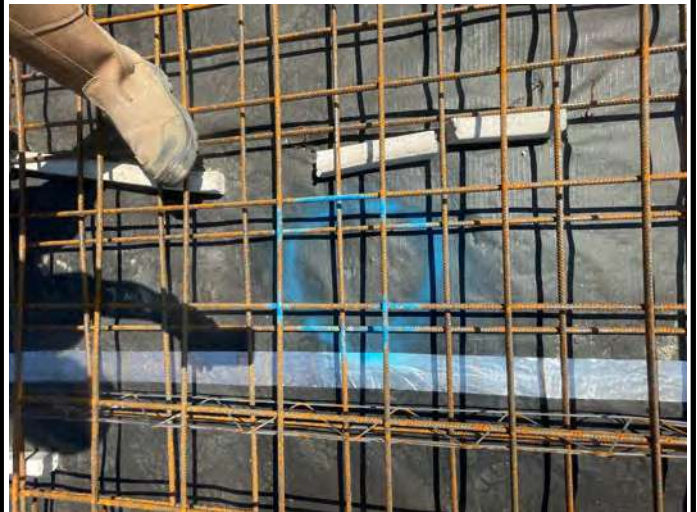
Additional image of identified fault

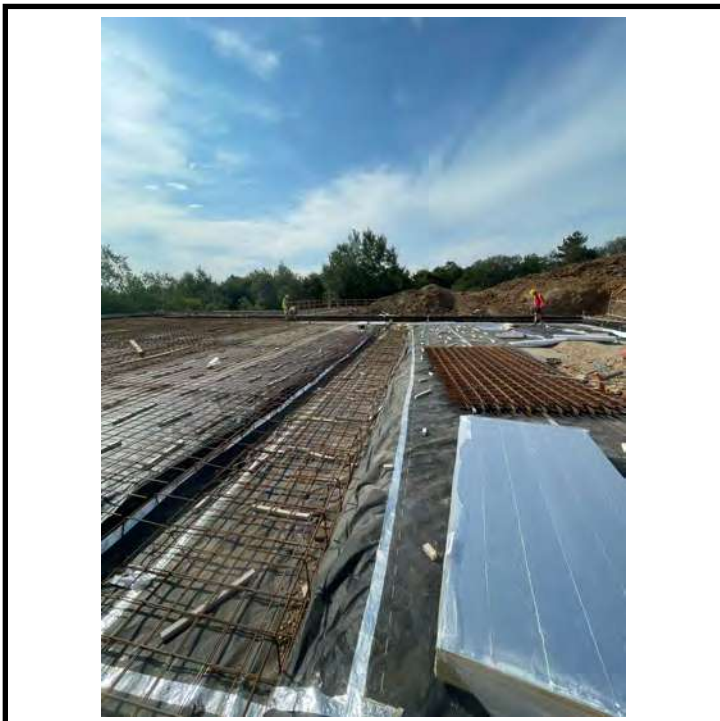
LOCATION/GRID LINE: Orange highlighted area

Today's verification visit was inspect the installation of the Corden EPS total gas barrier. The Corden double sided butyl tape has been used to seal each lap.

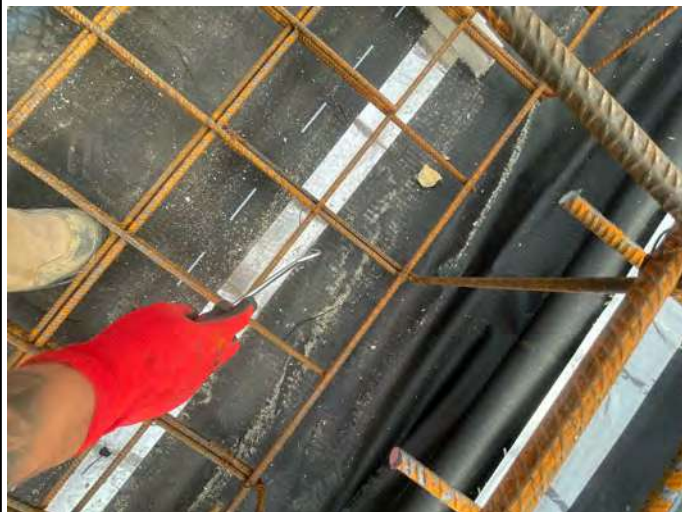
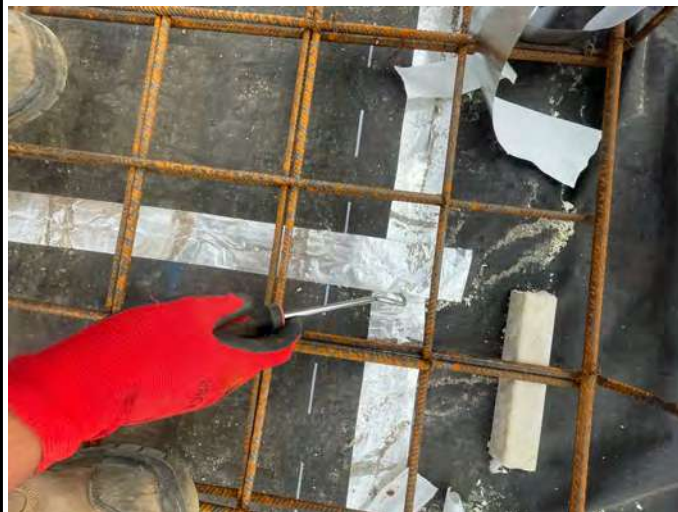
Photo of repair that was carried out to the thickening section which was outstanding from the previous visit.

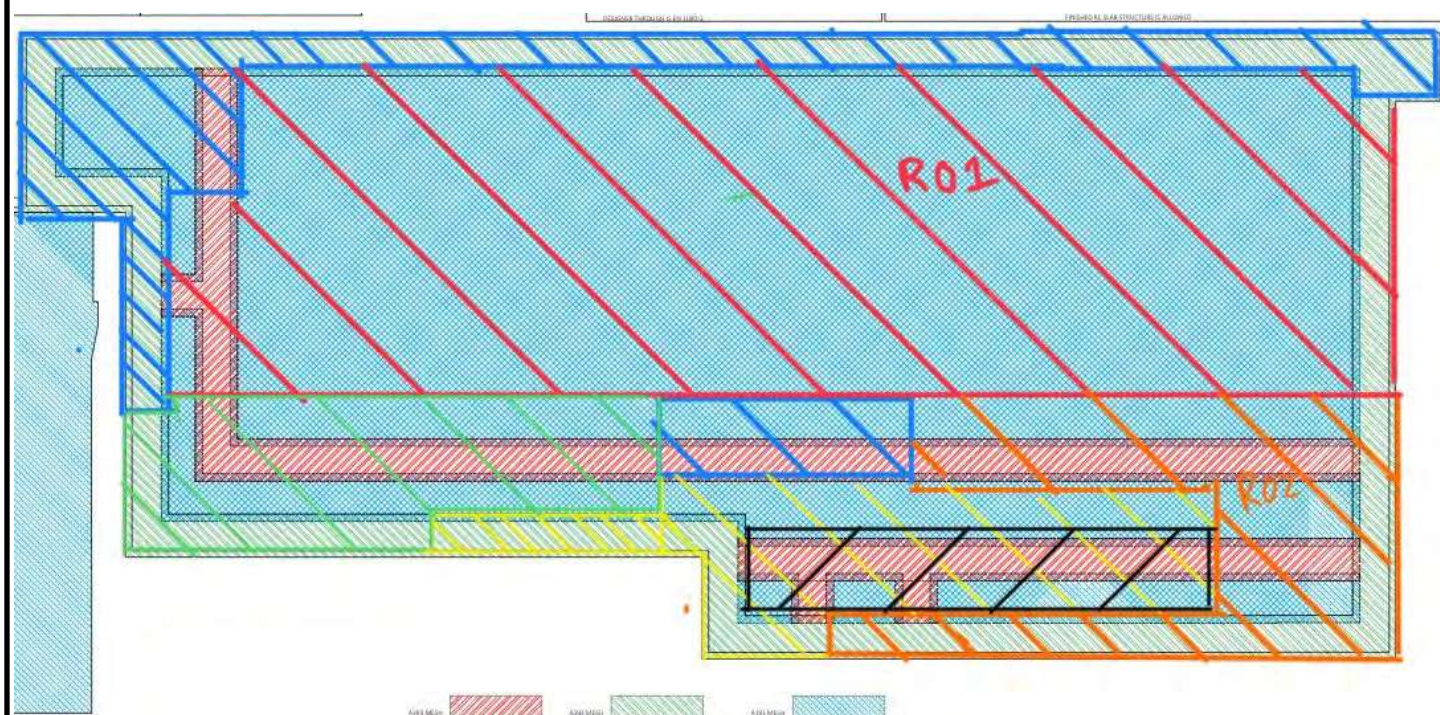
The photograph above shows a plan layout of the site. The area highlighted in yellow shows where the verification inspection took place on site today.

As can be seen from the above image there is an area outlined in black to the area inspected (yellow) which has been covered with insulation and steel reinforcement. Due to this being in place and unable to remove on site the client will need to provide photographic evidence of the membrane installation to this area.

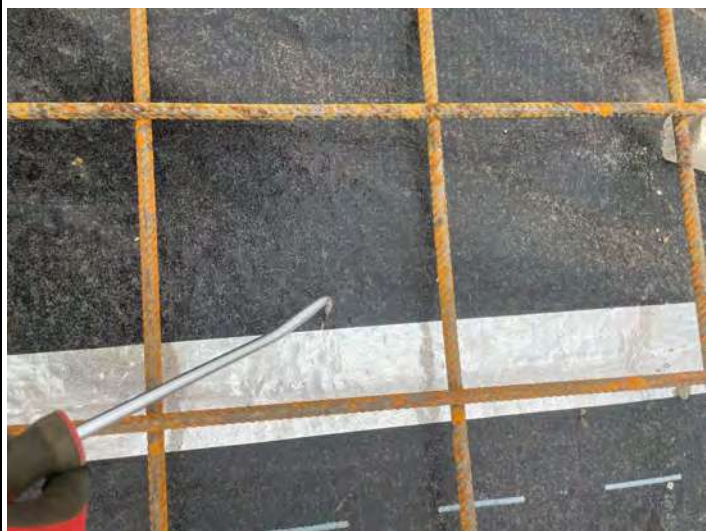
LOCATION/GRID LINE: Yellow highlighted area

Today's verification visit was inspect the installation of the Corden EPS total gas barrier. To the area highlighted in yellow, The Corden double sided butyl tape has been used to seal each lap of the adjacent sheets of membrane.

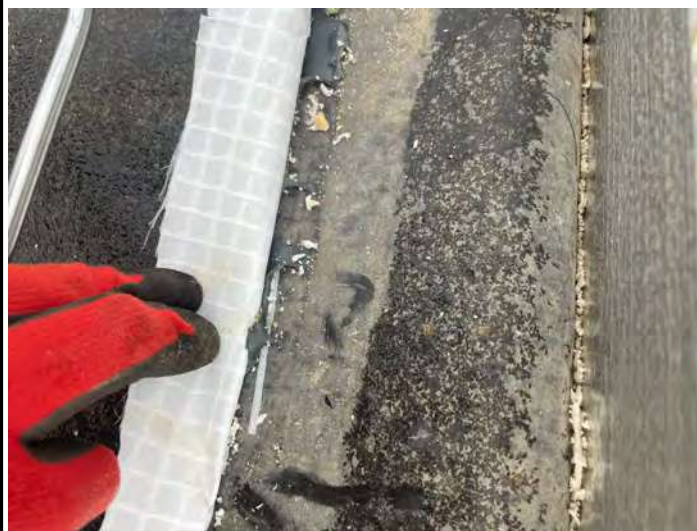
As per the design this is has then been further sealed using the Corden EPS lap tape. A thorough visual inspection coinciding with a mechanical stress point test was carried out to available areas.

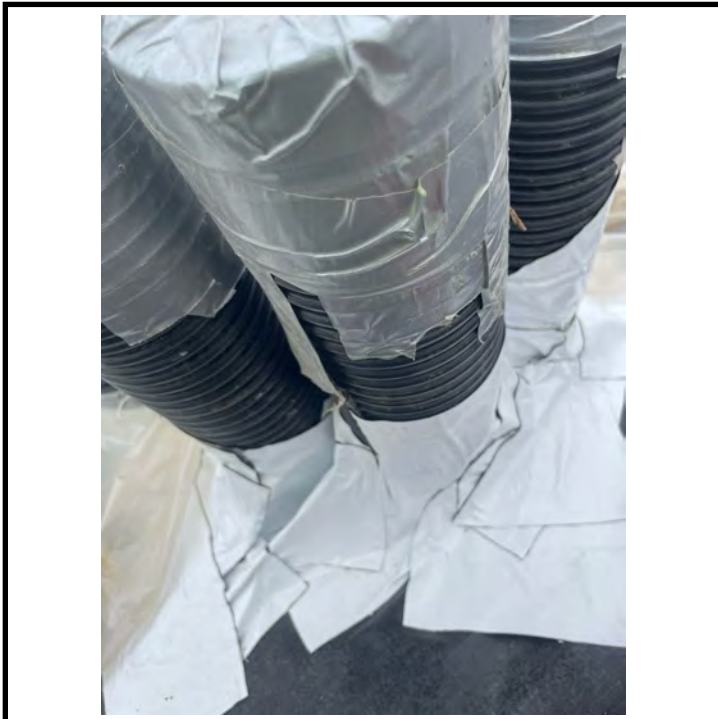
LOCATION/GRID LINE: Pipe penetrations

As can be seen from the above photograph the service entry points and pipe penetrations to the area have been successfully sealed.

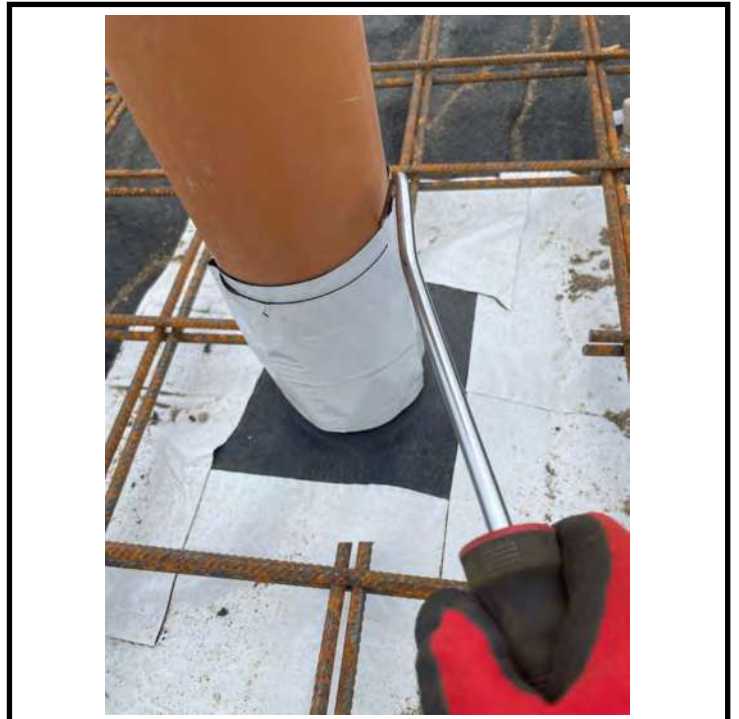
All service ducts have been sealed using the Corden GR SAM which have been sealed creating a continuous system. Pipe penetrations have been sealed using a conjunction of the Corden pre formed top hats and Corden GR SAM.

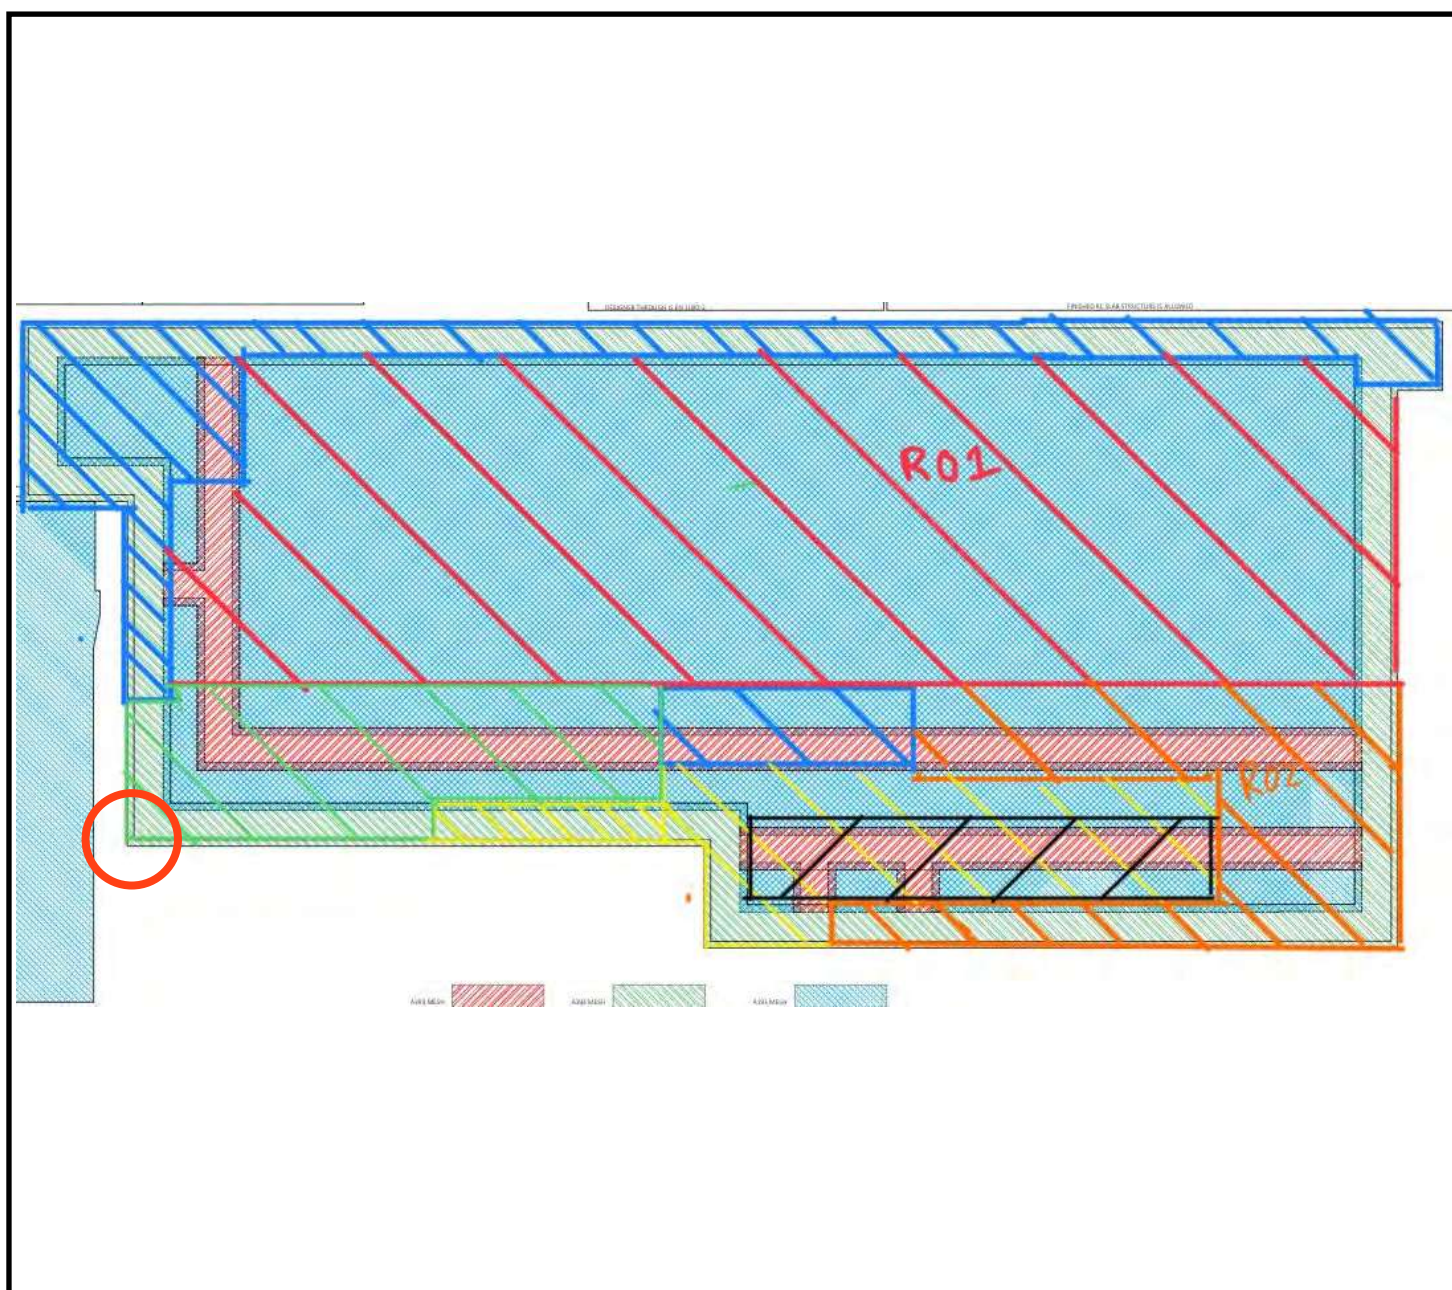
The photograph above shows a plan layout of the site. All areas bar the corner of the green section have now had photographic evidence provided for the outstanding remediations

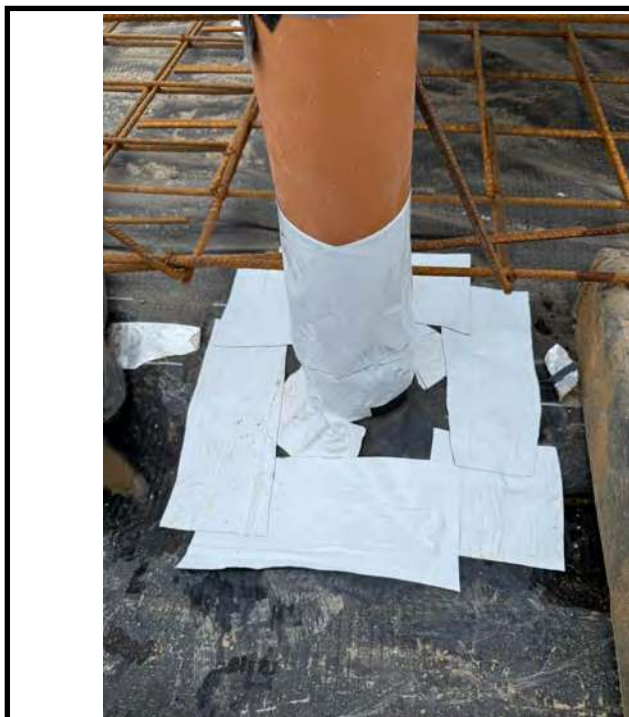
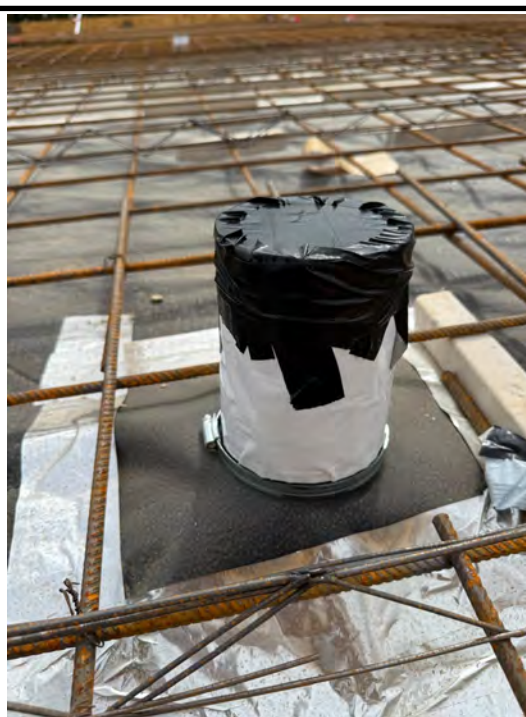
LOCATION/GRID LINE: Outstanding pipe penetrations

As can be seen from the photographic evidence above provided the client all the outstanding pipe penetrations have been successfully sealed.

The team from AMN Civils insured each penetration has been sealed using either the pre-formed top hats or the Corden gas resistant self adhesive membrane.

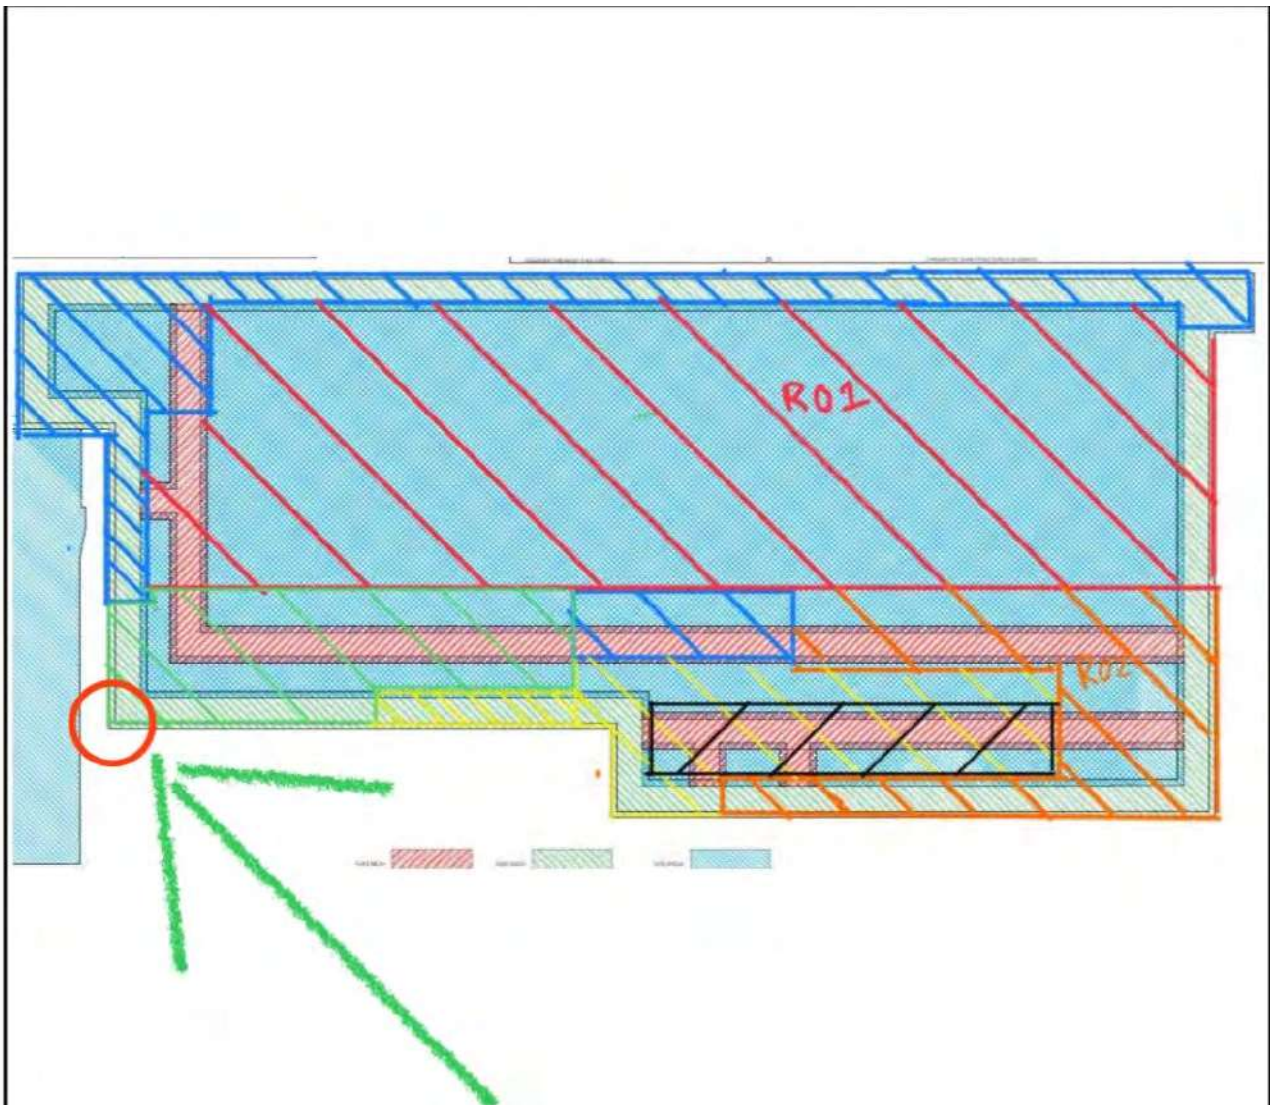
The photograph above shows a plan layout of the site. The area circled in red shows the corner in the green section where repair work was carried out and where the verification inspection took place.

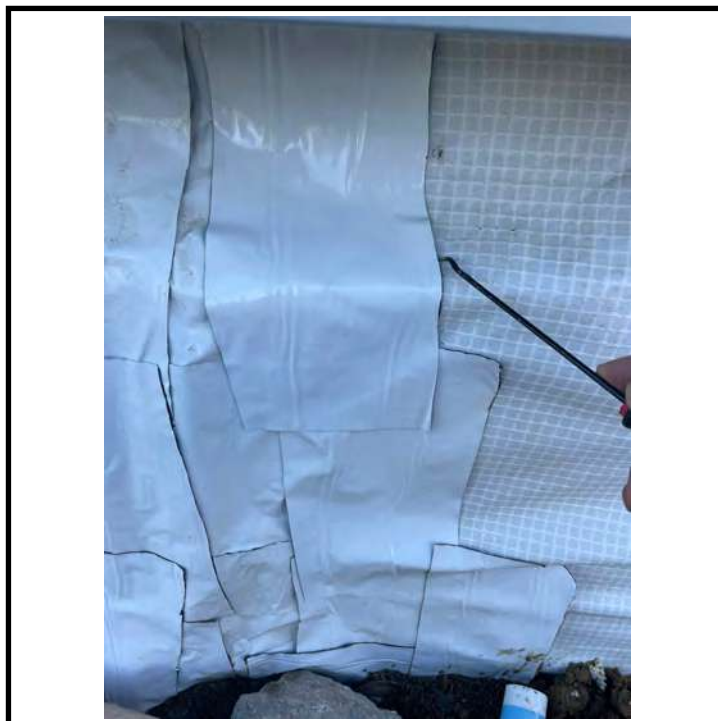
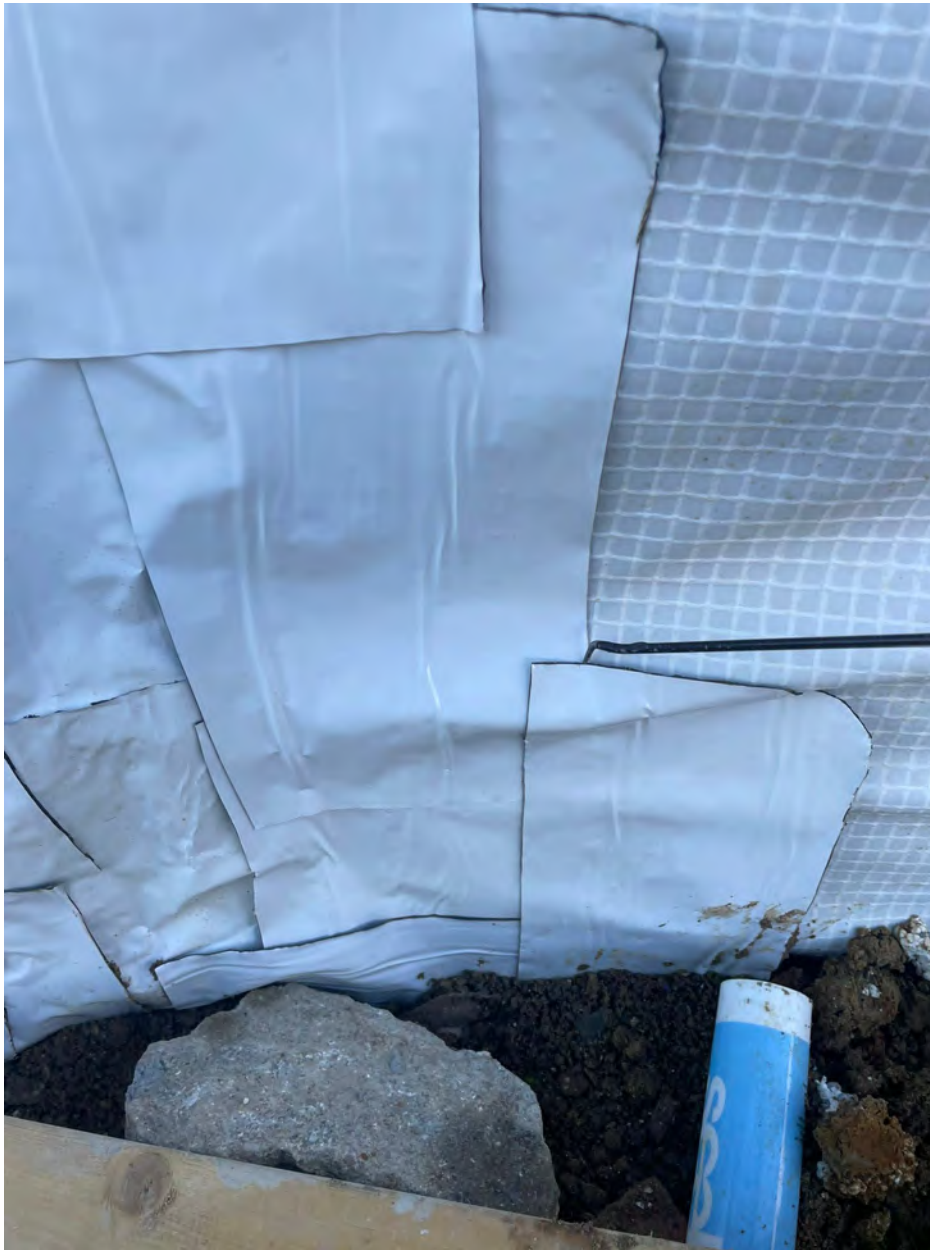
LOCATION/GRID LINE: Green Area - Repair Works

The purpose of the verification visit was to inspect the corner area which had been sealed due to the steel beam no longer being extended.

The installers have repaired the area by placing numerous strips of Corden EPS GRM Self Adhesive Membrane around the corner area, onto the existing Corden EPS

Total Gas Barrier, as seen in the above images. Sufficient heat and firm rolled pressure have been applied to ensure that the Corden EPS GRM Self Adhesive Membrane has fully bonded and that a tight seal has been achieved throughout.

Thorough visual inspections, supported by mechanical point stress testing conducted upon all aspects of the repair work, identified no faults or defects. A complete adhesion of the Corden EPS GRM Self Adhesive Membrane has been achieved.  
Tested and verified in accordance with CIRIA 735.

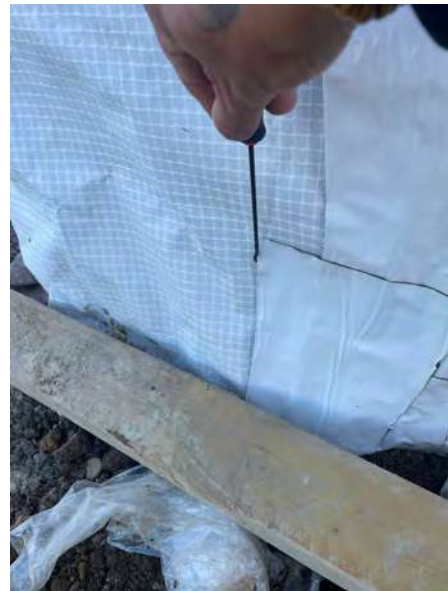
A mechanical point stress test being conducted upon the Corden EPS GRM Self Adhesive Membrane.

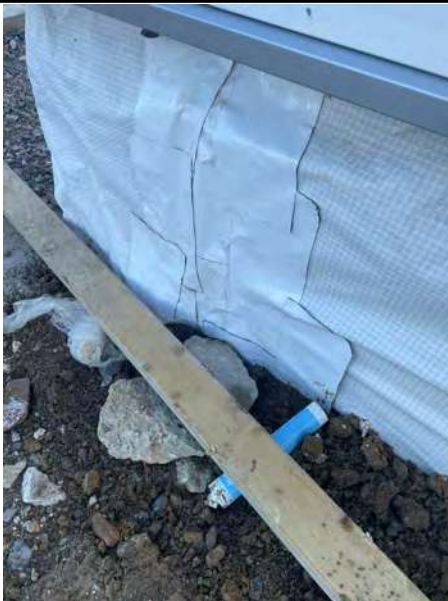
Strips of Corden EPS GRM Self Adhesive Membrane applied around the corner to seal the area.

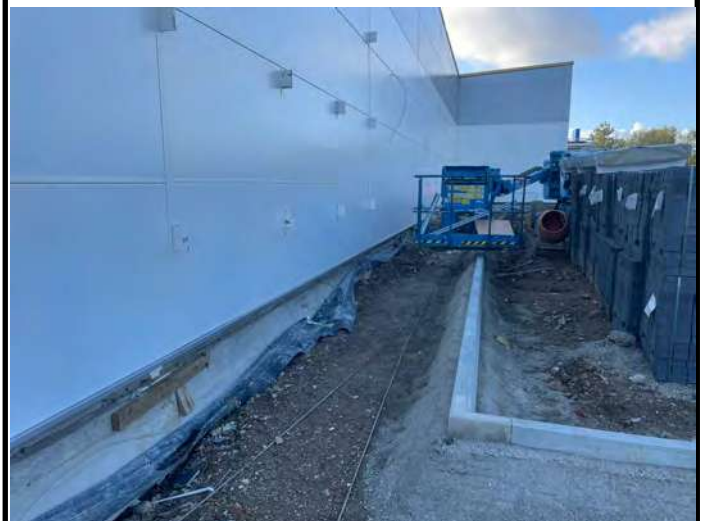
As can be seen in the image above the perimeter edge detailing is still to be completed.

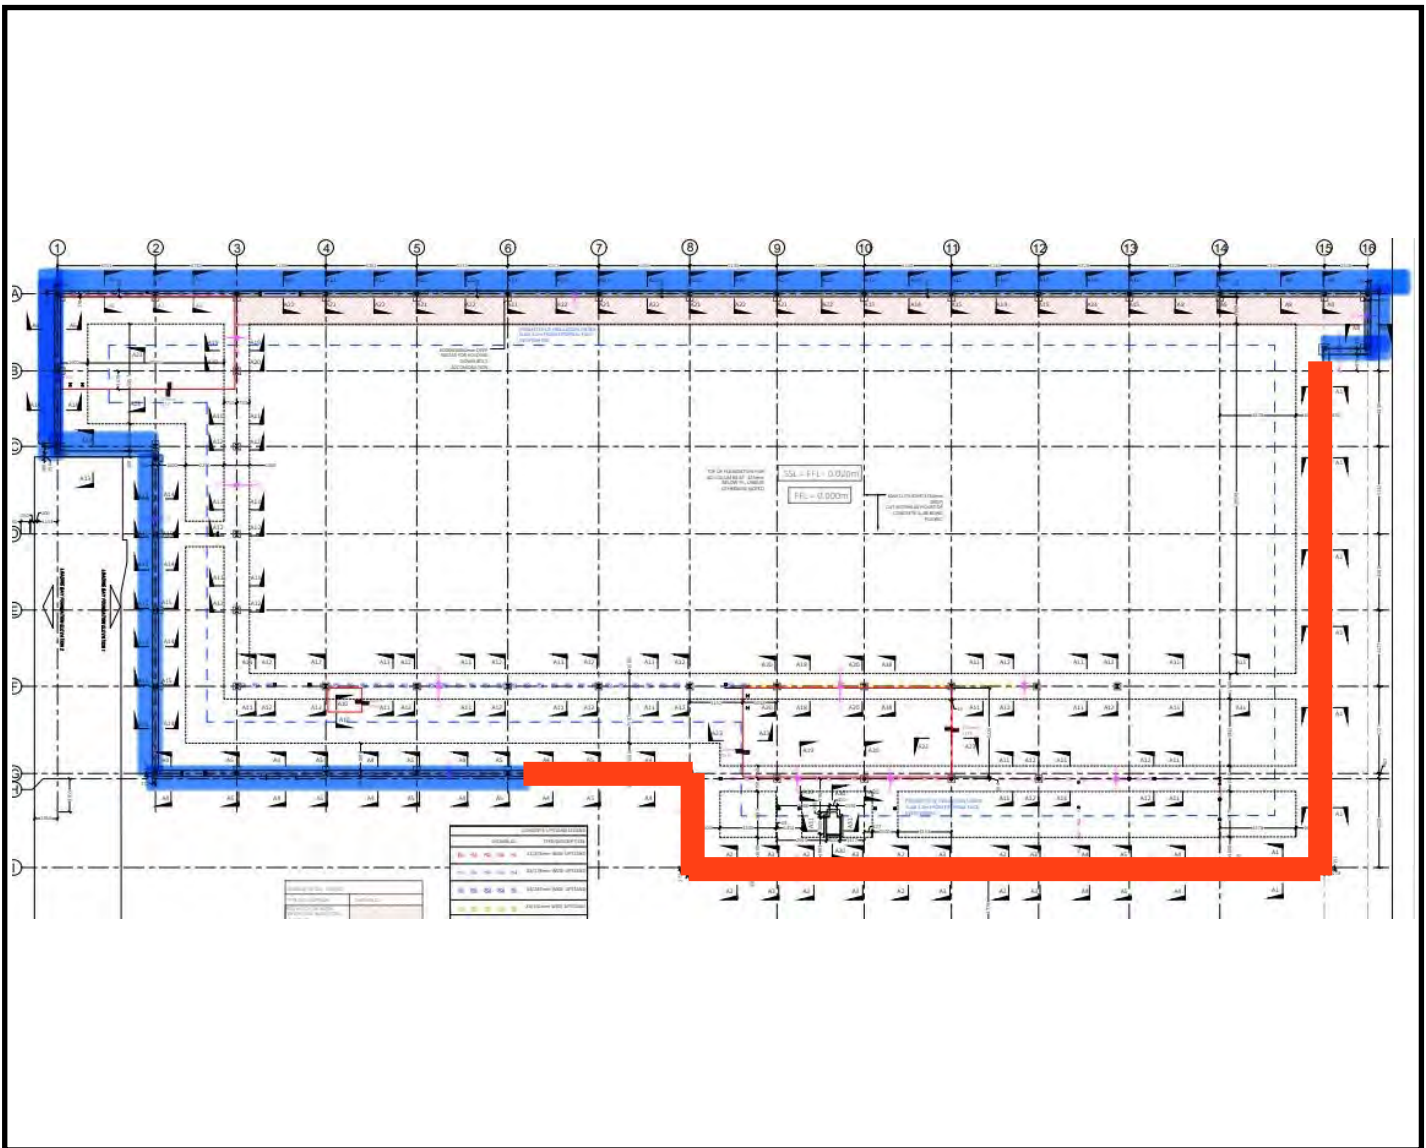
The photograph above shows a plan layout of the site. The areas highlighted in blue show all accessible areas around the perimeter. The areas highlighted in red show areas that were covered and therefore, could not be inspected. It has been recommended that these areas are uncovered in order that a full inspection can be conducted by GeoShield during the next verification visit.

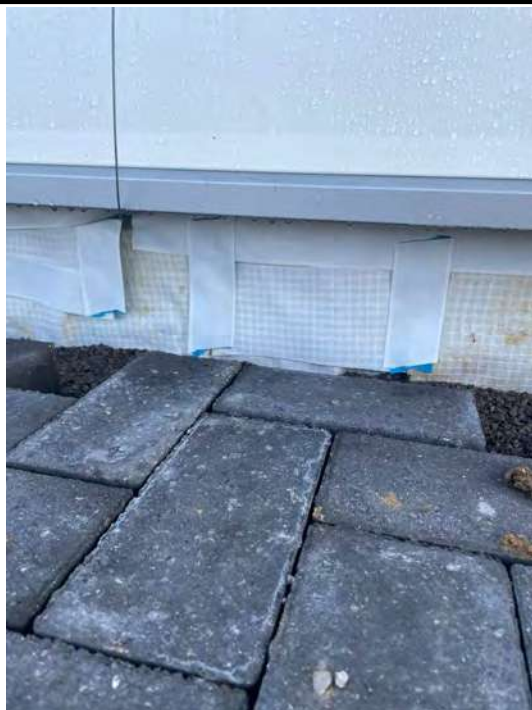
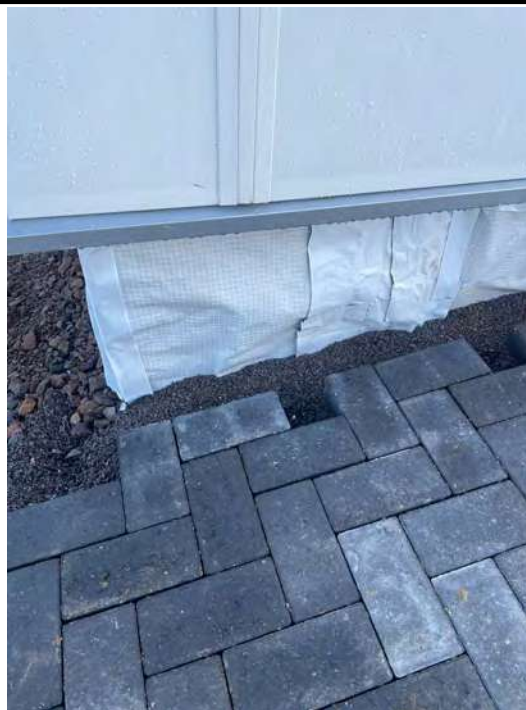
LOCATION/GRID LINE: Perimeter Detailing

The purpose of the verification visit was to inspect the majority of the perimeter detailing carried out around the building. The entire perimeter that is accessible has been left outstanding due to the dual taped system not being in place correctly. The double sided butyl tape beneath the overlaps between the adjacent sheets of

membrane was not in a continuous length, with gaps left in areas where gases could escape. The width of double sided butyl tape was also not sufficient. No foil lap tape was used on the top of the lap joints. The lap joints have not been sealed in accordance with manufacturer's specifications and design details issued.

The pipe penetrations present around the accessible perimeter areas have not been sealed correctly. These have been sealed with double sided butyl tape and there were also a number of holes and defects that have been repaired using double sided butyl tape, which is not sufficient. It has been recommended to acquire and install the Corden EPS GRM Self Adhesive Membrane to any holes or defects around the perimeter. A further verification is required prior to sign off of the perimeter being achieved.

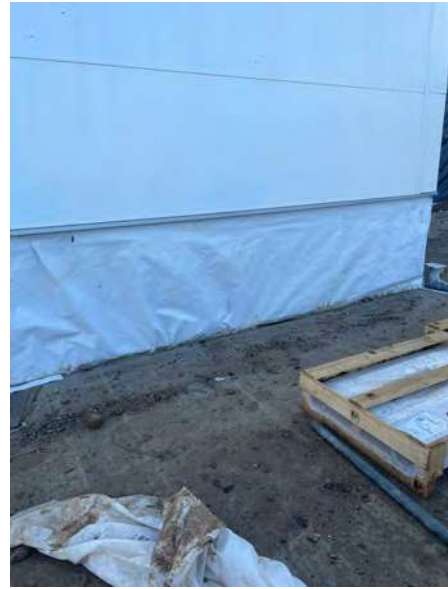
Insufficient installation to the perimeter due to the dual taped system not being correctly implemented.

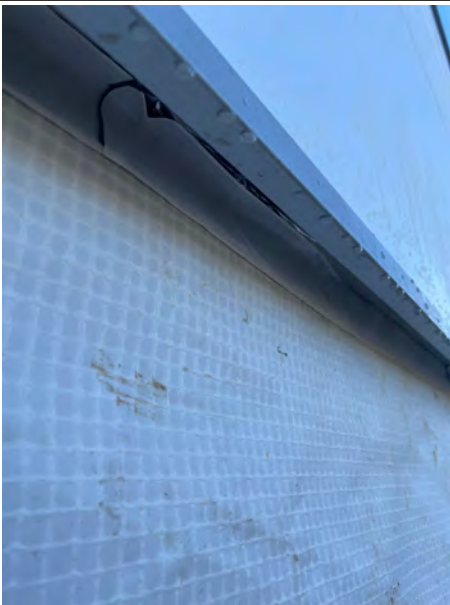
Insufficient installation to the perimeter due to the dual taped system not being correctly implemented.

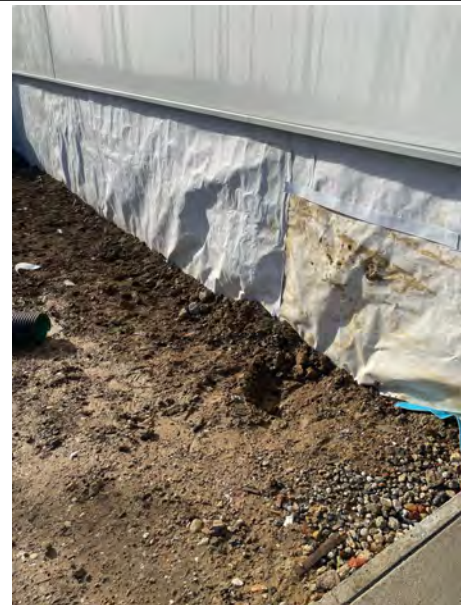
Insufficient installation to the perimeter due to the dual taped system not being correctly implemented.

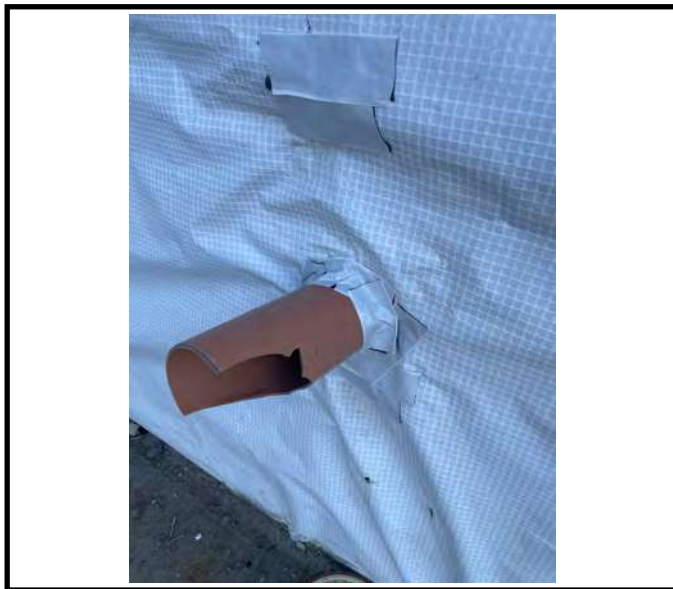
A pipe penetration incorrectly sealed with double sided butyl tape.

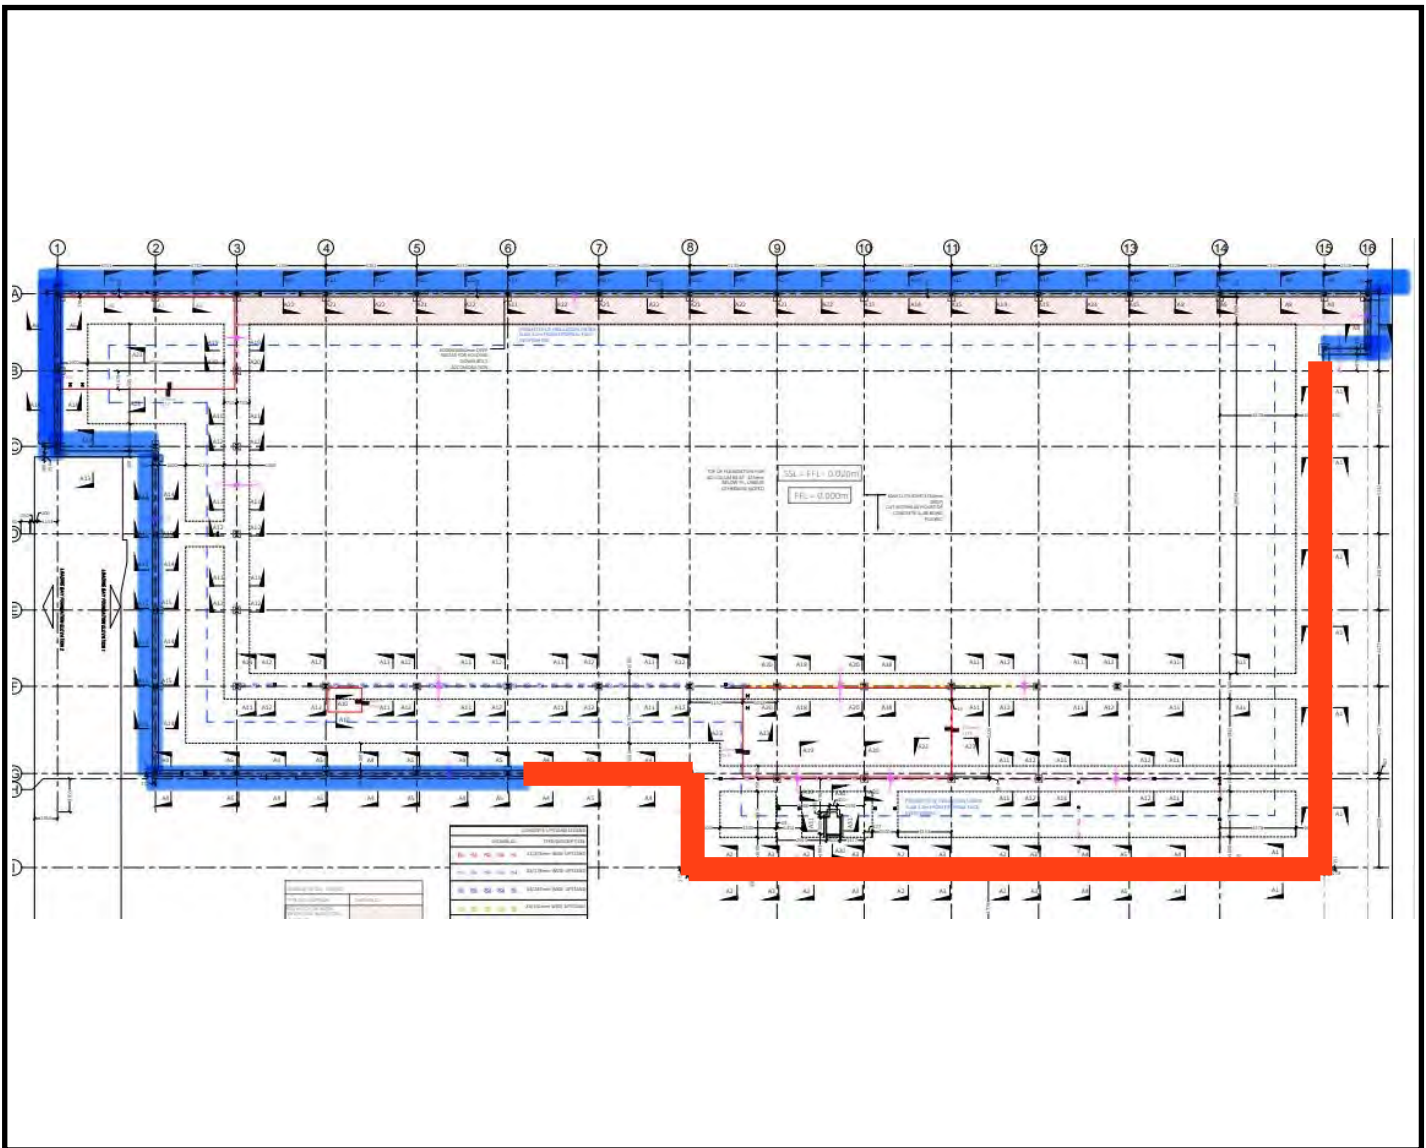
The photograph above shows a plan layout of the site. The areas highlighted in blue show all accessible areas around the perimeter. The areas highlighted in red show areas that were covered and therefore, could not be inspected. It has been recommended that these areas are uncovered in order that a full inspection can be conducted by GeoShield during the next verification visit.

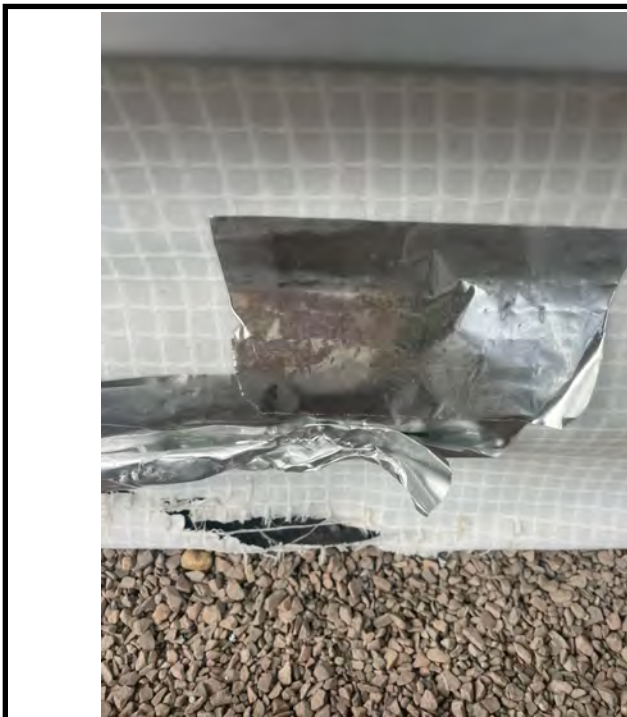
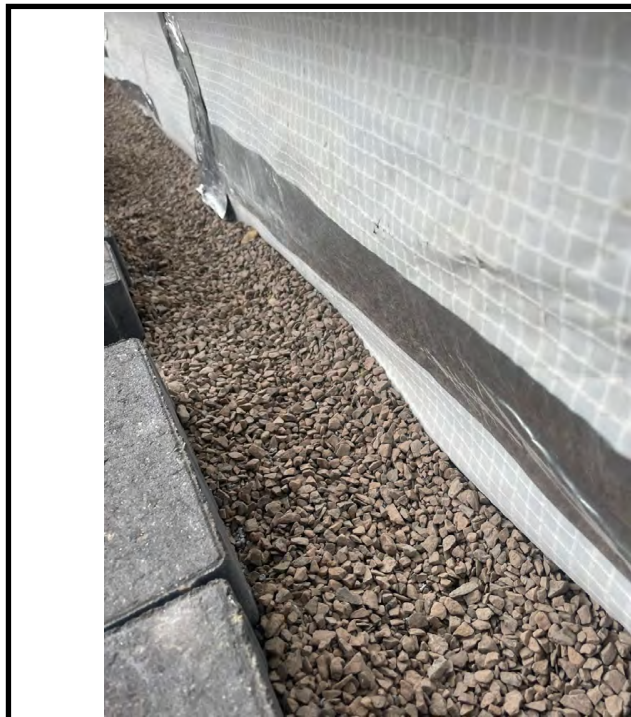
LOCATION/GRID LINE: Perimeter Detailing

The purpose of the verification visit was to inspect the majority of the perimeter detailing carried out around the building. The entire perimeter that is accessible has been left outstanding due to the dual taped system not being in place correctly. The double sided butyl tape beneath the overlaps between the adjacent sheets of

membrane was not in a continuous length, with gaps left in areas where gases could escape. The width of double sided butyl tape was also not sufficient. No foil lap tape was used on the top of the lap joints. The lap joints have not been sealed in accordance with manufacturer's specifications and design details issued.

The pipe penetrations present around the accessible perimeter areas have not been sealed correctly. These have been sealed with double sided butyl tape and there were also a number of holes and defects that have been repaired using double sided butyl tape, which is not sufficient. It has been recommended to acquire and install the Corden EPS GRM Self Adhesive Membrane to any holes or defects around the perimeter. A further verification is required prior to sign off of the perimeter being achieved.

It has been recommended to use a specialist gas membrane installation team to carry out any future works.

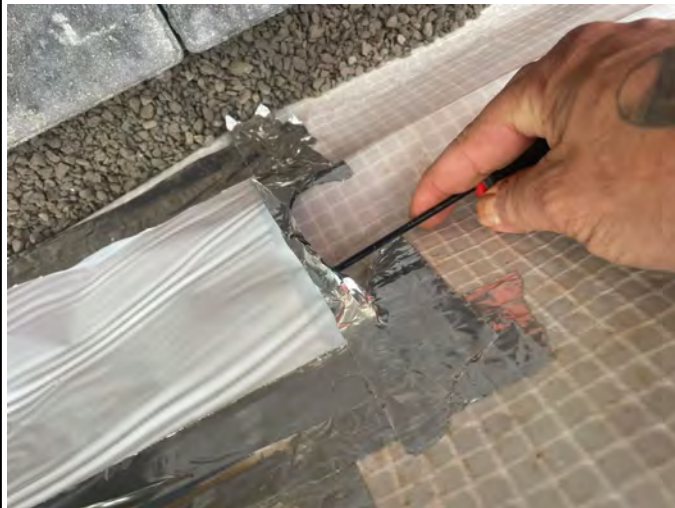
The tapes have not correctly adhered to the membrane.
