# Gas Membrane Verification Report

**Lidl, Havant**  
**Somborne Drive**  
**Havant**  
**PO9 5AN**

# GeoShield Verification Report 1

PROJECT: Lidl, Havant

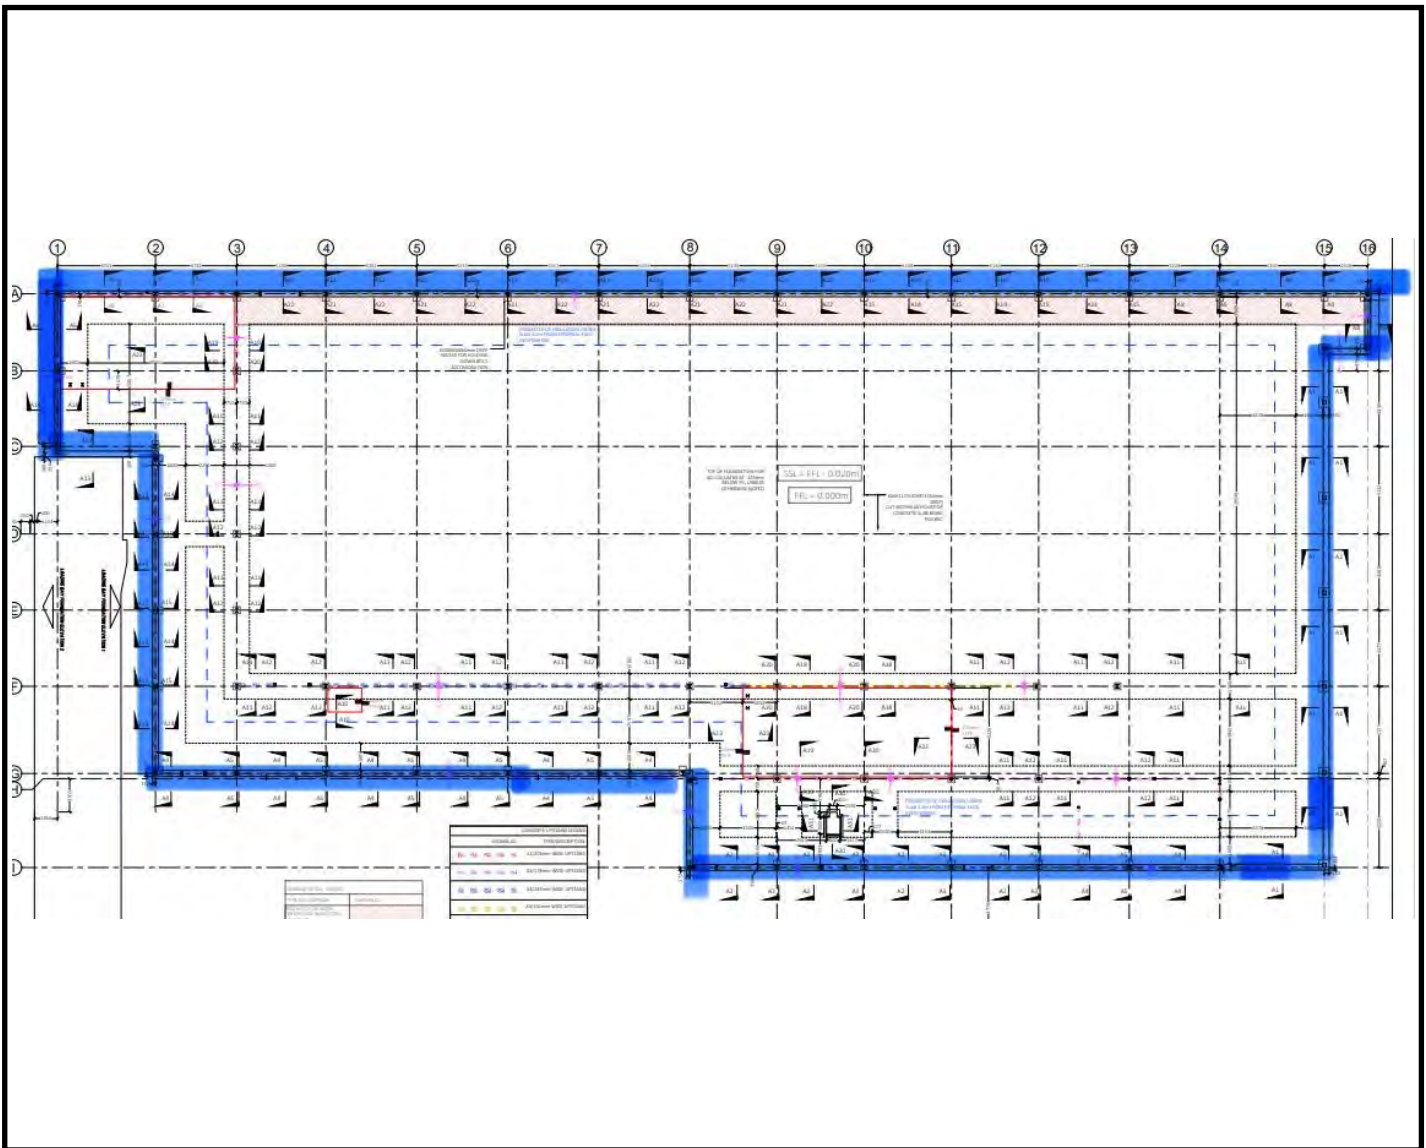
The photograph above shows a plan layout of the site. The areas highlighted in blue show the perimeter where the verification inspection took place. All areas that were previously inaccessible around the perimeters have been exposed in order that remedial work could be conducted and a further verification inspection undertaken.

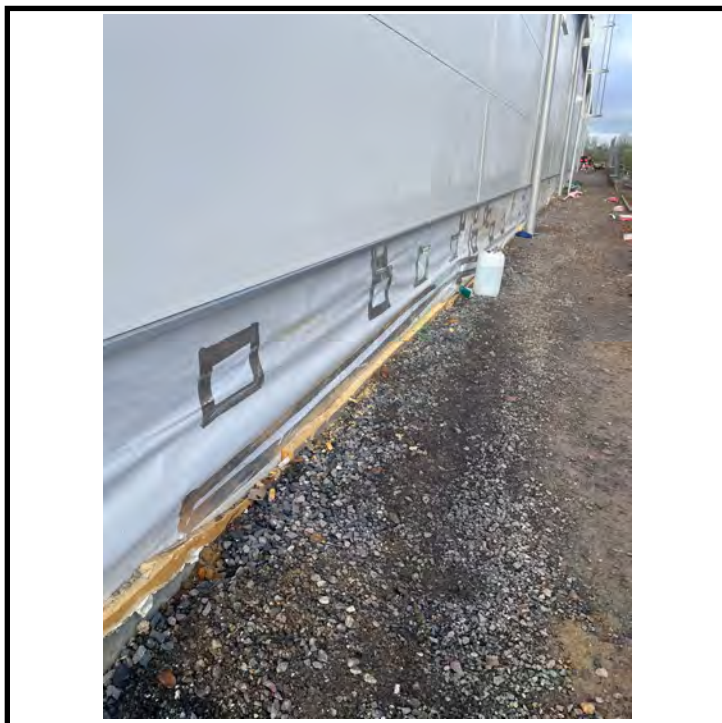
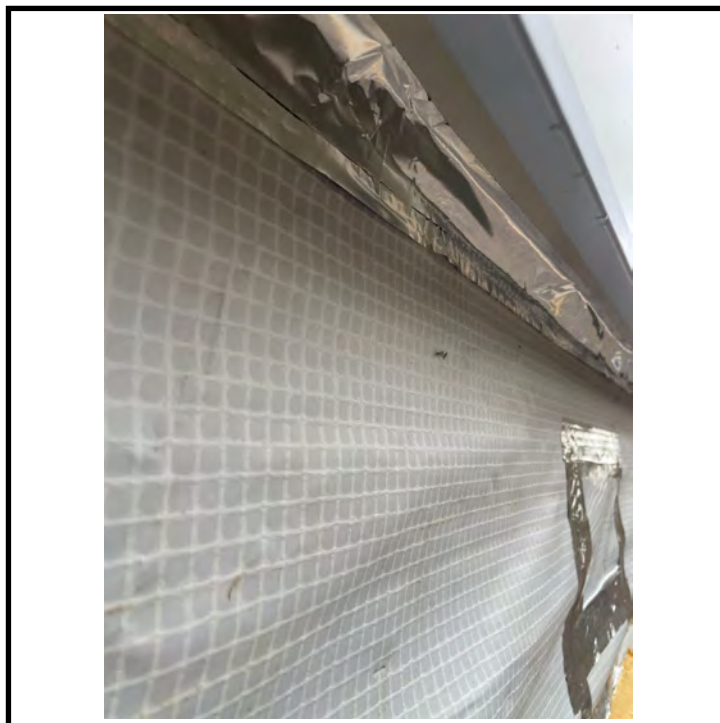
LOCATION/GRID LINE: Perimeter Detailing - 100%

The purpose of the verification visit was to inspect the entire perimeter detailing, including all outstanding remediations and faults identified during previous inspections. The Corden EPS Total Gas Barrier has been dressed down and out across the perimeter upstands from the slab area. All lap joints between the

adjacent sheets of Corden EPS Total Gas Barrier have been sealed using the dual taped system, consisting of Corden EPS Double Sided Butyl Tape beneath the adjacent sheets and over-taped using Corden EPS Gas Resistant Aluminium Lap Tape. Sufficient heat and rolled pressure have been applied to ensure the tapes

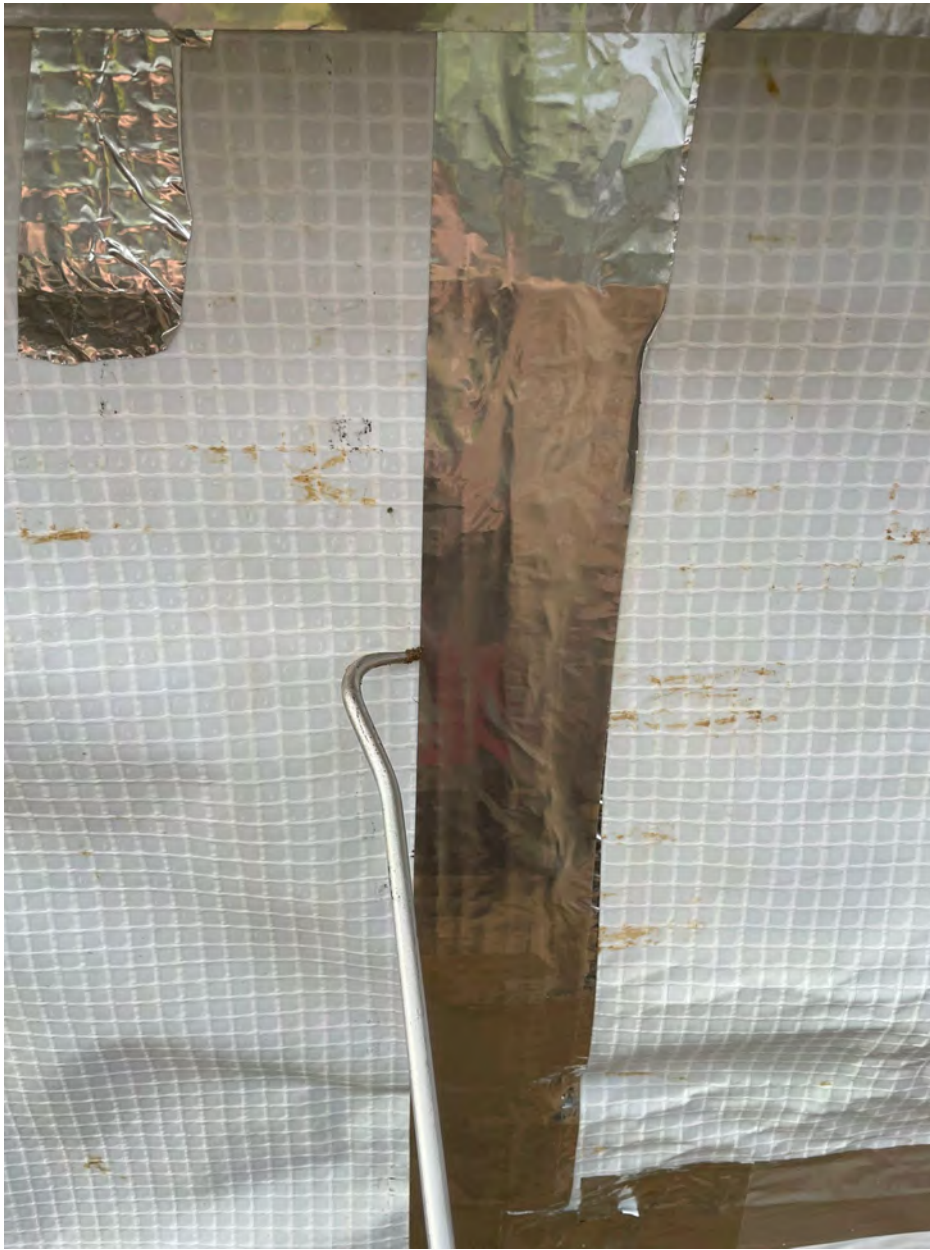
## VERIFICATION ITEM ONE

have fully bonded. Further photographic evidence of the Corden EPS Double Sided Butyl Tape beneath the membrane have been included within the 'Additional Photographs' section of this report. All lap joints were subjected to thorough mechanical point stress testing, as shown in the image above. The condition of the Corden EPS Total Gas Barrier was also visually inspected where a couple of punctures and tears were identified.

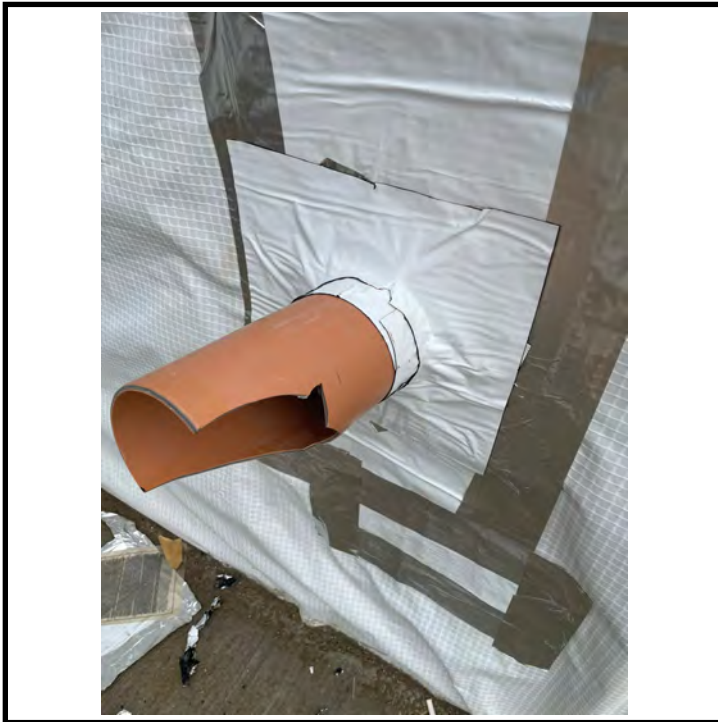
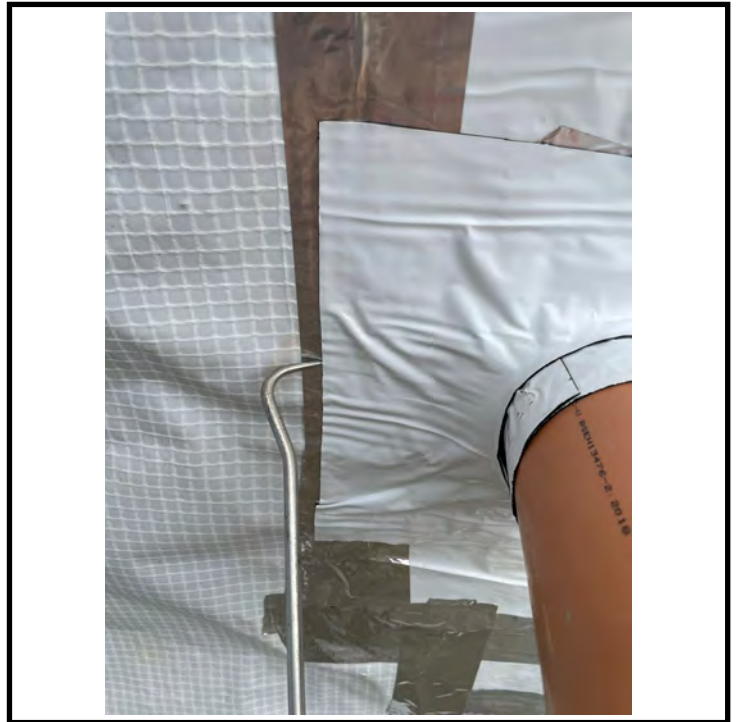
INSPECTION DETAILS: Pipe Penetrations

There were a total of two pipe penetrations around the perimeter that required sealing. As these had not been sealed upon the arrival of GeoShield to site, these were treated as a required remediation. The pipe penetrations have been sealed during the visit, in the presence of GeoShield using Corden EPS GRM which

is a gas resistant self adhesive membrane. The Corden EPS GRM has been placed intricately around the base circumference of the pipe penetrations and heated into position using a hot air tool. Firm rolled pressure is applied using a silicone roller to aid in the adhesion.

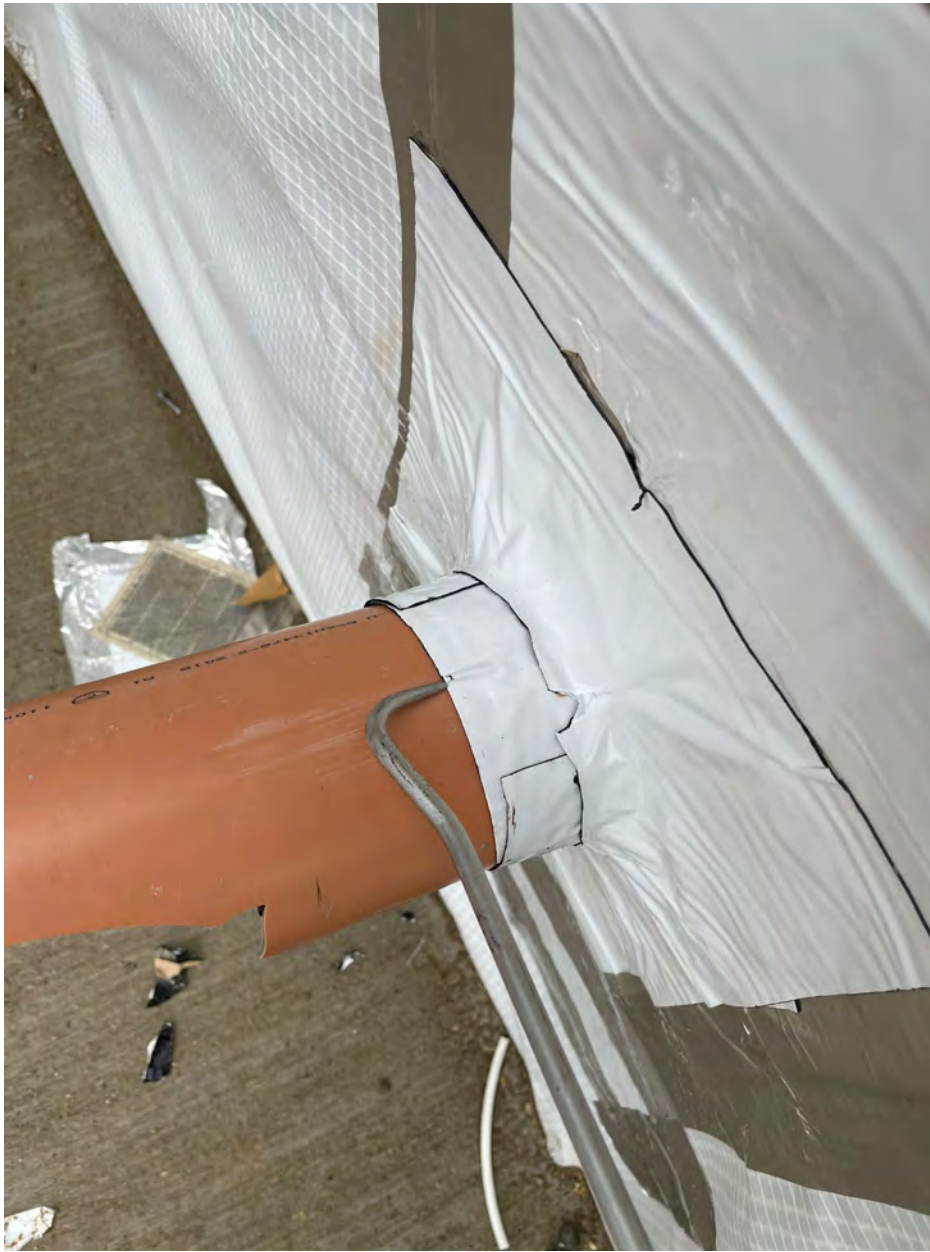
## VERIFICATION ITEM TWO

Thorough visual inspections, along with mechanical point stress testing were conducted upon the two sealed pipe penetration. No further faults or defects were identified. A complete adhesion of the Cordem EPS GRM has been achieved.  
Tested and verified in accordance with CIRIA 735.

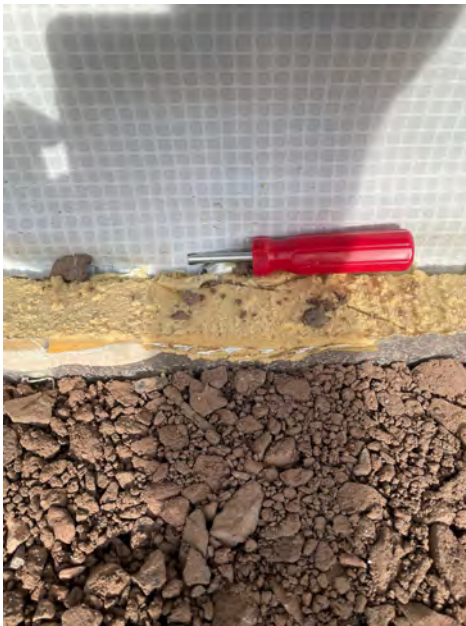
### Faults Identified & Remediated

As mentioned, a number of faults were identified during the testing procedures conducted upon all completed remedial work around the perimeter. The faults consisted of holes within the membrane and the two pipe penetrations that had not been sealed upon arrival to site. All areas were brought to the attention

of the installers and remediated during the visit, in the presence of GeoShield. The faults were remediated by applying 150mm patches of Cordex EPS GRM over the affected areas, with heat and rolled pressure applied to aid in the adhesion. No further faults or defects were identified.

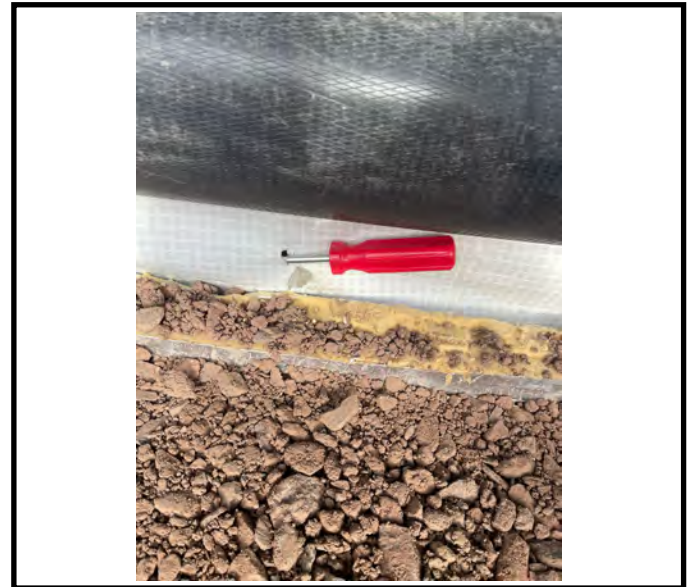
A puncture identified in the membrane.

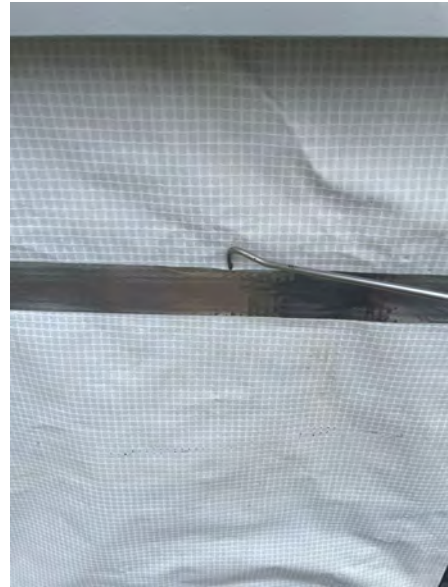
A mechanical point stress test being conducted upon a taped lap joint.
