# ARBORICULTURAL IMPACT ASSESSMENT AND PRELIMINARY METHOD STATEMENT

For the siting of 1No. Shepherd's Hut for Class C1 Tourist  
Accommodation on the land adjacent to Broad Oak,  
Copse Lane, Hayling Island, PO11 0QB

| Document reference: | MDJAC-BS25106-AIAPMS-01 Rev. A |
| Date: | 12 February 2025 |

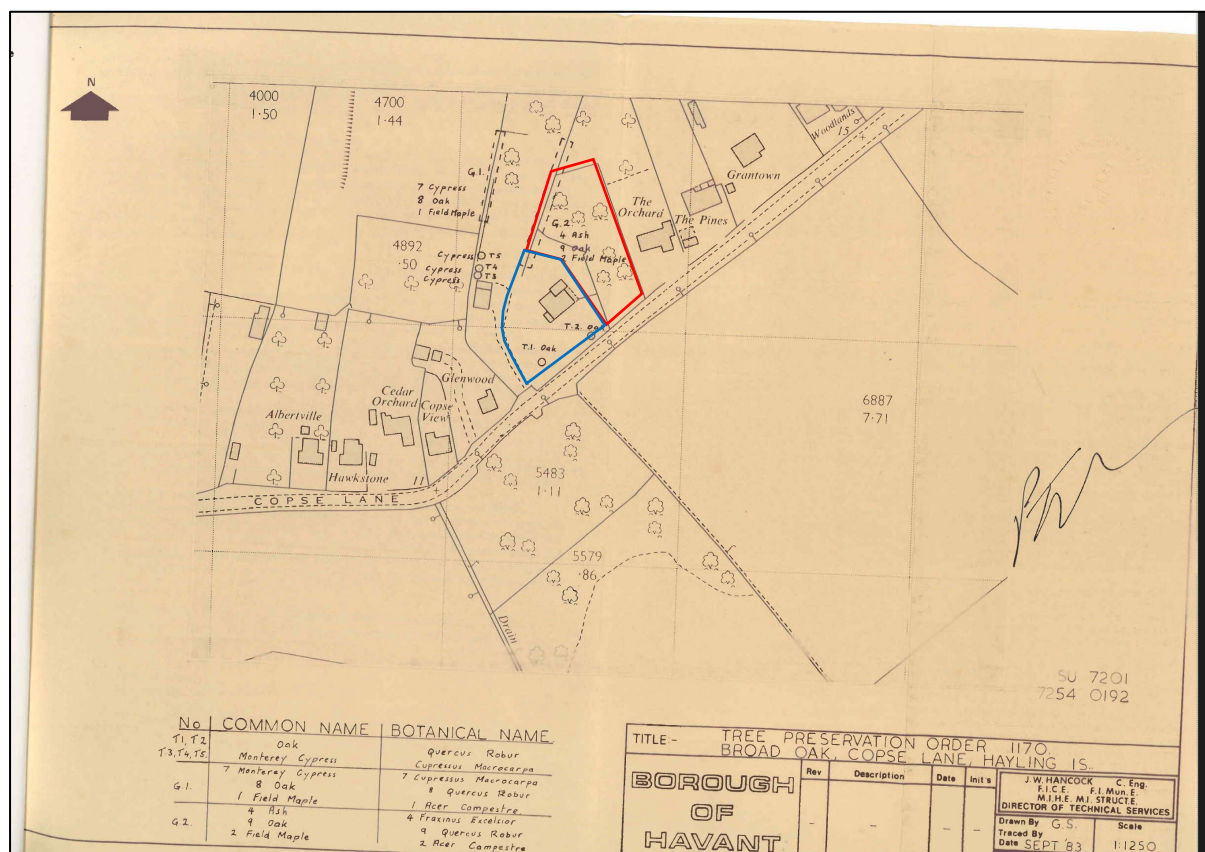
Figure 1: screenprint of the TPO Map, with the approximate locations of the application boundary shown in red.

2.1.2 Detailed assessment of the TPO Map (shown below), suggest that the land ownership boundaries may have changed over time, and there may be cartographical errors; specifically in relation to the way that designation G2 of the order is illustrated. Consequently, I have provided an indication as to which trees I consider to be covered by the order, based on their approximate location and the species listed within the order. The trees I consider to be covered are identified by **magenta text** in the accompanying tree survey schedule and tree protection plan.
