## **Padnell Grange - Structural Condition Survey**

### **Structural Appraisal Report**

**Ref:** 251363/J Ham

**Date:** 05 Jan 2026

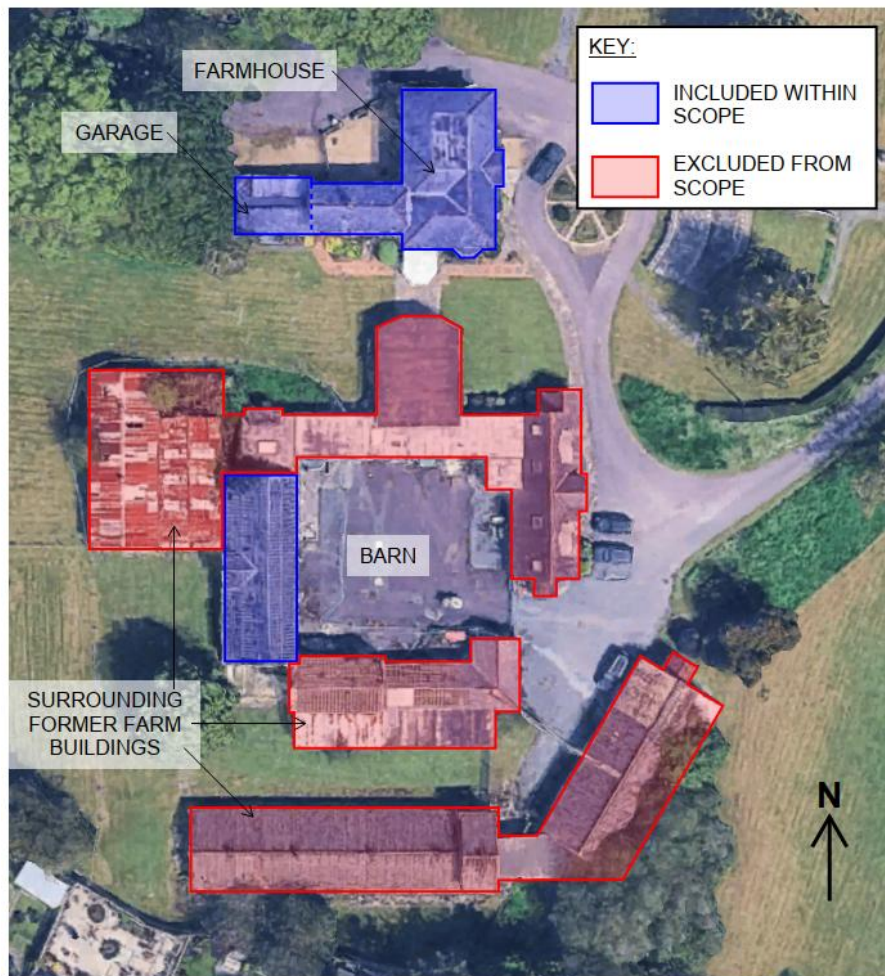
**Figure 1 – Site plan.**

- 2.1 Padnell Grange is a former farm which comprises of a number of buildings accumulated during its development since approximately the mid-Nineteenth Century. Most of the buildings are not considered to be of historical significance and are expected to be demolished for the redevelopment of the site. The two buildings that have been identified as of potential interest are the farmhouse and the Nineteenth Century barn. These buildings are identified in the site plan provided in Figure 1 overleaf.
