8<sup>th</sup> May 2026

## **13885 – Havant Phase 3A: - Engineers Response to planning condition 29**

**Proposal:** Existing Sewer Conditions

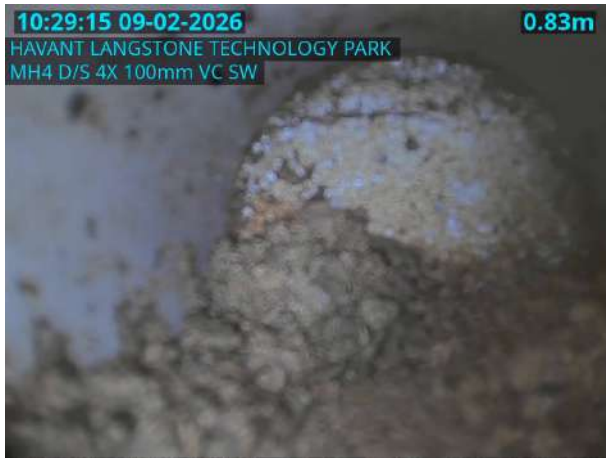
MH4X\_D\_09022026\_1029\_088.jpg, 00:00:09, 0.83 m  
General remark, Line capped

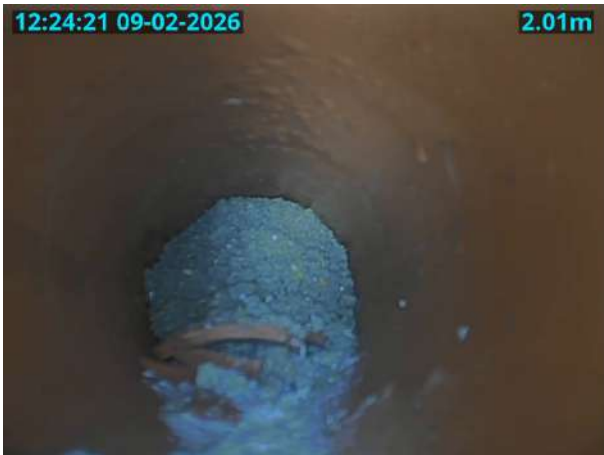
11AX\_U\_09022026\_1224\_013.jpg, 00:00:17, 2.01 m  
 Collapsed drain or sewer, 100% cross-sectional area loss

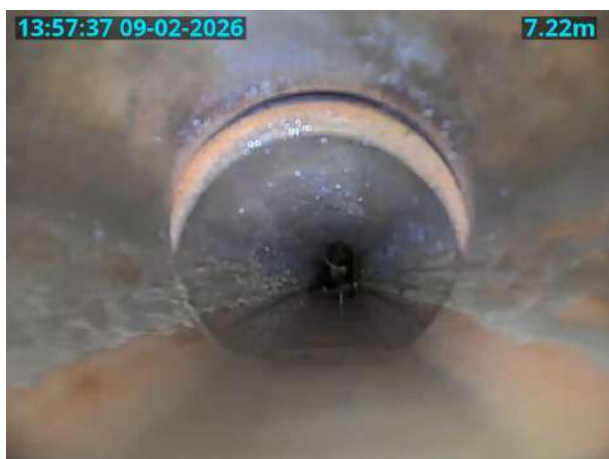
10BX\_U\_09022026\_1357\_021.jpg, 00:00:48, 7.22 m  
Joint displaced, medium

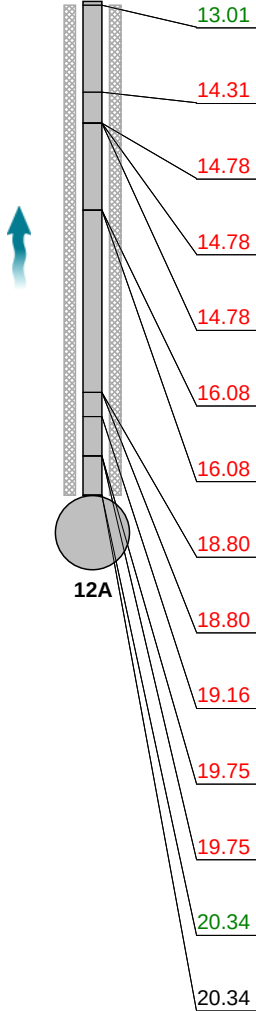
| Scale: | 1:113 | Position [m] | Code | Observation | MPEG | Photo | Grade |
|---|---|---|---|---|---|---|---|
| | | 13.01 | S03 | DER | Settled deposits, coarse, 20% cross-sectional area loss, start | 00:01:19 | |
| | | 14.31 | | CLJ | Crack, longitudinal at joint at 3 o'clock | 00:01:29 | 2 / 2 |
| | | 14.78 | | FL | Fracture, longitudinal at 8 o'clock | 00:01:31 | 3 / 2 |
| | | 14.78 | | FL | Fracture, longitudinal at 4 o'clock | 00:01:31 | 3 / 2 |
| | | 14.78 | | FC | Fracture, circumferential from 7 o'clock to 5 o'clock | 00:01:31 | 12AX_U_0 9022026_1411_026. 3 / 2 |
| | | 16.08 | | FL | Fracture, longitudinal at 8 o'clock | 00:01:41 | 3 / 2 |
| | | 16.08 | | FL | Fracture, longitudinal at 10 o'clock | 00:01:41 | 12AX_U_0 9022026_1411_027. 3 / 2 |
| | | 18.80 | | FL | Fracture, longitudinal at 2 o'clock | 00:02:03 | 3 / 2 |
| | | 18.80 | | FL | Fracture, longitudinal at 10 o'clock | 00:02:03 | 12AX_U_0 9022026_1411_028. 3 / 2 |
| | | 19.16 | | FM | Fractures, multiple from 12 o'clock to 12 o'clock | 00:02:06 | 12AX_U_0 9022026_1411_029. 4 / 2 |
| | | 19.75 | | B | Broken pipe from 2 o'clock to 8 o'clock | 00:02:12 | 12AX_U_0 9022026_1411_030. 4 |

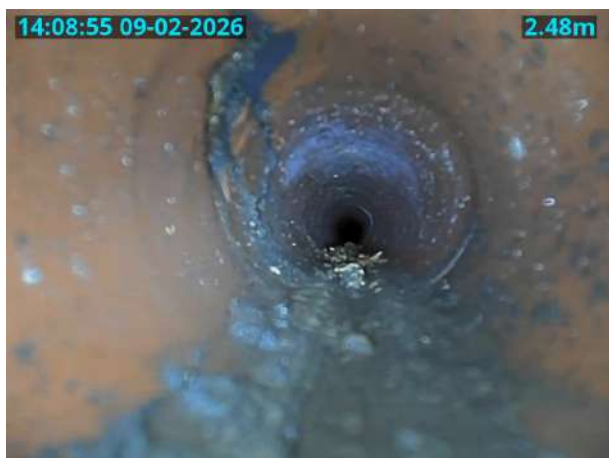
12AX\_U\_09022026\_1411\_022.jpg, 00:00:18, 2.48 m  
Hole in drain or sewer from 9 o'clock to 11 o'clock

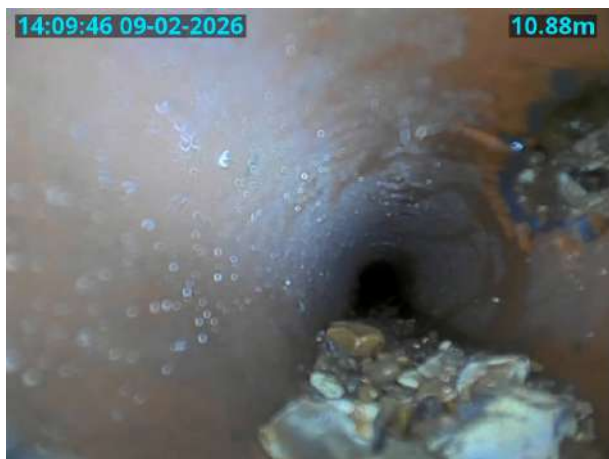
12AX\_U\_09022026\_1411\_024.jpg, 00:01:09, 10.88 m  
Hole in drain or sewer from 1 o'clock to 3 o'clock

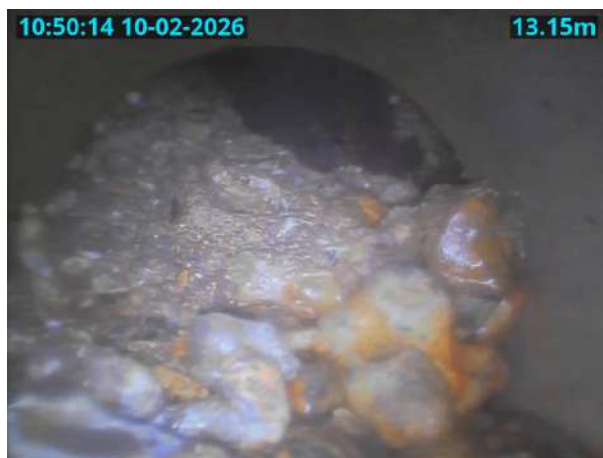
MH26X\_U\_10022026\_1050\_043.jpg, 00:01:20, 13.15 m  
Finish node, other special chamber, reference: MH26, Pipe runs to ground

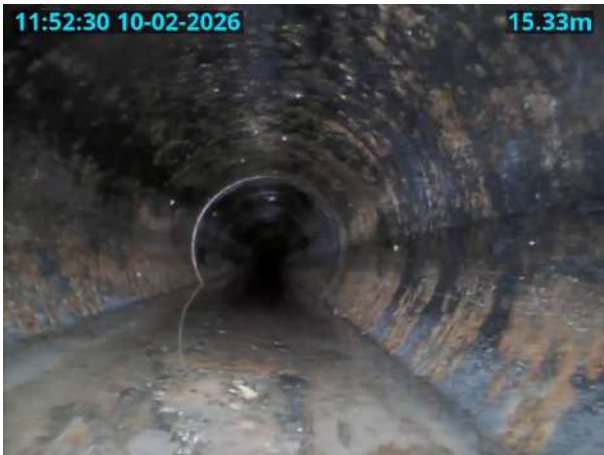
MH10X\_U\_10022026\_1155\_048.jpg, 00:02:34, 15.33 m  
General photograph taken at this point

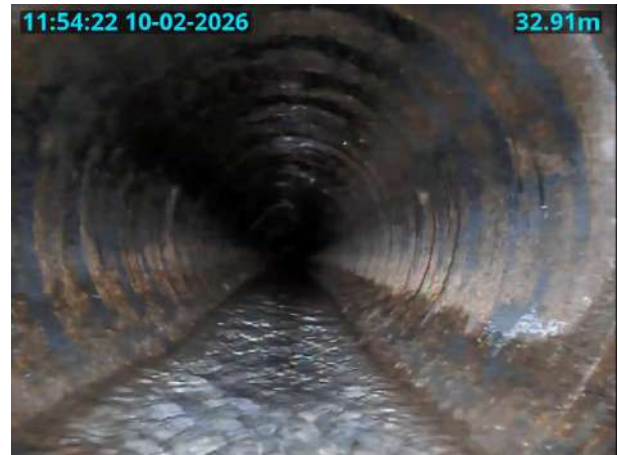
MH10X\_U\_10022026\_1155\_049.jpg, 00:04:26, 32.91 m  
General photograph taken at this point

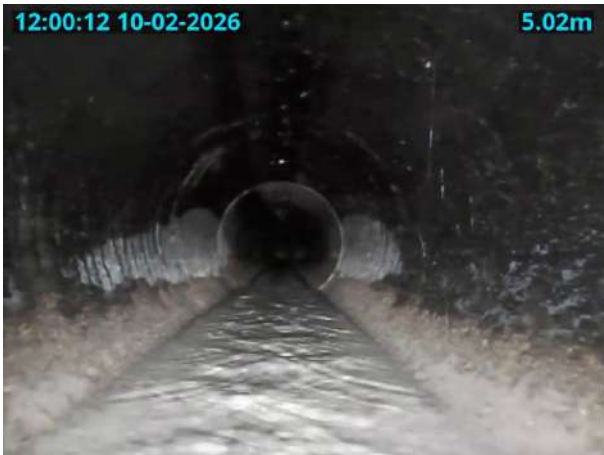
MH30X\_D\_10022026\_1201\_106.jpg, 00:00:35, 5.02 m  
 General photograph taken at this point

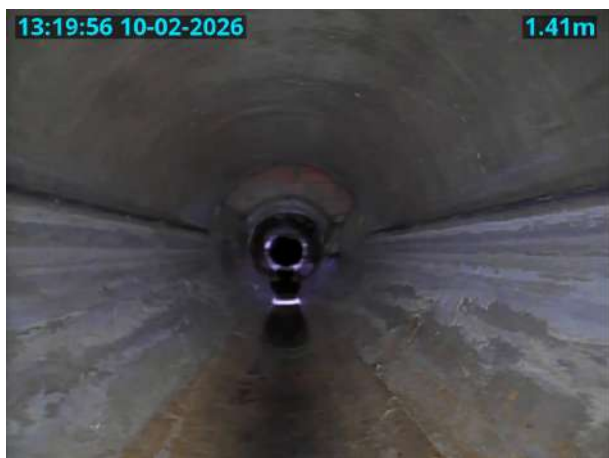
MH31X\_D\_10022026\_1320\_051.jpg, 00:00:19, 1.41 m  
General photograph taken at this point

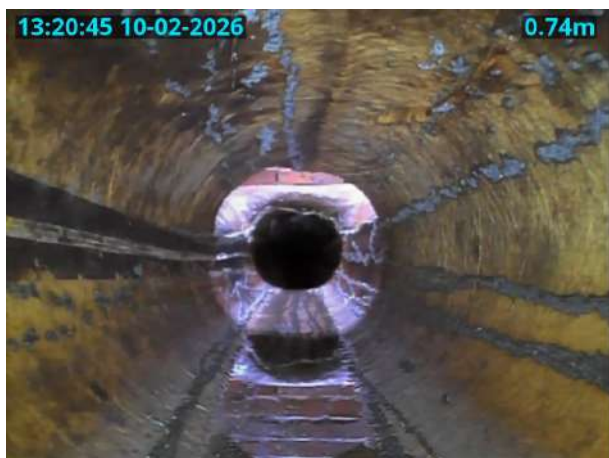
MH32X\_D\_10022026\_1320\_052.jpg, 00:00:11, 0.74 m  
General photograph taken at this point

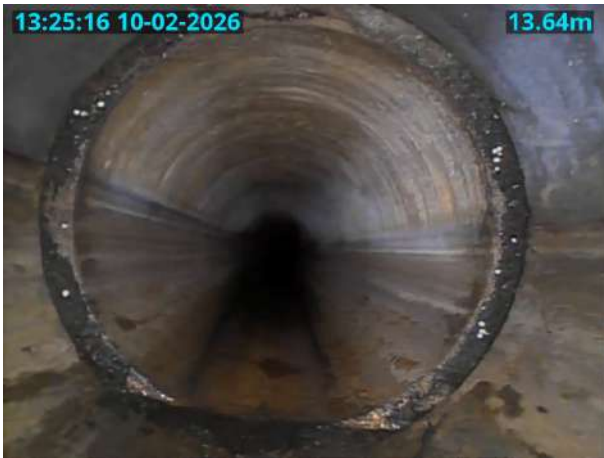
MH33X\_U\_10022026\_1326\_053.jpg, 00:01:22, 13.64 m  
 General photograph taken at this point

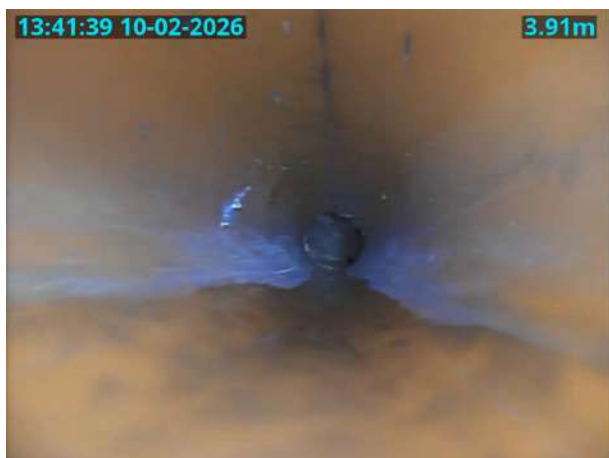
MH32AX\_U\_10022026\_1341\_054.jpg, 00:00:25, 3.91 m  
 General photograph taken at this point

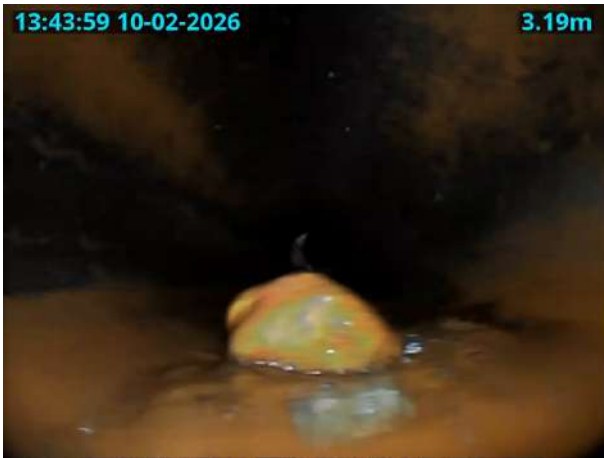
MH32AY\_U\_10022026\_1344\_055.jpg, 00:00:20, 3.19 m  
General photograph taken at this point

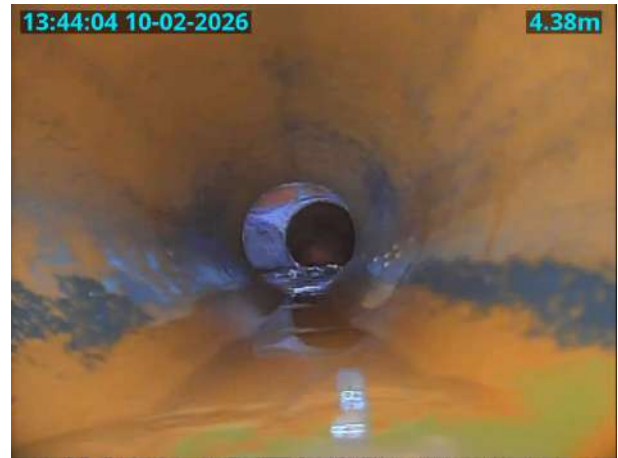
MH32AY\_U\_10022026\_1344\_056.jpg, 00:00:25, 4.38 m  
General photograph taken at this point

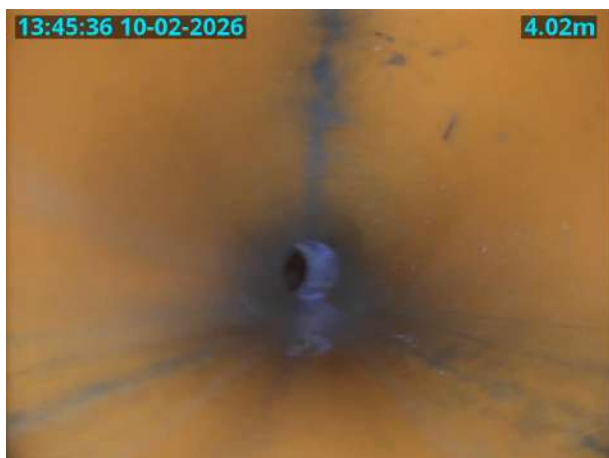
MH32AZ\_U\_10022026\_1345\_107.jpg, 00:00:22, 4.02 m  
 General photograph taken at this point

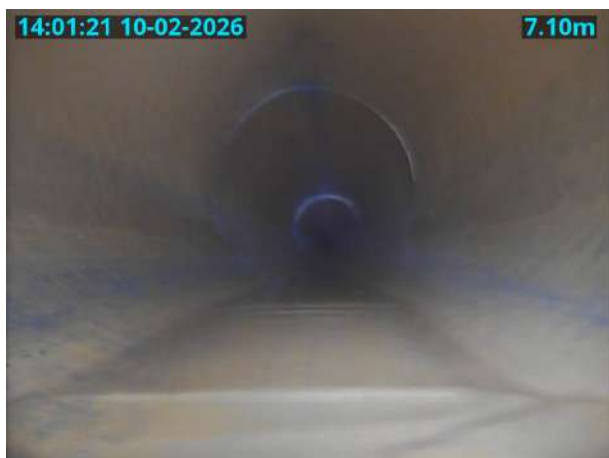
MH34X\_U\_10022026\_1404\_057.jpg, 00:00:47, 7.10 m  
General photograph taken at this point

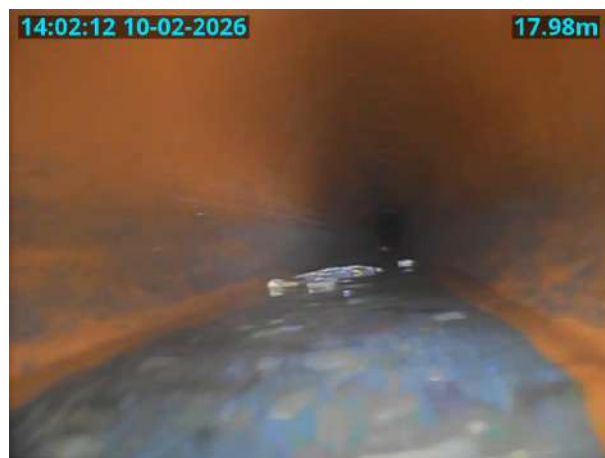
MH34X\_U\_10022026\_1404\_058.jpg, 00:01:38, 17.98 m  
General photograph taken at this point

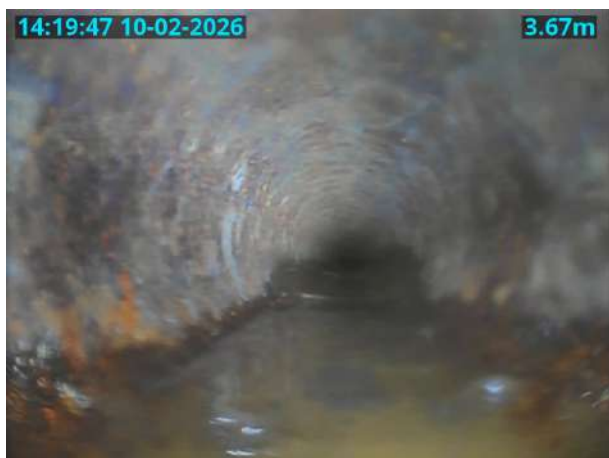
35BX\_U\_10022026\_1420\_059.jpg, 00:00:24, 3.67 m  
 General photograph taken at this point

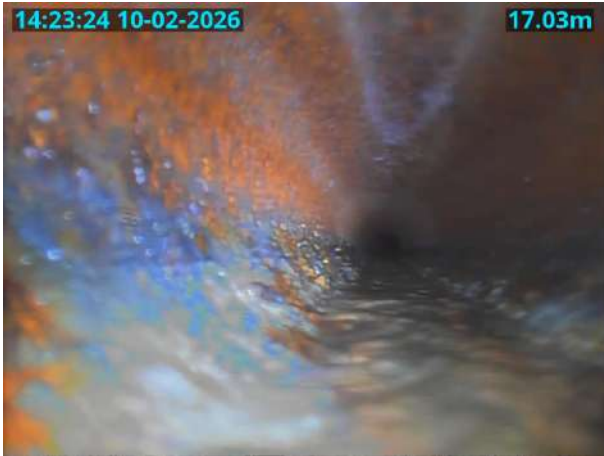
MH35X\_D\_10022026\_1424\_060.jpg, 00:01:49, 17.03 m  
General photograph taken at this point

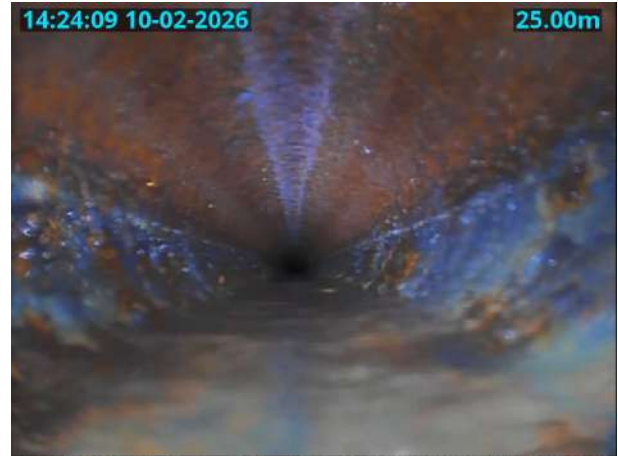
MH35X\_D\_10022026\_1424\_061.jpg, 00:02:34, 25.00 m  
General photograph taken at this point

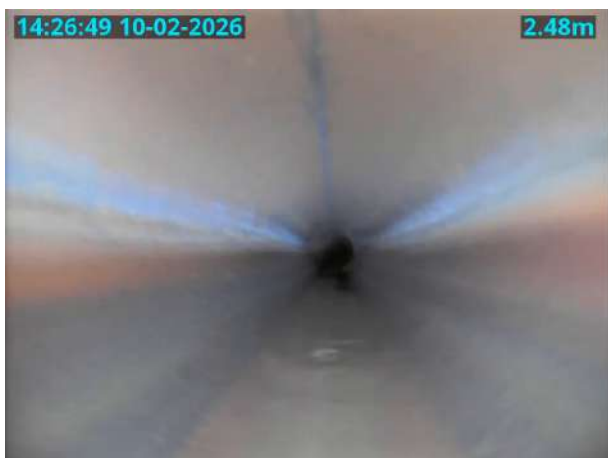
MH36X\_U\_10022026\_1427\_062.jpg, 00:00:14, 2.48 m  
General photograph taken at this point

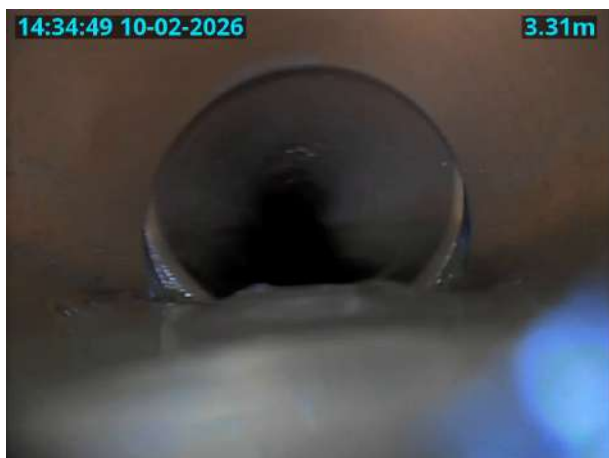
36AX\_U\_10022026\_1435\_063.jpg, 00:00:17, 3.31 m  
 Joint displaced, medium

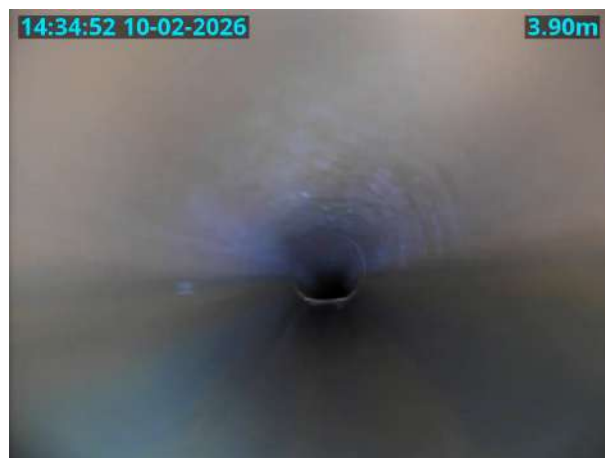
36AX\_U\_10022026\_1435\_064.jpg, 00:00:20, 3.90 m  
 General photograph taken at this point

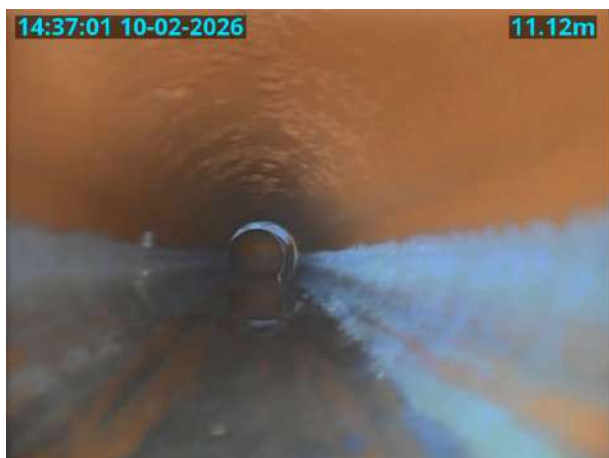
36BX\_U\_10022026\_1438\_108.jpg, 00:01:00, 11.12 m  
General photograph taken at this point

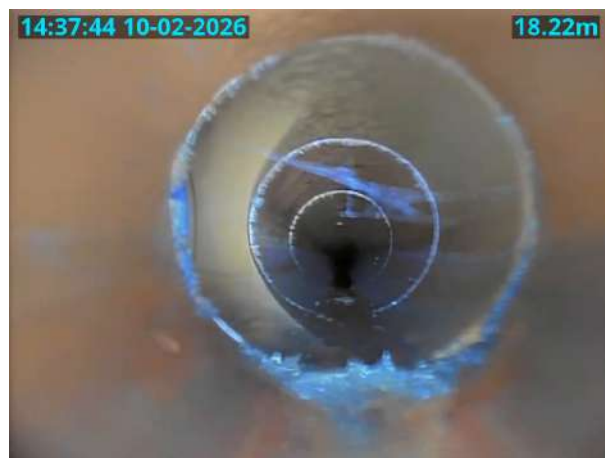
36BX\_U\_10022026\_1438\_109.jpg, 00:01:42, 18.22 m  
General photograph taken at this point

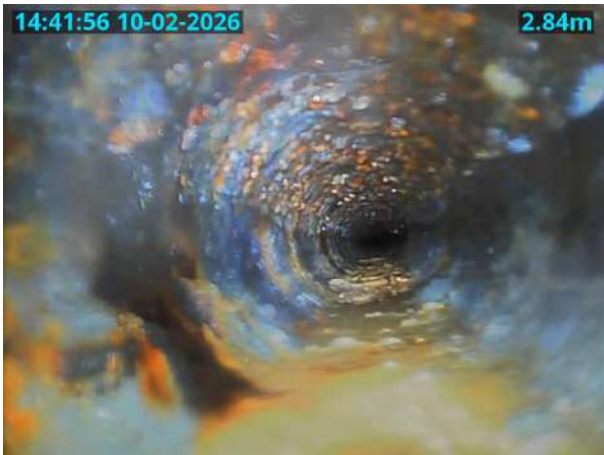
36CX\_U\_10022026\_1442\_065.jpg, 00:00:41, 2.84 m  
 General photograph taken at this point

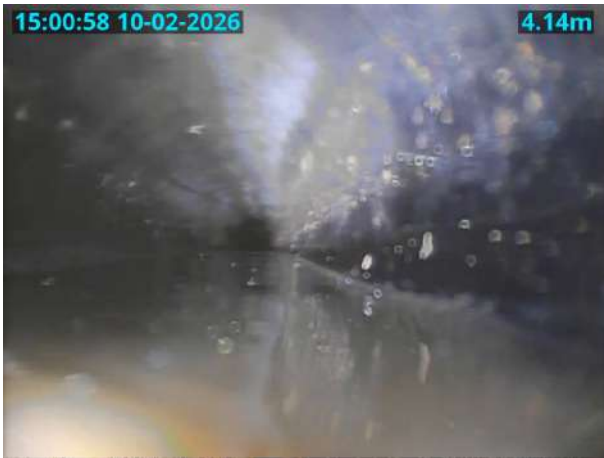
37BX\_U\_10022026\_1501\_067.jpg, 00:00:23, 4.14 m  
General photograph taken at this point

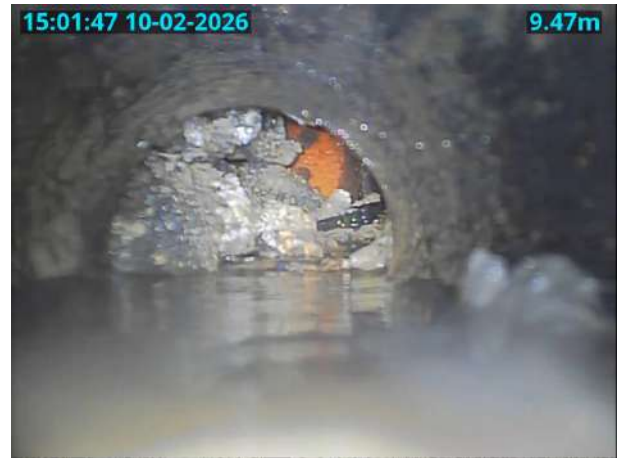
37BX\_U\_10022026\_1501\_068.jpg, 00:01:13, 9.47 m  
Collapsed drain or sewer, 70% cross-sectional area loss

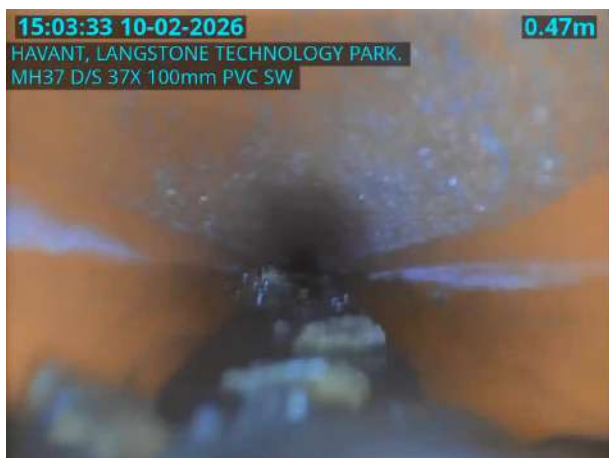
MH37X\_D\_10022026\_1505\_069.jpg, 00:00:02, 0.47 m  
General photograph taken at this point

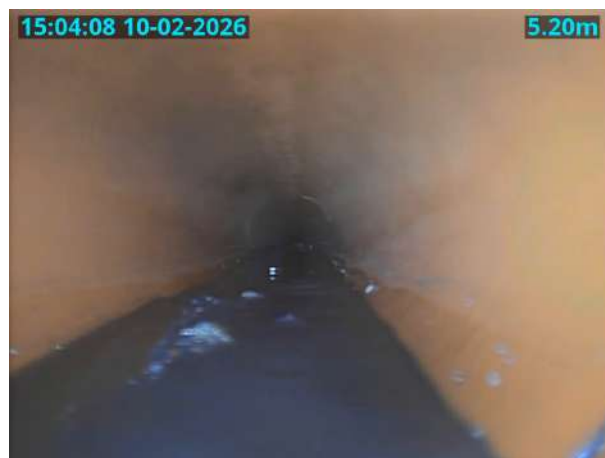
MH37X\_D\_10022026\_1505\_070.jpg, 00:00:37, 5.20 m  
General photograph taken at this point

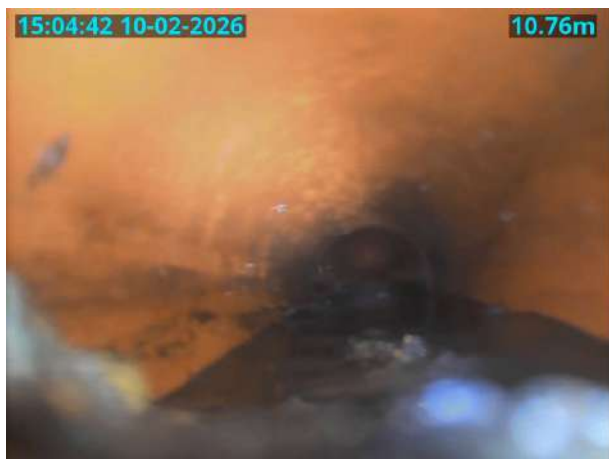
MH37X\_D\_10022026\_1505\_071.jpg, 00:01:12, 10.76 m  
Settled deposits, fine, 40% cross-sectional area loss

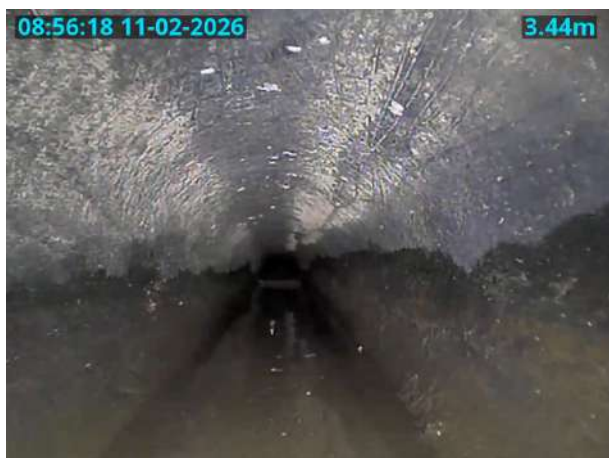
MH38X\_D\_11022026\_0856\_072.jpg, 00:00:43, 3.44 m  
General photograph taken at this point

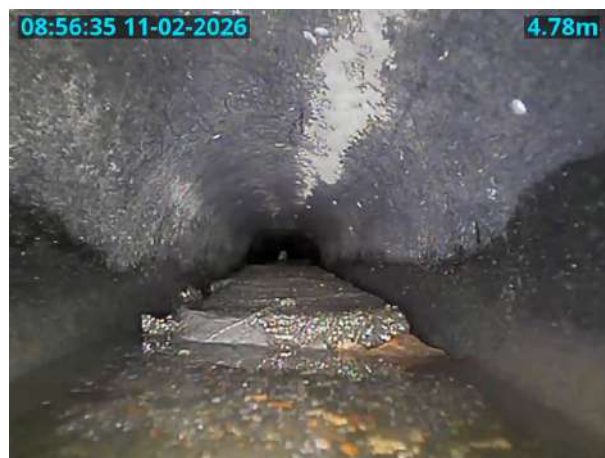
MH38X\_D\_11022026\_0856\_073.jpg, 00:01:01, 4.78 m  
Other obstacles, other object in invert from 4 o'clock to 8 o'clock, 40% cross-sectional area loss, Wood

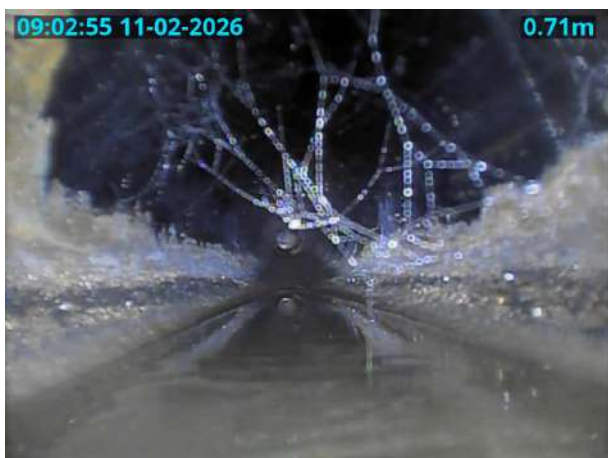
| Item No. | Inspection Direction | PLR | Client's Job Ref | Contractor's Job Ref |
|---|---|---|---|---|
| 58 | Upstream | 38AX | | |

38AX\_U\_11022026\_0903\_074.jpg, 00:00:12, 0.71 m  
 General photograph taken at this point

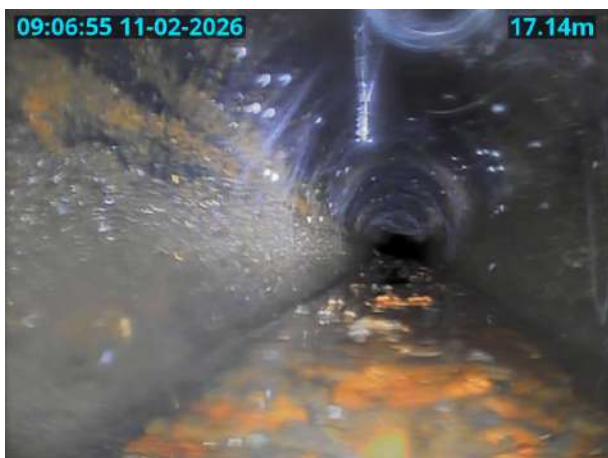
| Item No. | Inspection Direction | PLR | Client's Job Ref | Contractor's Job Ref |
|---|---|---|---|---|
| 59 | Upstream | 38BX | | |

38BX\_U\_11022026\_0908\_075.jpg, 00:02:20, 17.14 m  
General photograph taken at this point

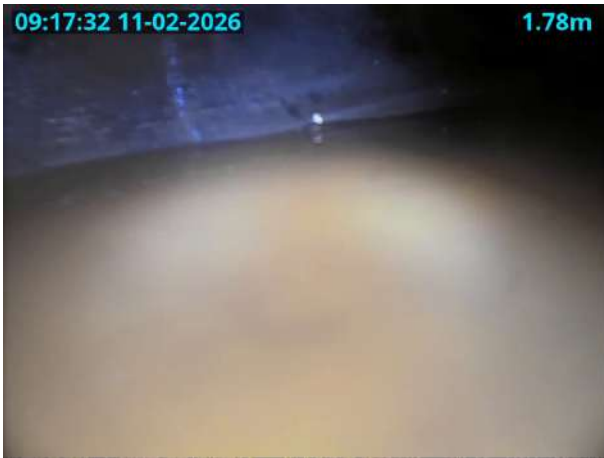
| Item No. | Inspection Direction | PLR | Client's Job Ref | Contractor's Job Ref |
|---|---|---|---|---|
| 60 | Downstream | GY3X | | |

GY3X\_D\_11022026\_0917\_076.jpg, 00:00:14, 1.78 m  
 Finish node, major connection without manhole, reference:  
 Main

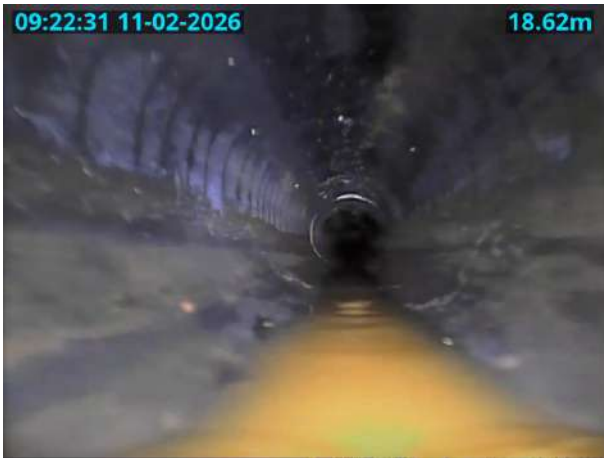
| Item No. | Inspection Direction | PLR | Client's Job Ref | Contractor's Job Ref |
|---|---|---|---|---|
| 61 | Upstream | MH38X | | |

MH38X\_U\_11022026\_0923\_077.jpg, 00:01:50, 18.62 m  
General photograph taken at this point

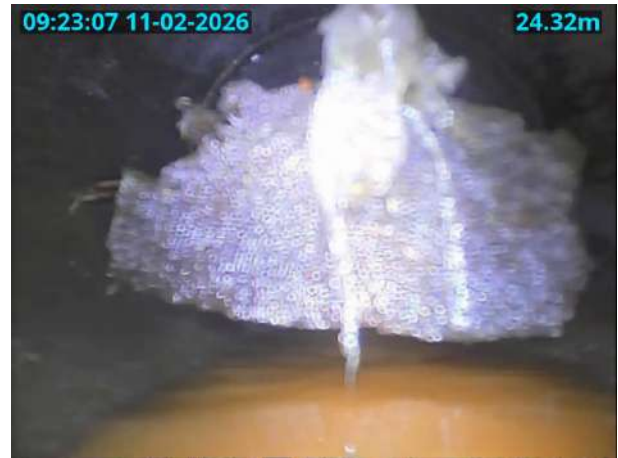
MH38X\_U\_11022026\_0923\_078.jpg, 00:02:27, 24.32 m  
Survey abandoned, Overlap complete

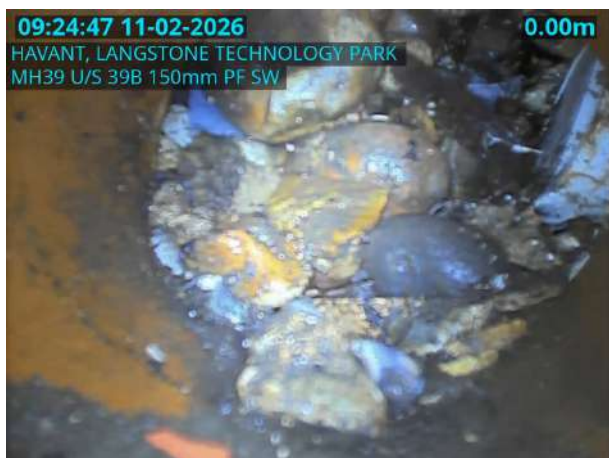
| Item No. | Inspection Direction | PLR | Client's Job Ref | Contractor's Job Ref |
|---|---|---|---|---|
| 62 | Upstream | 39BX | | |

39BX\_U\_11022026\_0924\_110.jpg, 00:00:03, 0.00 m  
Settled deposits, coarse, 100% cross-sectional area loss

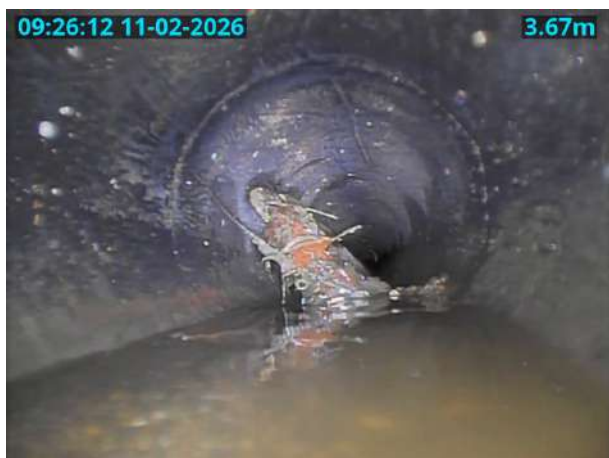
| Item No. | Inspection Direction | PLR | Client's Job Ref | Contractor's Job Ref |
|---|---|---|---|---|
| 63 | Downstream | MH39X | | |

MH39X\_D\_11022026\_0927\_111.jpg, 00:00:35, 3.67 m  
 Settled deposits, other, 40% cross-sectional area loss, Rubble  
 / twiggs, Pushing

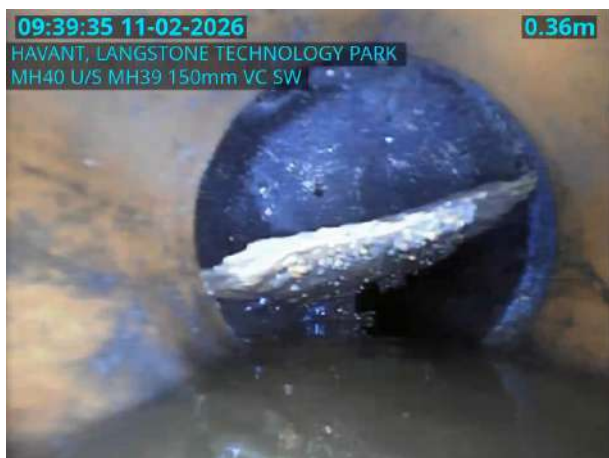
| Item No. | Inspection Direction | PLR | Client's Job Ref | Contractor's Job Ref |
|---|---|---|---|---|
| 64 | Upstream | MH39X | | |

MH39X\_U\_11022026\_0939\_079.jpg, 00:00:03, 0.36 m  
 Settled deposits, coarse, 40% cross-sectional area loss

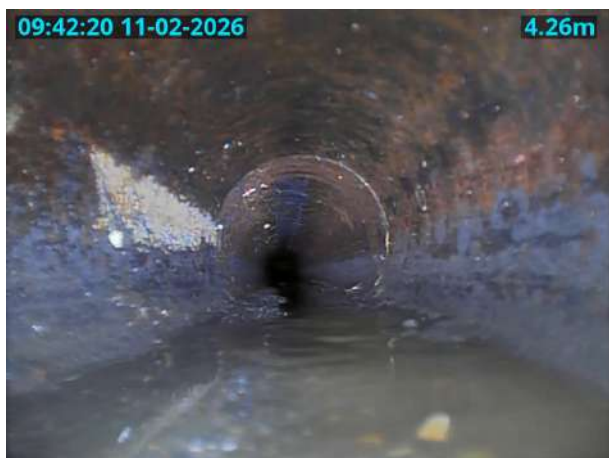
| Item No. | Inspection Direction | PLR | Client's Job Ref | Contractor's Job Ref |
|---|---|---|---|---|
| 65 | Downstream | MH40X | | |

MH40X\_D\_11022026\_0943\_080.jpg, 00:00:31, 4.26 m  
General photograph taken at this point

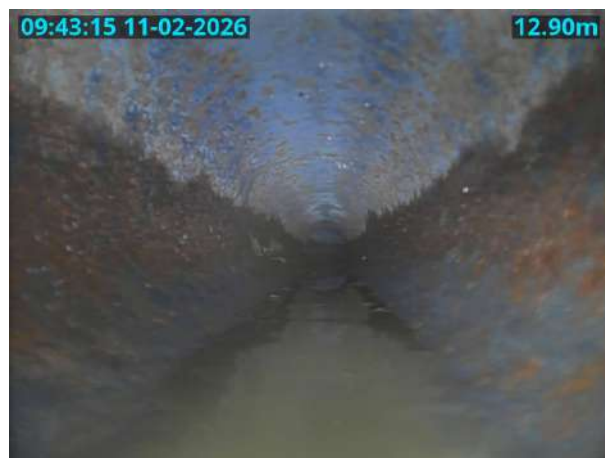
MH40X\_D\_11022026\_0943\_081.jpg, 00:01:27, 12.90 m  
General photograph taken at this point

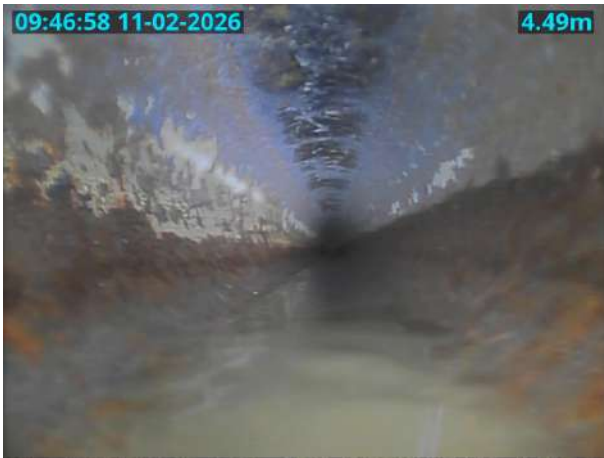
| Item No. | Inspection Direction | PLR | Client's Job Ref | Contractor's Job Ref |
|---|---|---|---|---|
| 66 | Downstream | MH33CX | | |

MH33CX\_D\_11022026\_0947\_082.jpg, 00:00:32, 4.49 m  
 General photograph taken at this point

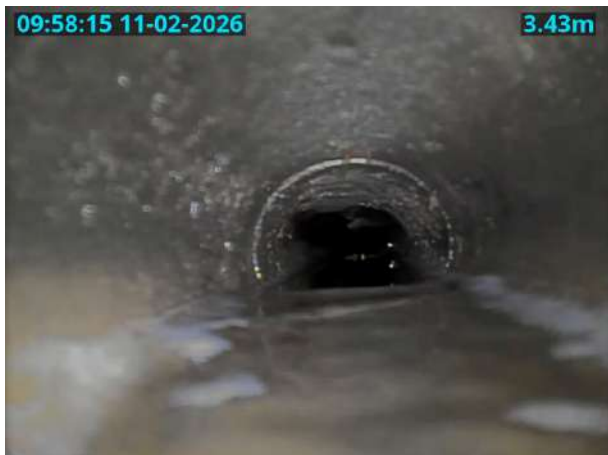
| Item No. | Inspection Direction | PLR | Client's Job Ref | Contractor's Job Ref |
|---|---|---|---|---|
| 67 | Downstream | MH41X | | |

MH41X\_D\_11022026\_0958\_112.jpg, 00:00:20, 3.43 m  
General photograph taken at this point

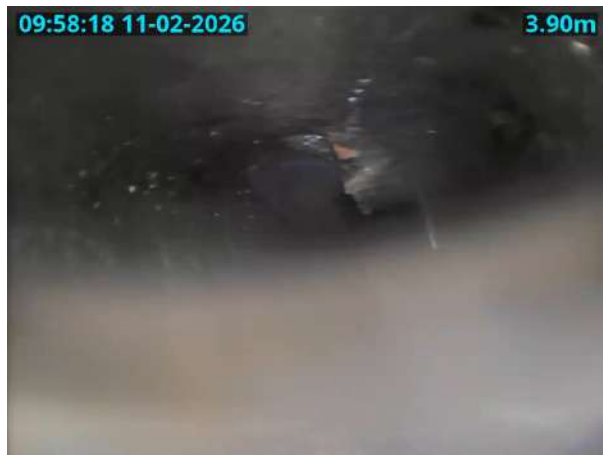
MH41X\_D\_11022026\_0958\_113.jpg, 00:00:24, 3.90 m  
Hole in drain or sewer at 12 o'clock

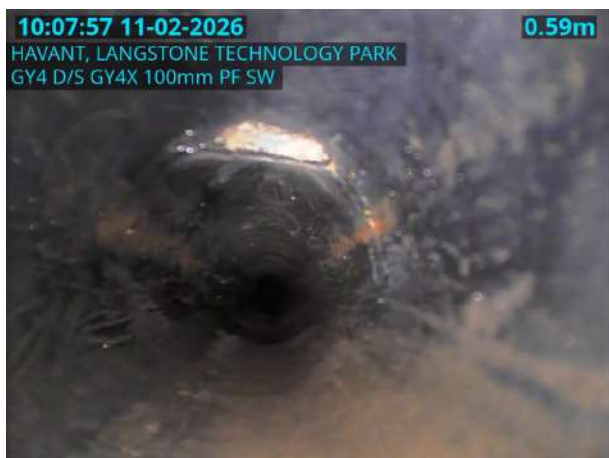
| Item No. | Inspection Direction | PLR | Client's Job Ref | Contractor's Job Ref |
|---|---|---|---|---|
| 68 | Downstream | GY4X | | |

GY4X\_D\_11022026\_1009\_083.jpg, 00:00:03, 0.59 m  
Hole in drain or sewer at 12 o'clock

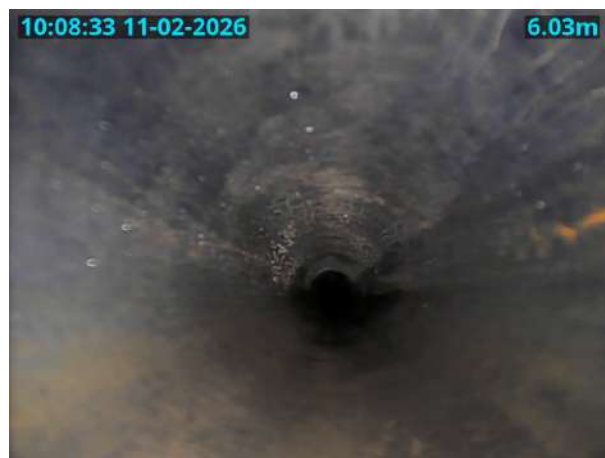
GY4X\_D\_11022026\_1009\_084.jpg, 00:00:40, 6.03 m  
General photograph taken at this point

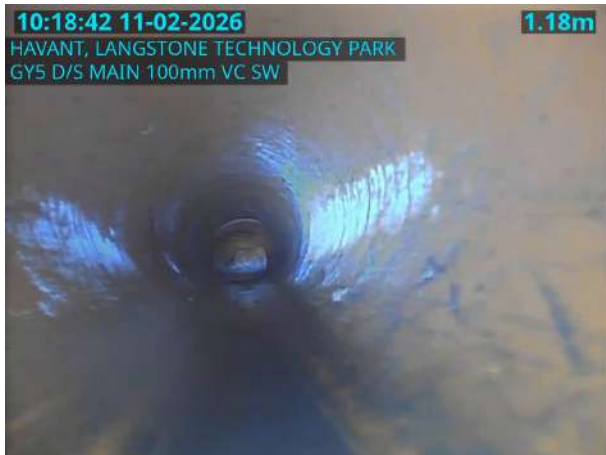
| Item No. | Inspection Direction | PLR | Client's Job Ref | Contractor's Job Ref |
|---|---|---|---|---|
| 69 | Downstream | GY5X | | |

GY5X\_D\_11022026\_1018\_085.jpg, 00:00:07, 1.18 m  
General photograph taken at this point

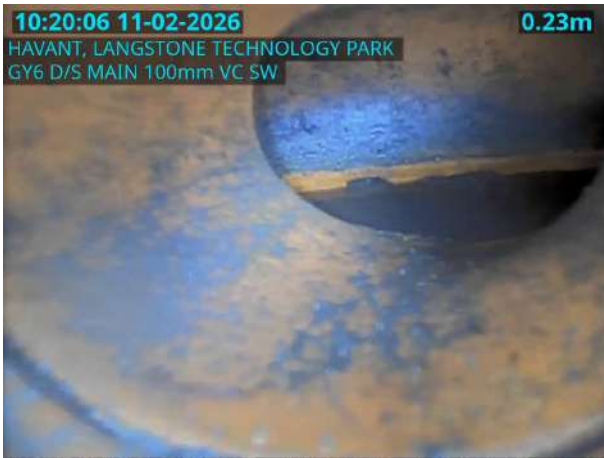
| Item No. | Inspection Direction | PLR | Client's Job Ref | Contractor's Job Ref |
|---|---|---|---|---|
| 70 | Downstream | GY6X | | |

GY6X\_D\_11022026\_1020\_086.jpg, 00:00:03, 0.23 m  
General photograph taken at this point

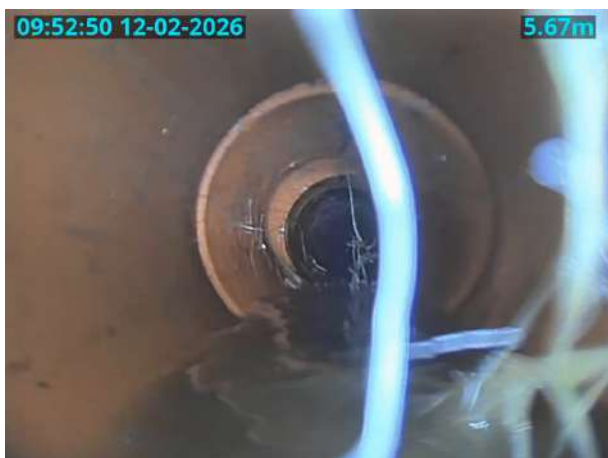
| Item No. | Inspection Direction | PLR | Client's Job Ref | Contractor's Job Ref |
|---|---|---|---|---|
| 71 | Downstream | MH50X | | |

MH50X\_501639b4-1eef-4419-a24c-3575b4543346\_20260223\_123148\_407.jpg, 00:00:45, 5.67 m  
Roots, mass, 10% cross-sectional area loss

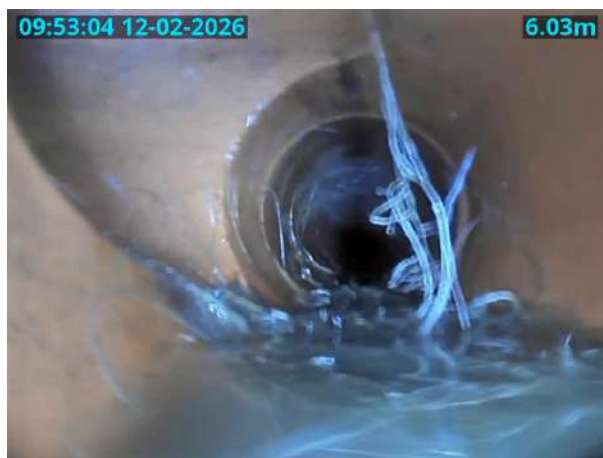
MH50X\_4b2c89ca-b867-4f42-ba8d-87102b712706\_20260223\_123235\_731.jpg, 00:00:59, 6.03 m  
Junction at 10 o'clock, 100mm dia

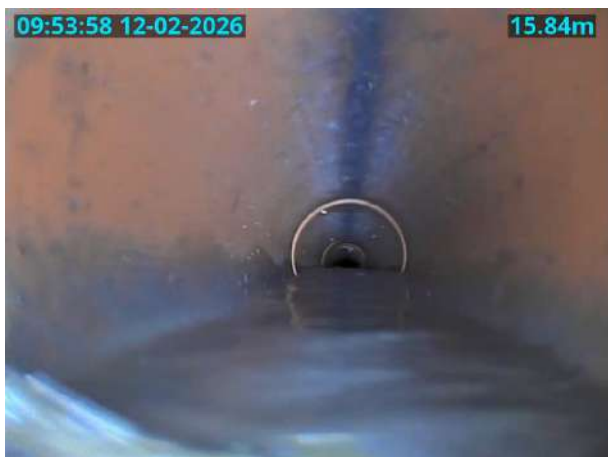
MH50X\_5ff3765e-78a2-405e-8e3c-dcf9fef40dc9\_20260223\_123427\_065.jpg, 00:01:52, 15.84 m  
Water level, 25% of the vertical dimension

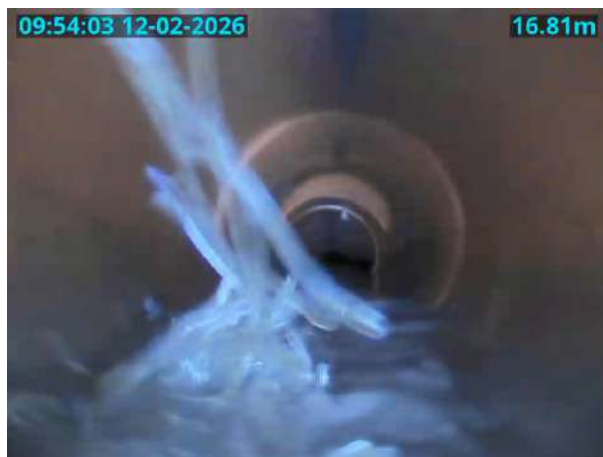
| Scale: | 1:142 | Position [m] | Code | Observation | MPEG | Photo | Grade |
|---|---|---|---|---|---|---|---|
| | | <u>16.81</u> | RM | Roots, mass, 10% cross-sectional area loss | 00:01:57 | MH50X_c4<br>d21d95-e8<br>03-416a-b | 3 |

MH50X\_c4d21d95-e803-416a-bae8-30b0d6476027\_20260223\_123447\_718.jpg, 00:01:57, 16.81 m  
Roots, mass, 10% cross-sectional area loss

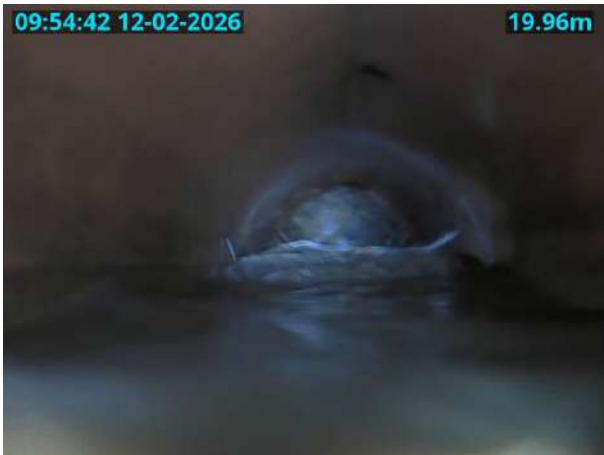
| Item No. | Inspection Direction | PLR | Client's Job Ref | Contractor's Job Ref |
|---|---|---|---|---|
| 71 | Downstream | MH50X | | |

MH50X\_c99950d4-75a9-4f05-9ece-dc993876aabf\_20260223\_123633\_668.jpg, 00:02:36, 20.00 m  
Survey abandoned, ROOTS MASS 90%

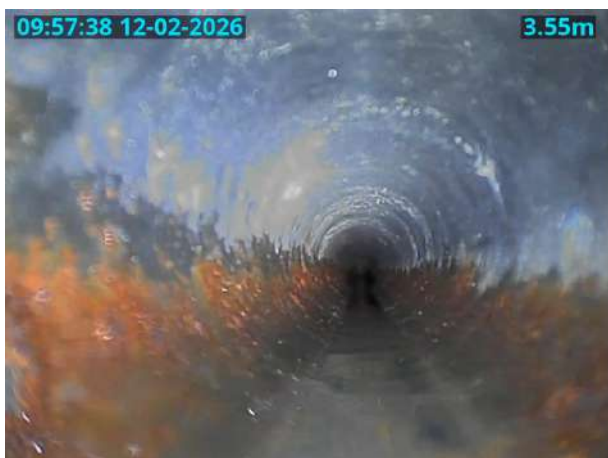
| Item No. | Inspection Direction | PLR | Client's Job Ref | Contractor's Job Ref |
|---|---|---|---|---|
| 72 | Upstream | 50AX | | |

50AX\_d744a6ec-30cf-4855-887a-bebf4297be33\_20260223\_1  
23910\_965.jpg, 00:00:29, 3.55 m  
General photograph taken at this point

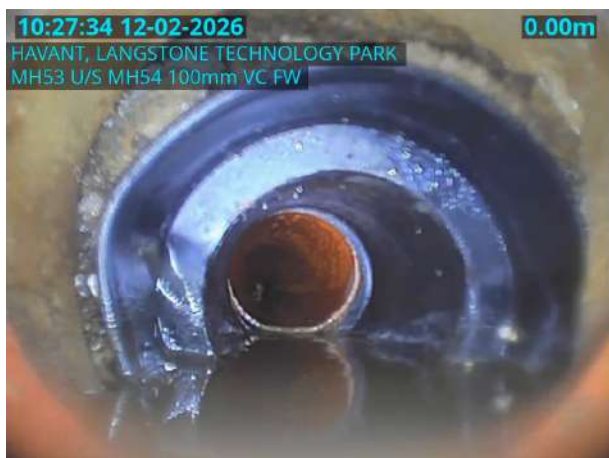
| Item No. | Inspection Direction | PLR | Client's Job Ref | Contractor's Job Ref |
|---|---|---|---|---|
| 78 | Upstream | MH54X | | |

MH54X\_798307c4-09e6-4b34-a5a9-306f880723f1\_20260223\_125610\_257.jpg, 00:00:03, 0.00 m  
Water level, 20% of the vertical dimension

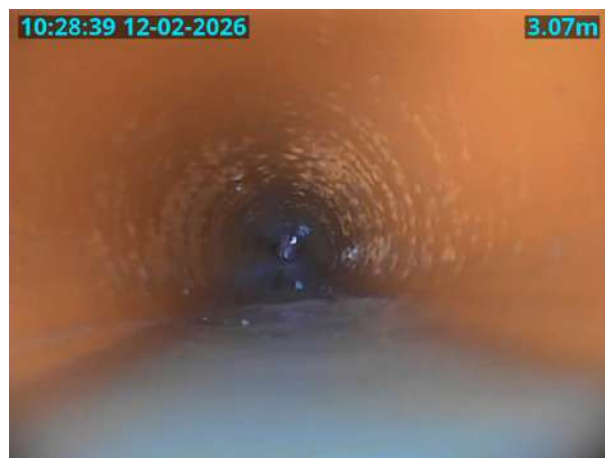
MH54X\_2803b975-b308-4e8e-83bb-015ae72626ca\_20260223\_125645\_123.jpg, 00:01:07, 3.07 m  
Water level, 5% of the vertical dimension

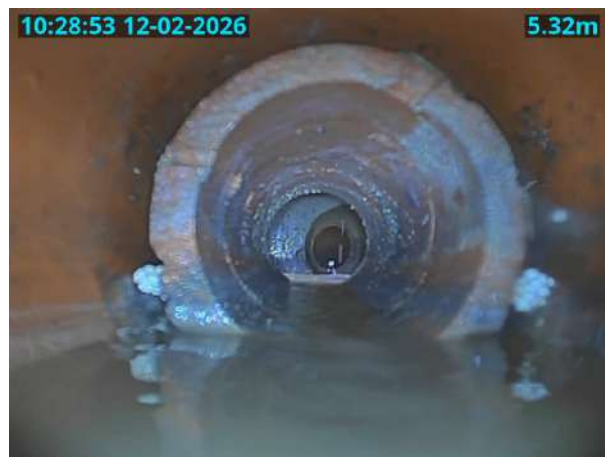
MH54X\_bbf75885-3e25-4d5c-be48-c9567dbaeb8a\_20260223\_125822\_392.jpg, 00:01:22, 5.40 m  
Pipe material changes to vitrified clay at this point

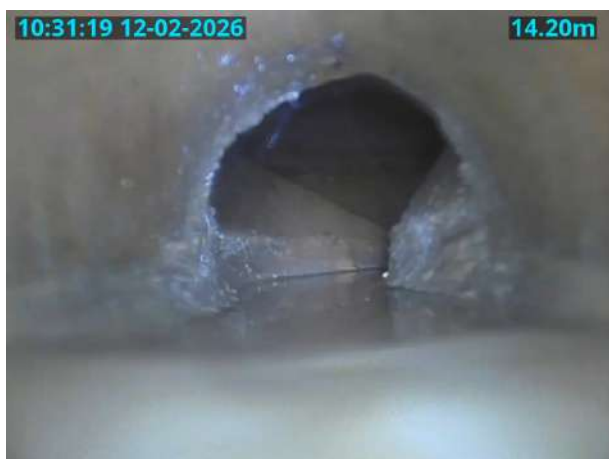
MH53X\_a10c0ad8-8dfe-446d-8c74-1b8eb4108b60\_20260223\_133740\_881.jpg, 00:01:21, 14.20 m  
Water level, 20% of the vertical dimension

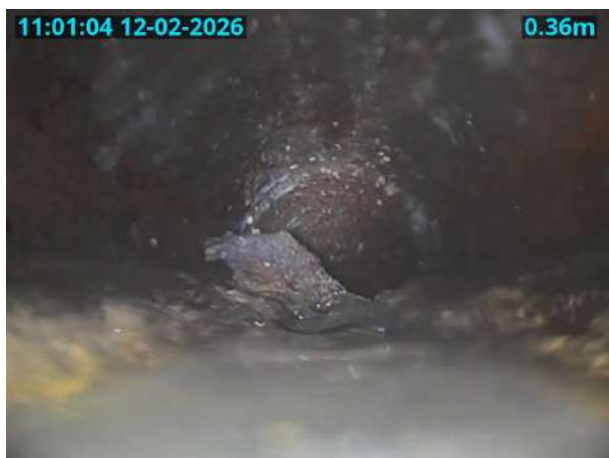
MH56X\_f6baea80-03cf-48b7-8a11-8c1329f72436\_20260223\_134022\_818.jpg, 00:00:10, 0.36 m  
Settled deposits, hard or compacted, 20% cross-sectional area loss, start

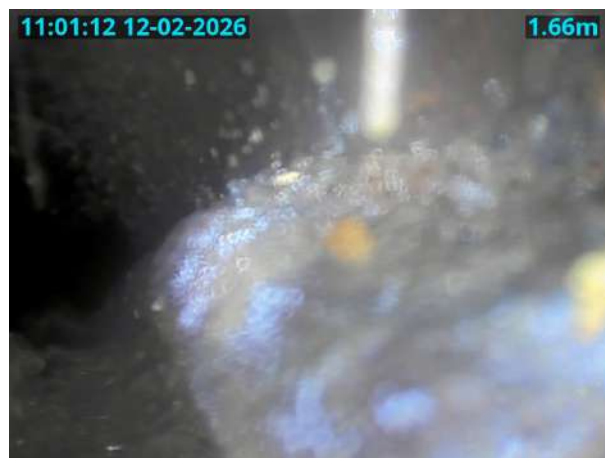
MH56X\_04ceadd2-c3ea-4a61-a940-9907a48c0365\_20260223\_134058\_224.jpg, 00:00:18, 1.66 m  
Settled deposits, hard or compacted, 30% cross-sectional area loss, change

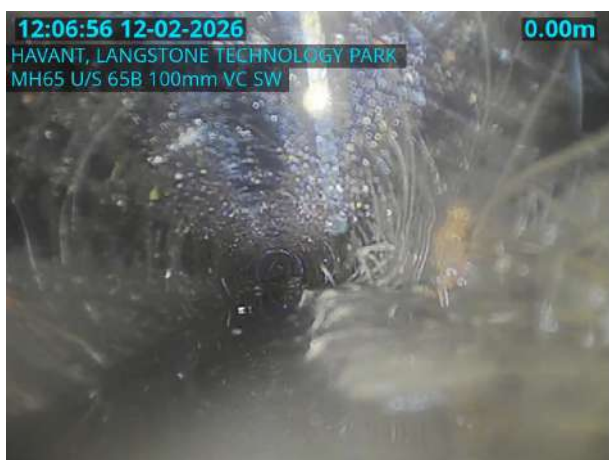
65BX\_cc464784-8f3f-48e0-b571-1108eed4f1f5\_20260223\_134846\_758.jpg, 00:00:01, 0.00 m  
Settled deposits, fine, 20% cross-sectional area loss, start

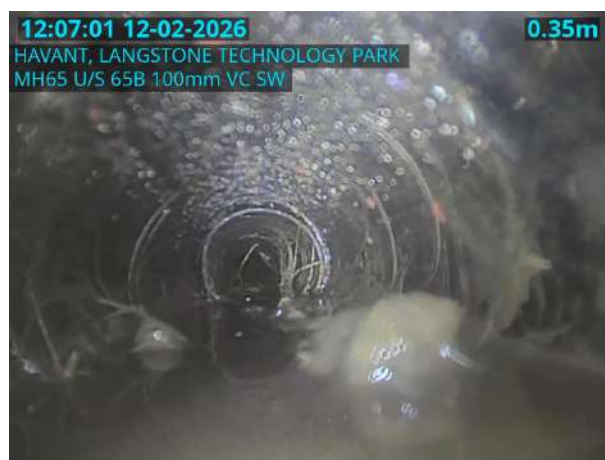
65BX\_6caa402f-0d17-43a1-84e7-f25ef14caea4\_20260223\_134908\_595.jpg, 00:00:06, 0.35 m  
Roots, fine

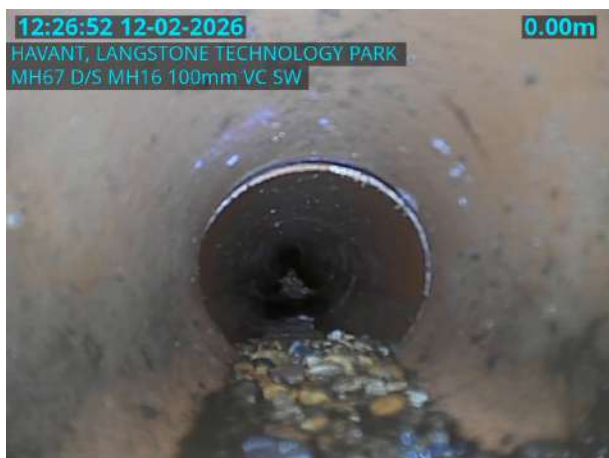
MH67X\_e6423dbc-9058-4b13-915d-2083dd1ee47e\_20260223\_135555\_032.jpg, 00:00:01, 0.00 m  
Settled deposits, coarse, 10% cross-sectional area loss, start, STONES AND SILT

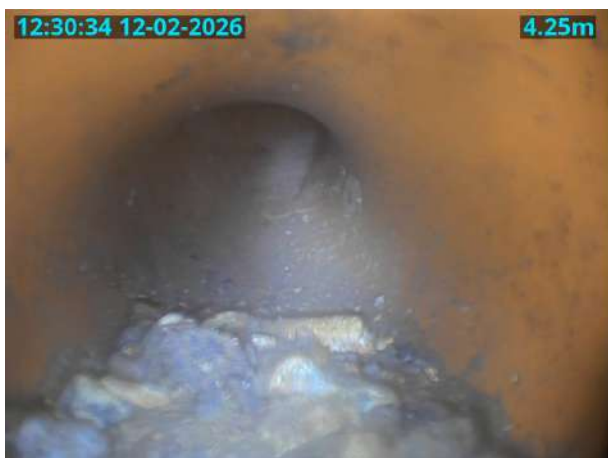
67AX\_e712470a-26e3-4134-b2d9-cdc196dac5e0\_20260223\_140250\_670.jpg, 00:00:29, 4.25 m  
Settled deposits, coarse, 10% cross-sectional area loss, finish

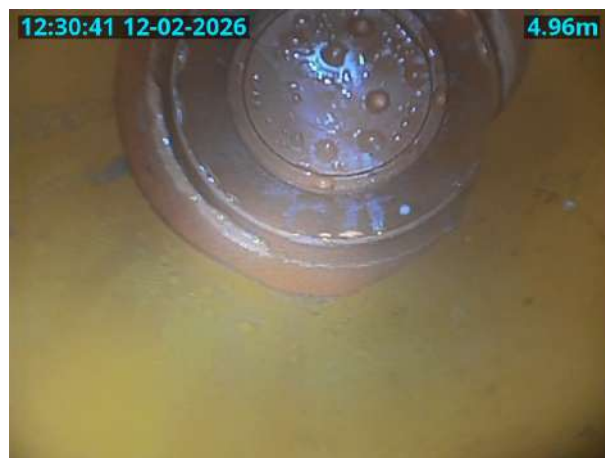
67AX\_694923d4-9b3e-47ff-87b4-f1e0f30c1e9e\_20260223\_140410\_886.jpg, 00:00:36, 4.96 m  
Finish node, other special chamber, reference: 67A, CAPPED OFF

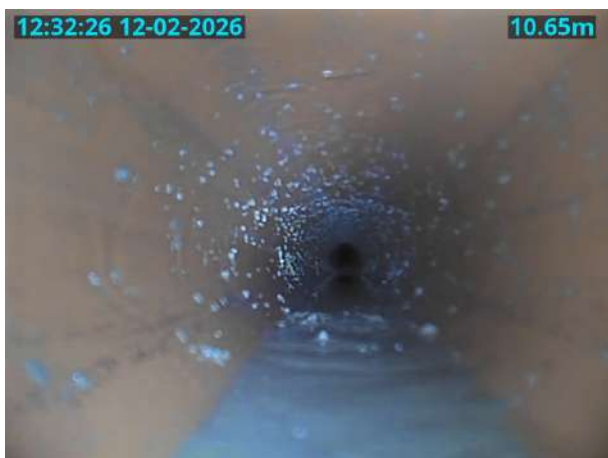
67BX\_d06e8542-cadb-4520-8807-97cf7d1b7d27\_20260223\_140759\_394.jpg, 00:01:13, 10.65 m  
Settled deposits, fine, 5% cross-sectional area loss

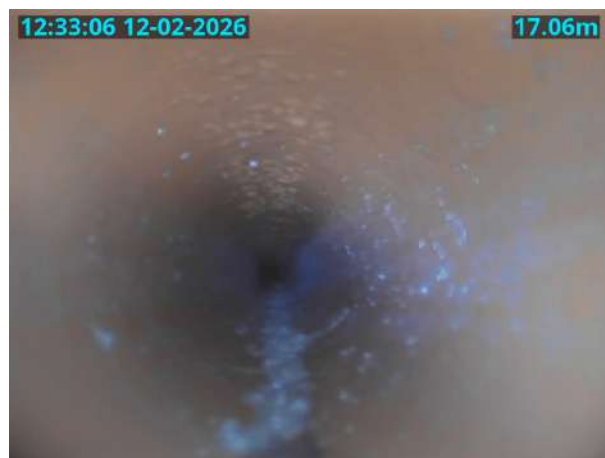
67BX\_aca055ae-d6f4-47a0-adba-0a7cf70847c0\_20260223\_140922\_990.jpg, 00:01:53, 17.06 m  
Settled deposits, fine, 5% cross-sectional area loss, start
