8<sup>th</sup> May 2026

## **13885 – Havant Phase 3A: - Engineers Response to planning condition 29**

**Proposal:** Existing Sewer Conditions

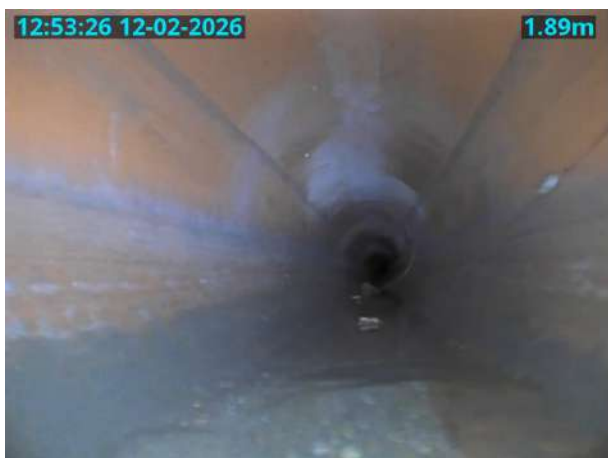
MH72X\_c1071194-29da-4955-a7d5-f5be990bfeba\_20260223\_141356\_370.jpg, 00:00:19, 1.89 m  
Settled deposits, fine, 5% cross-sectional area loss, start

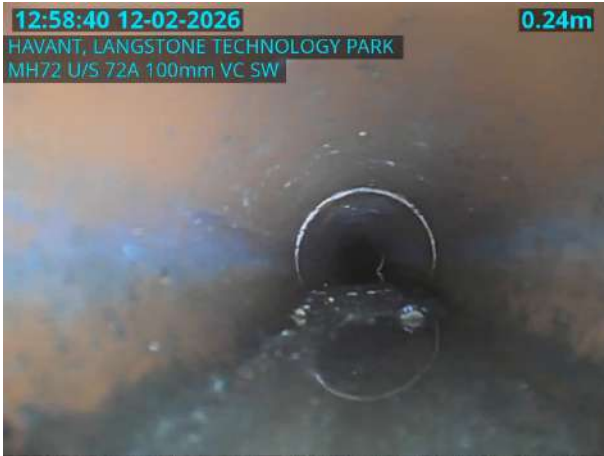
72AX\_5d567ff4-7933-4304-9a13-235b05de925e\_20260223\_1  
42422\_704.jpg, 00:00:05, 0.24 m  
Settled deposits, coarse, 15% cross-sectional area loss, start

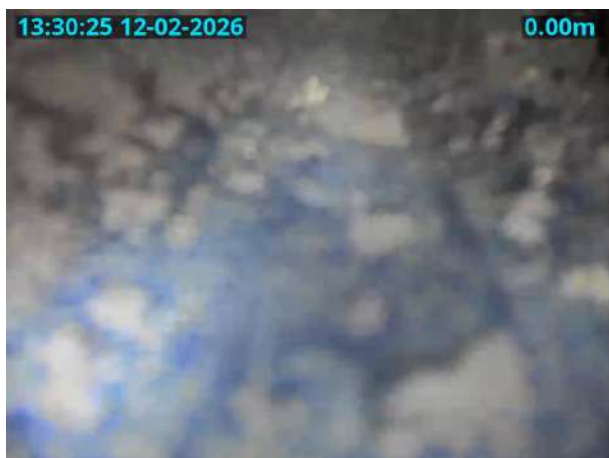
74AX\_372b5dbf-f9cf-4af8-9195-d83364a10624\_20260223\_143916\_686.jpg, 00:00:17, 0.00 m  
Settled deposits, fine, 35% cross-sectional area loss

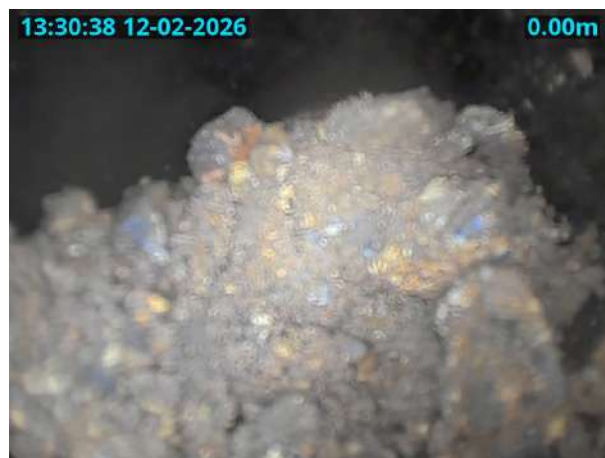
74AX\_78c8c9e3-c7b2-4bf7-9723-678fc35ca4e8\_20260223\_143922\_303.jpg, 00:00:17, 0.00 m  
Settled deposits, fine, 35% cross-sectional area loss

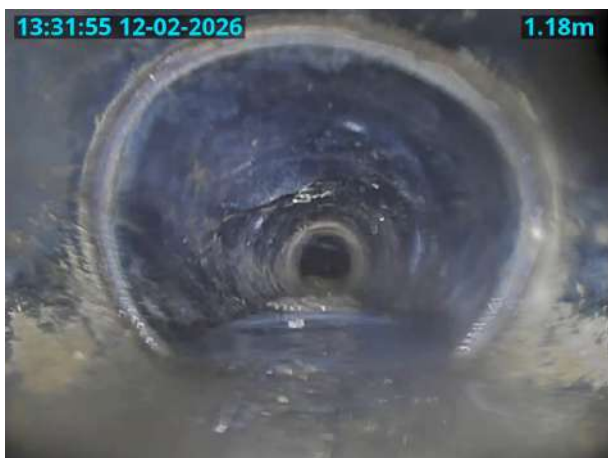
74CX\_0a3ddfd2-5c01-43a4-95a6-6f60dc623085\_20260223\_150152\_097.jpg, 00:00:09, 1.18 m  
Deformed sewer or drain, 10%

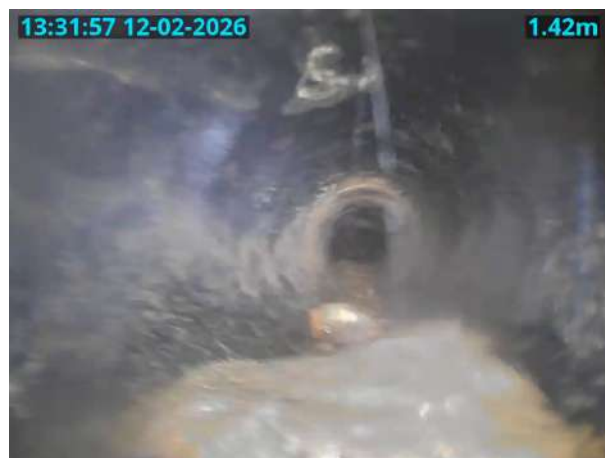
74CX\_bf3e348a-2beb-416e-b662-05e4b08a42e7\_20260223\_150208\_702.jpg, 00:00:11, 1.42 m  
Settled deposits, coarse, 10% cross-sectional area loss

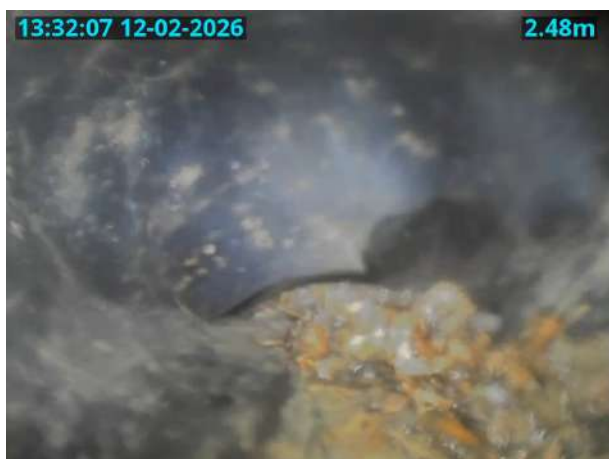
74CX\_bd552570-be25-4d06-bce7-7bfd50653d20\_20260223\_150247\_979.jpg, 00:00:21, 2.48 m  
Deformed sewer or drain, 80%, SQUASHED PIPE

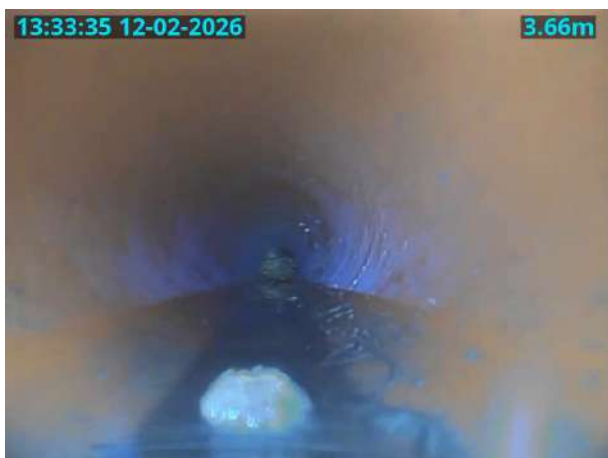
Settled deposits, coarse, 5% cross-sectional area loss, STONE

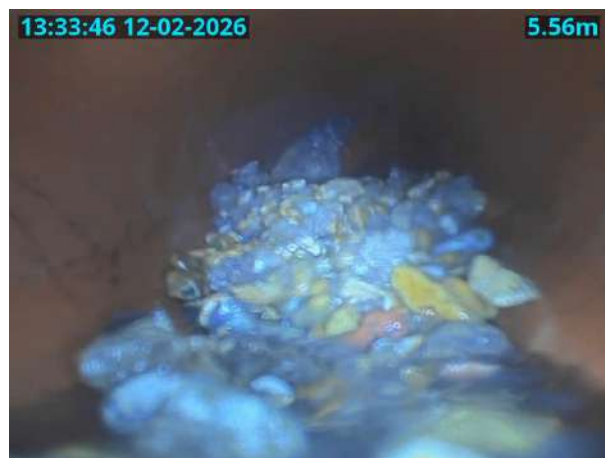
Settled deposits, coarse, 60% cross-sectional area loss, BACKFILL MATERIAL FROM BROKEN PIPE

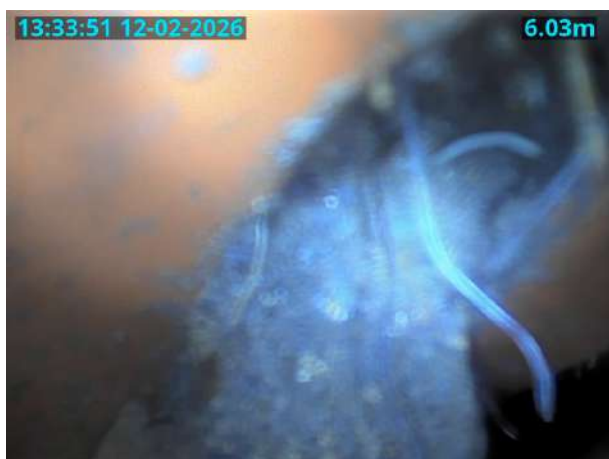
General remark, BROKEN PIPE

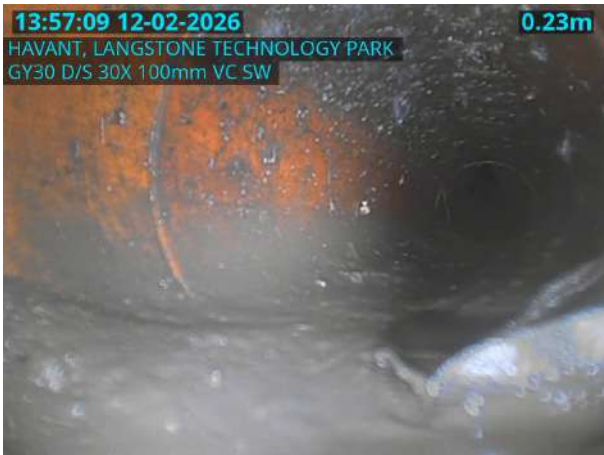
GY30X\_78ef184c-6b03-44f7-971c-f21d360c2085\_20260223\_152016\_732.jpg, 00:00:01, 0.00 m  
Settled deposits, fine, 20% cross-sectional area loss, start

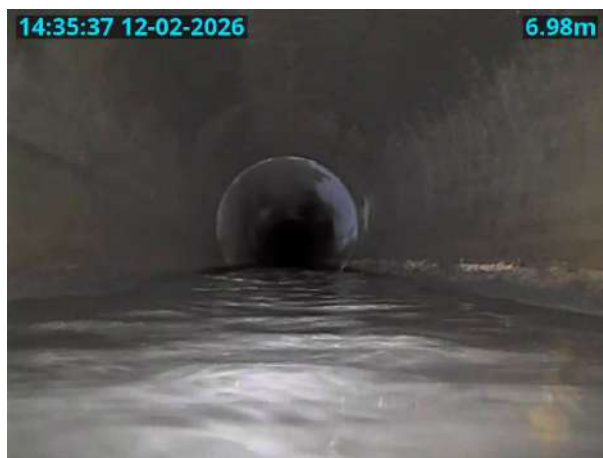
MH25X\_69069a43-4ba9-4455-8549-41131022f3ba\_20260223\_153256\_801.jpg, 00:00:43, 6.98 m  
Settled deposits, coarse, 10% cross-sectional area loss, finish

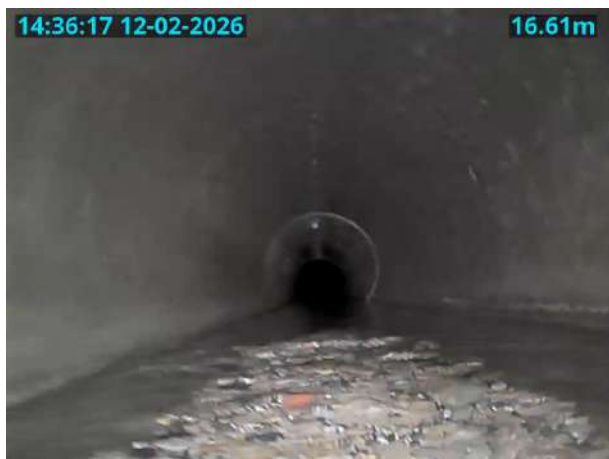
MH25X\_4aee4e54-6064-4f62-9aa3-2db974a143af\_20260223\_153356\_347.jpg, 00:01:23, 16.61 m  
Settled deposits, fine, 10% cross-sectional area loss, start

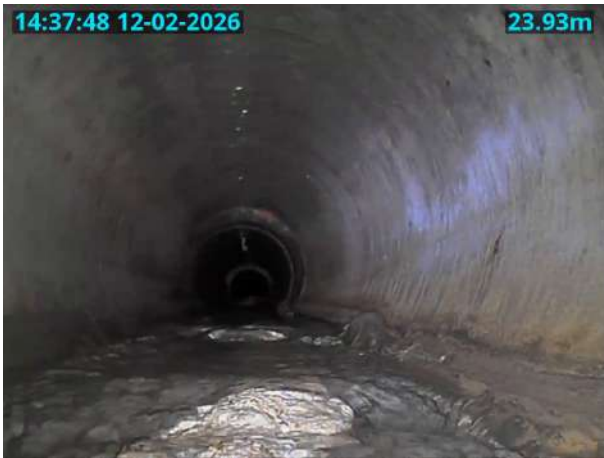
MH25X\_9838f1f9-094c-47cc-9e38-5bdfc7f75e6e\_20260223\_1  
53549\_810.jpg, 00:01:36, 23.93 m  
Settled deposits, coarse, 20% cross-sectional area loss,  
change, LARGE STONE

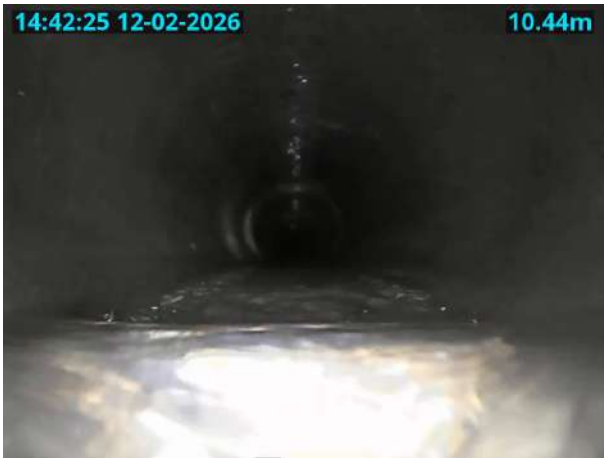
MH76X\_fd8ccc54-4fd8-42fe-8163-c02797994899\_20260223\_154041\_077.jpg, 00:01:12, 10.44 m  
Settled deposits, coarse, 15% cross-sectional area loss

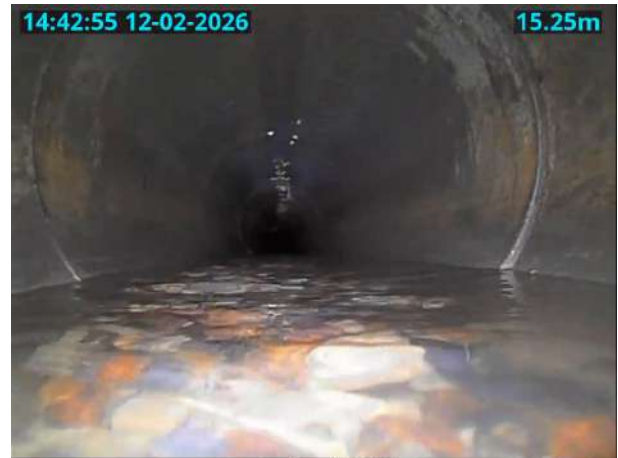
MH76X\_52cbf0c5-166a-4477-96cd-043014f41dee\_20260223\_154115\_591.jpg, 00:01:42, 15.25 m  
Settled deposits, coarse, 10% cross-sectional area loss, start

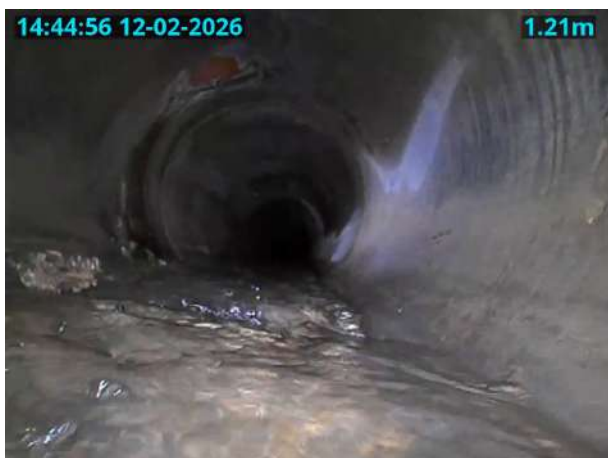
| Item No. | Inspection Direction | PLR | Client's Job Ref | Contractor's Job Ref |
|---|---|---|---|---|
| 97 | Downstream | MH78X | | |

MH78X\_39fa71cf-9ab2-4099-a4e1-105265ceb767\_20260223\_154432\_527.jpg, 00:00:11, 0.00 m  
Settled deposits, coarse, 10% cross-sectional area loss, start

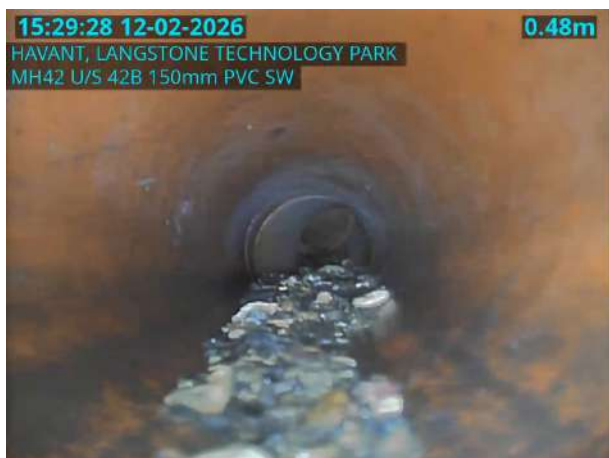
| Item No. | Inspection Direction | PLR | Client's Job Ref | Contractor's Job Ref |
|---|---|---|---|---|
| 98 | Upstream | 42BX | | |

42BX\_c7774460-d5ed-4b6a-9da7-0de6b60a6d77\_20260223\_155016\_734.jpg, 00:00:04, 0.48 m  
Settled deposits, coarse, 20% cross-sectional area loss, start

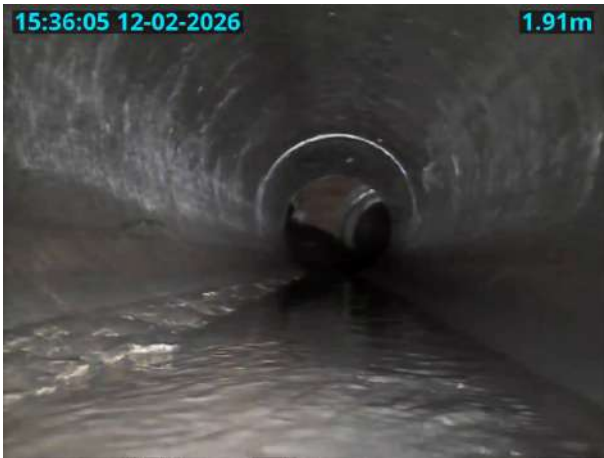
| Item No. | Inspection Direction | PLR | Client's Job Ref | Contractor's Job Ref |
|---|---|---|---|---|
| 99 | Downstream | MH43X | | |

MH43X\_e4f4f57e-b77e-4933-a380-fcd97a5b8112\_20260223\_155406\_667.jpg, 00:00:26, 1.50 m  
Settled deposits, fine, 5% cross-sectional area loss, start

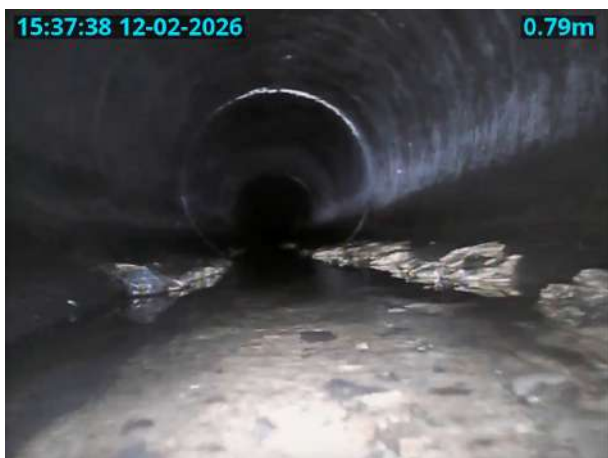
| Item No. | Inspection Direction | PLR | Client's Job Ref | Contractor's Job Ref |
|---|---|---|---|---|
| 100 | Downstream | MH80X | | |

MH80X\_5b86b685-05e6-4278-9c48-a11944ee3266\_20260223\_155607\_481.jpg, 00:00:11, 0.00 m  
Settled deposits, fine, 5% cross-sectional area loss, start

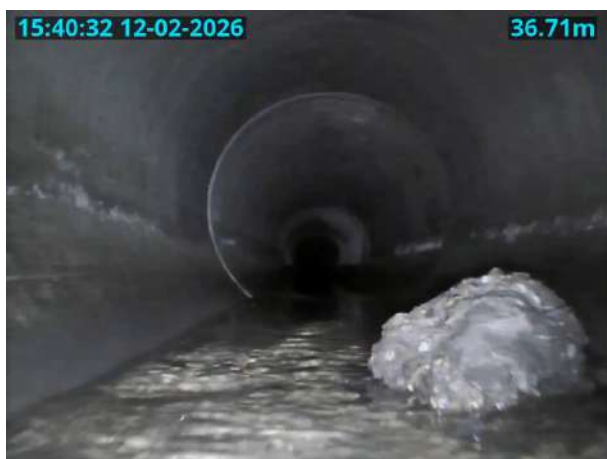
MH80X\_ea6cf17c-1c75-45b5-8a8a-b7ace45a023d\_20260223\_155813\_822.jpg, 00:03:05, 36.71 m  
Settled deposits, coarse, 15% cross-sectional area loss, STONE

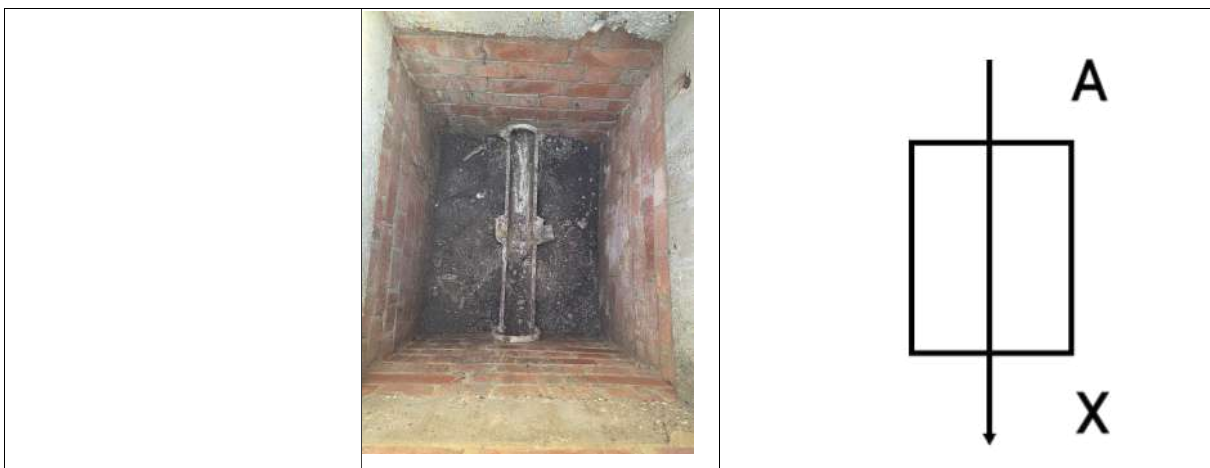
| Remarks: Benching damaged |

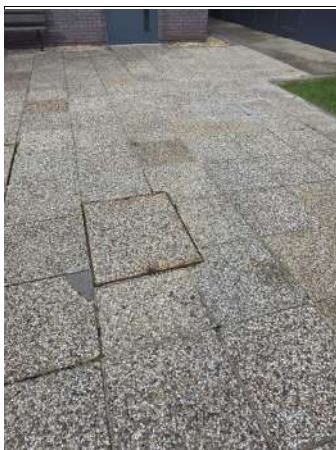
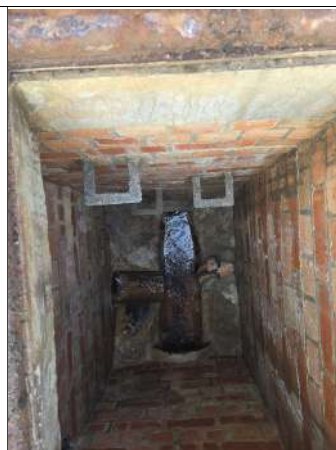
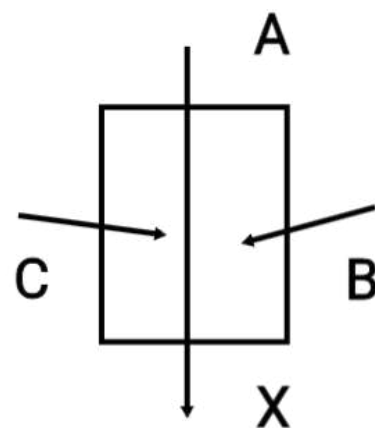
| Remarks: Infiltration from benching. |

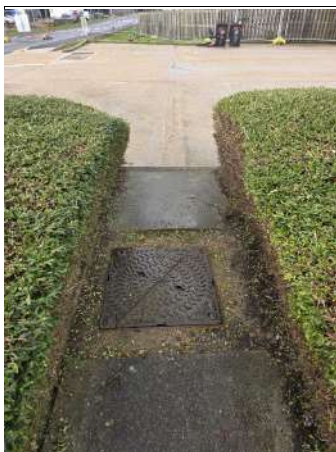
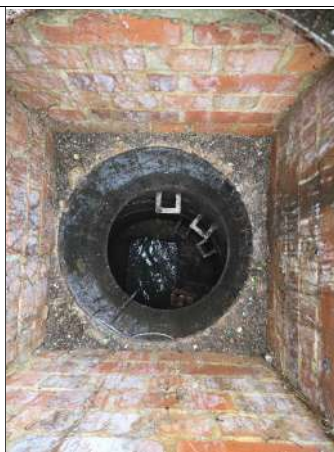
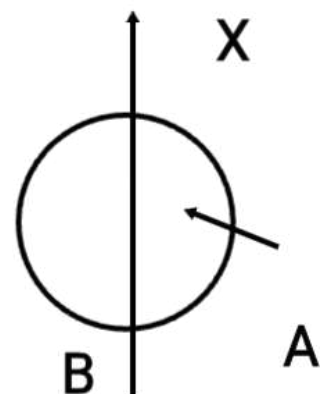
| Remarks: pipe sizes approx due to very fast flow. |

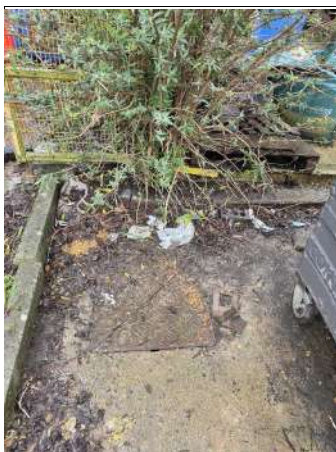
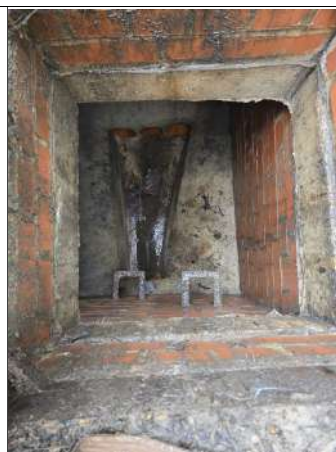
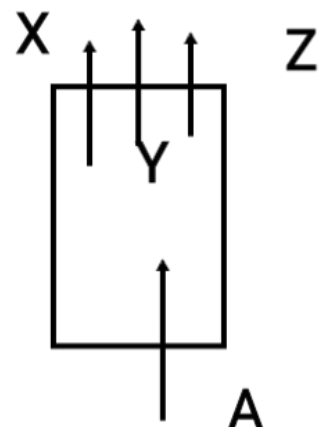
| Grid Ref: | Node Number: MH33 | Cover Level: 4.940 |

| Remarks: 3x outgoing pipes all identical |

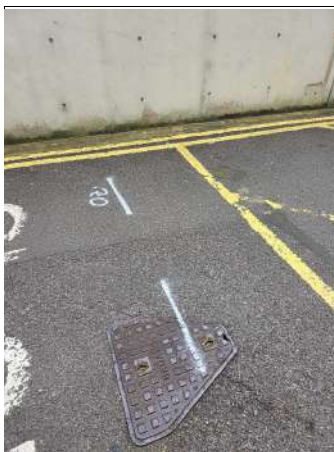
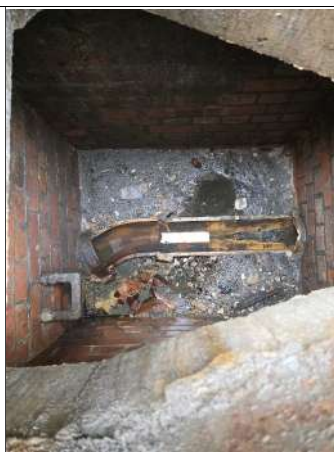
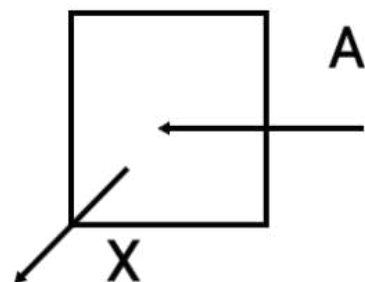
| Grid Ref: | Node Number: MH41 | Cover Level: 4.860 |

| Cover | Irons/Ladders | Shaft | Chamber | Benching <input checked="" type="checkbox"/> | Other |

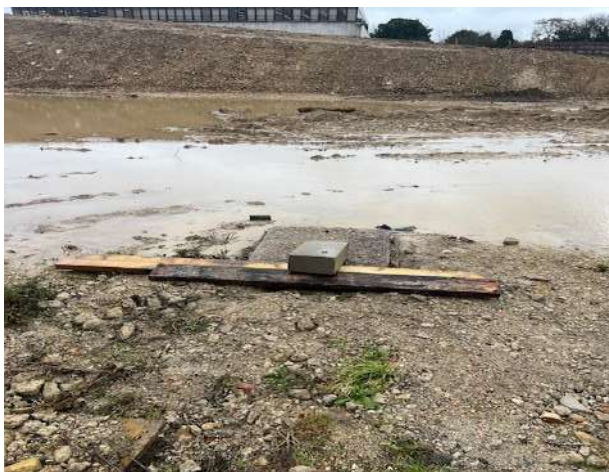
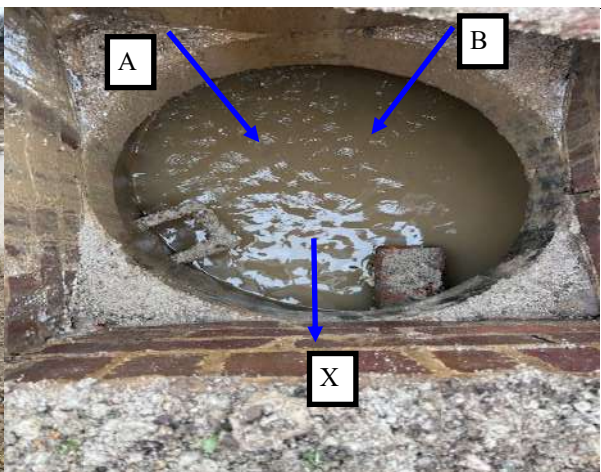
| Grid Ref: | Node Number: MH56 | Cover Level: | |

Remarks: Total depth 1.34m UTS - A + B = under slab and constant ground water run off into chamber from flooded land.

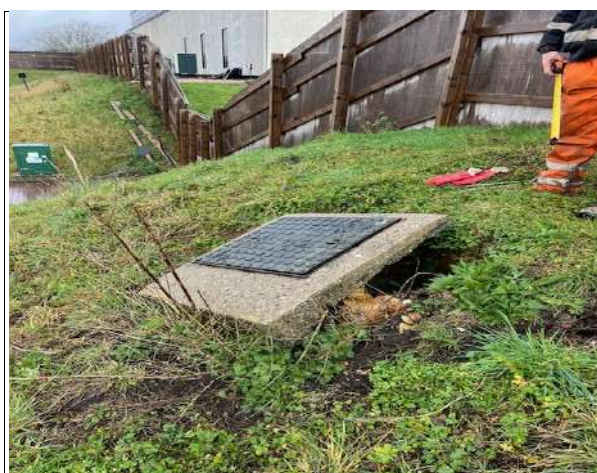
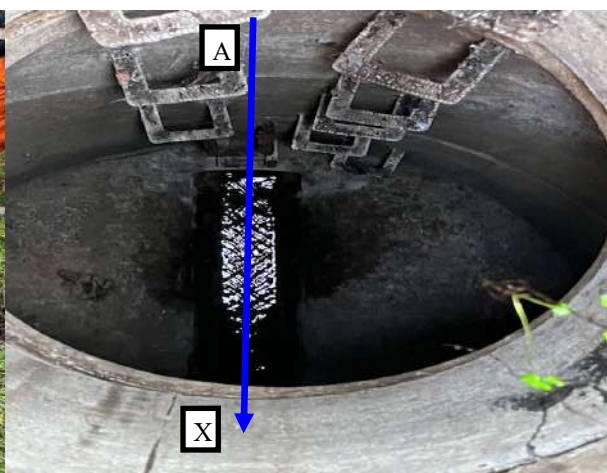
| Grid Ref: | Node Number: MH59 | Cover Level: 7.30 | |

Remarks: UTS - Confined Space Entry required. Unable to set tripod up on steep land/banking.  
Requires land to dry up to transport CCTV equipment to manhole.

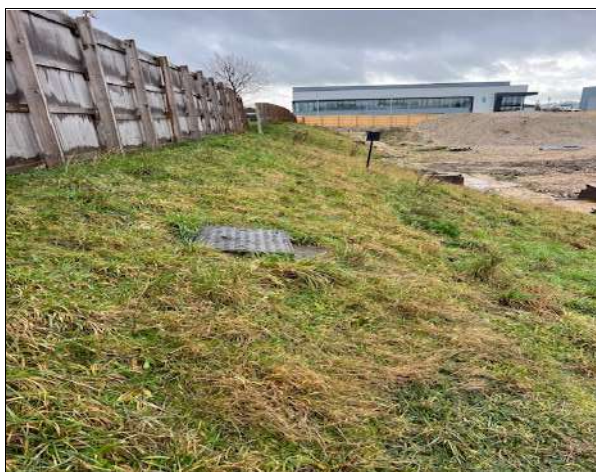
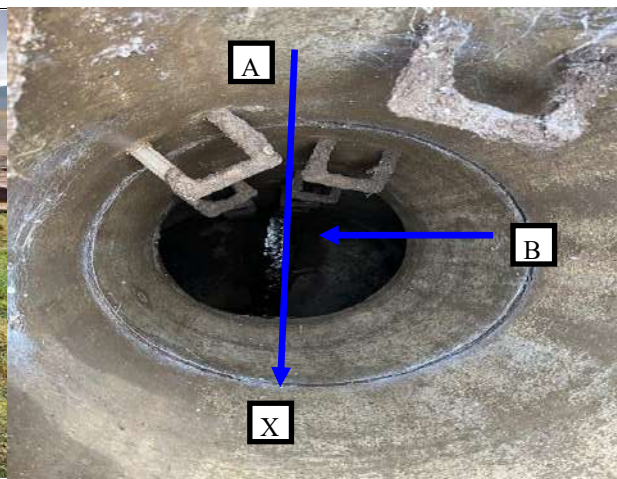
Grid Ref: Node Number: MH62 Cover Level: 7.65

Remarks: UTS - CONFINED SPACE ENTRY REQUIRED. Manhole on steep banking.

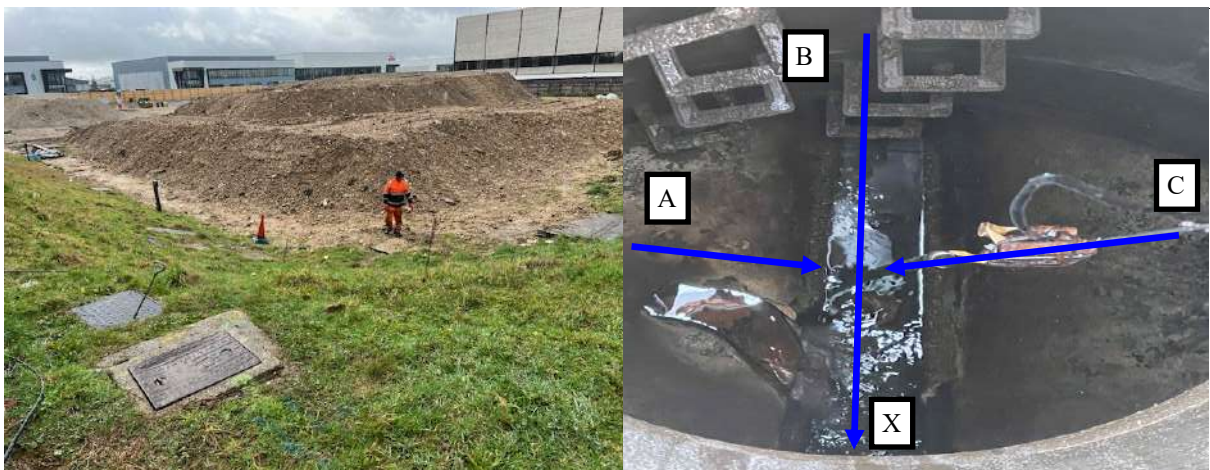
| Grid Ref: | Node Number: MH65 | Cover Level: 4.19 | |

Remarks: UNABLE TO CCTV SURVEY DUE TO LOCATION IN FAR CORNER OF SITE. NEED TO MANUALLY TRANSPORT EQUIPMENT TO MANHOLE. FLOODED AND BOGGY LAND.

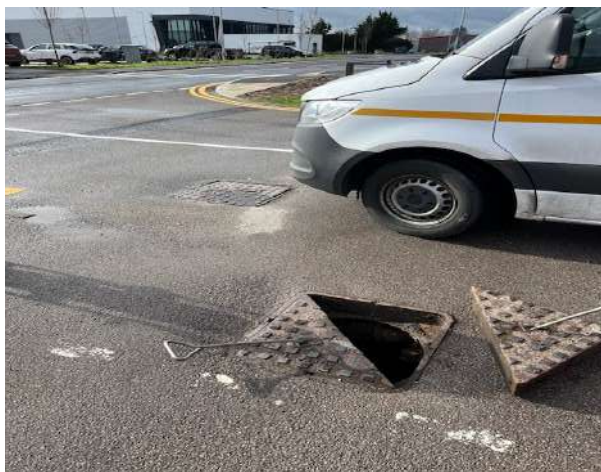
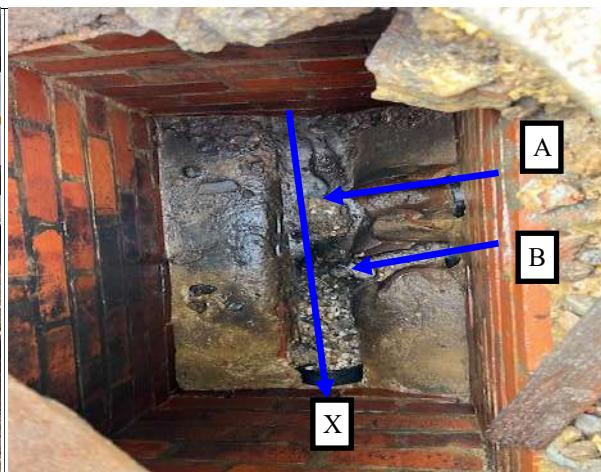
Remarks: HEAVILY SILTED/STONES IN CHAMBER, UTS OUTLET PIPE
