**Project Name:** 25 Albretia Avenue

**Project Date:** 19/06/2026

**Inspection Standard:** MSCC5 Domestic GB (DRB Scoring)

## Section Inspection - 19/06/2026 - Mh1 X

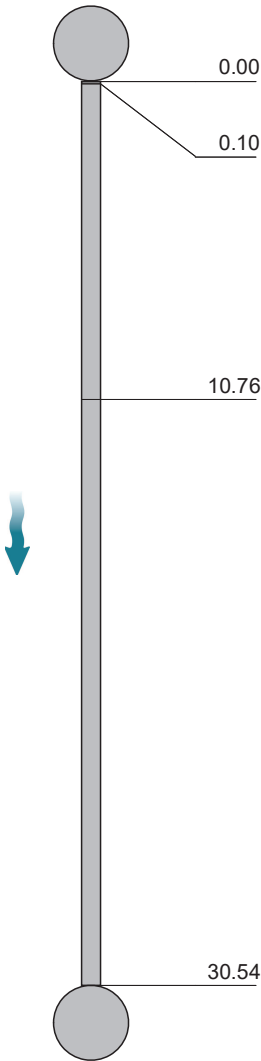
| <b>Comments:</b> Roots in line also a broken section of pipe. |

| Scale: 1:255 | Position [m] | Code | Observation | MPEG | Photo | Grade |
|---|---|---|---|---|---|---|
| | 0.10 | R | Roots: Roots in the line | 00:00:21 | 2 | B |
| | 10.76 | CC | Circumferential crack from 9 o'clock to 3 o'clock: Cracked pipe. | 00:01:22 | 3 | A |

| <b>Recommendations:</b> Repair needed on broken pipe. roots will need jetting out. |
