# Arboricultural Consultancy for Esure

| Insured | | Address | 1 Hartwood Gardens, Waterloooville, PO8 8RA | | |
| Client | Subsidence Management Services | Contact | | Claim No. | IFS-ESU-SUB-25-0122071 |

## 5. Technical Synopsis

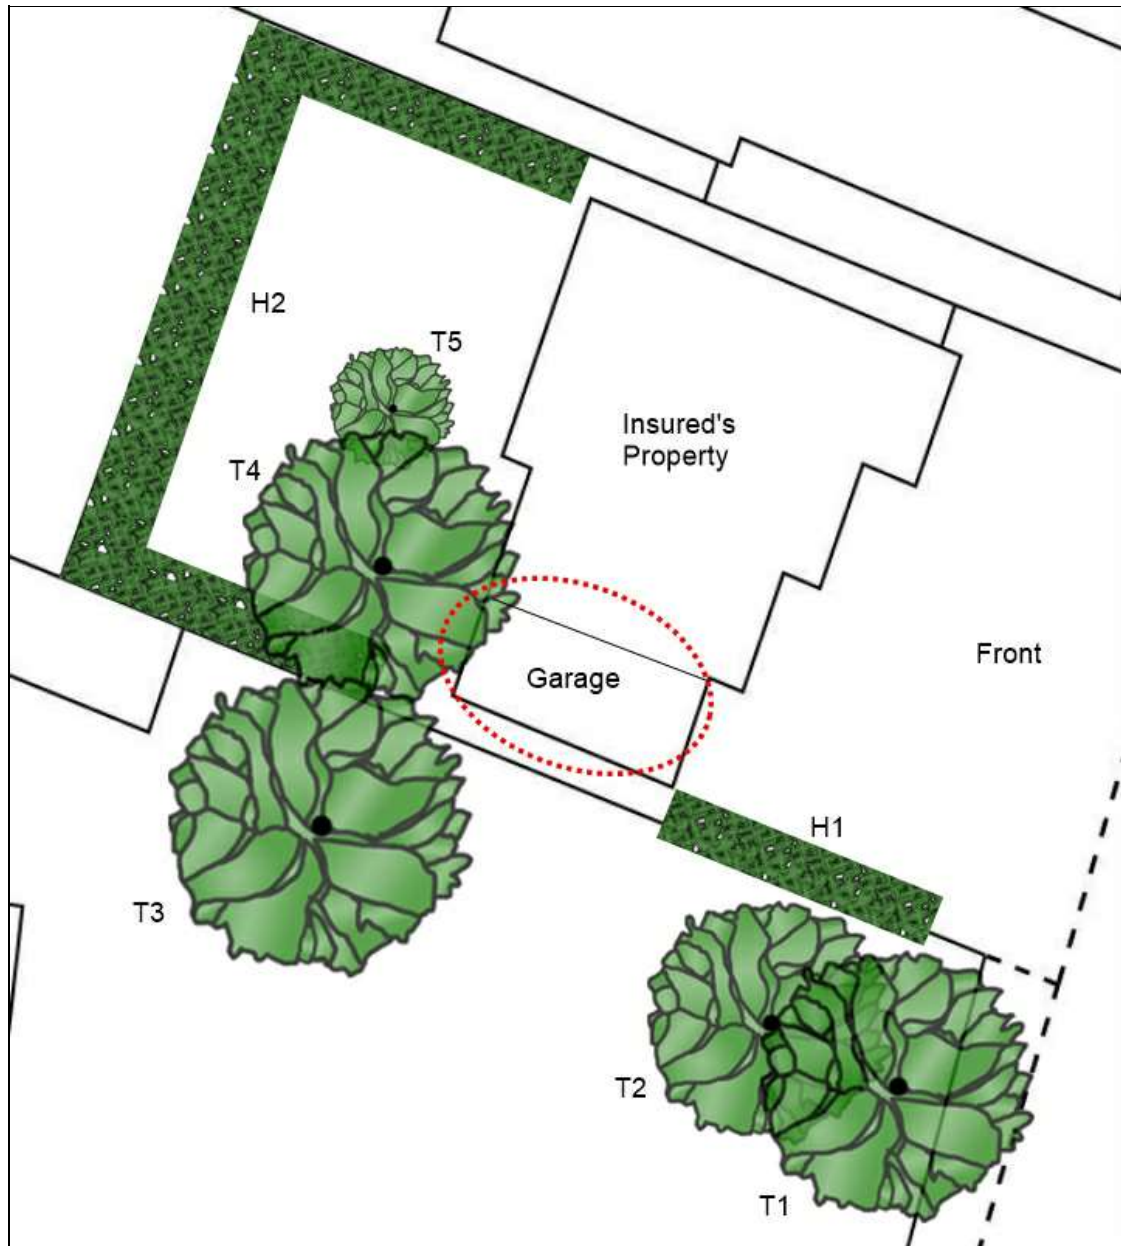
7. Site Plan

We understand that the current damage relates to the single attached garage located to the left-flank of the property, where cracking indicates downwards movement.

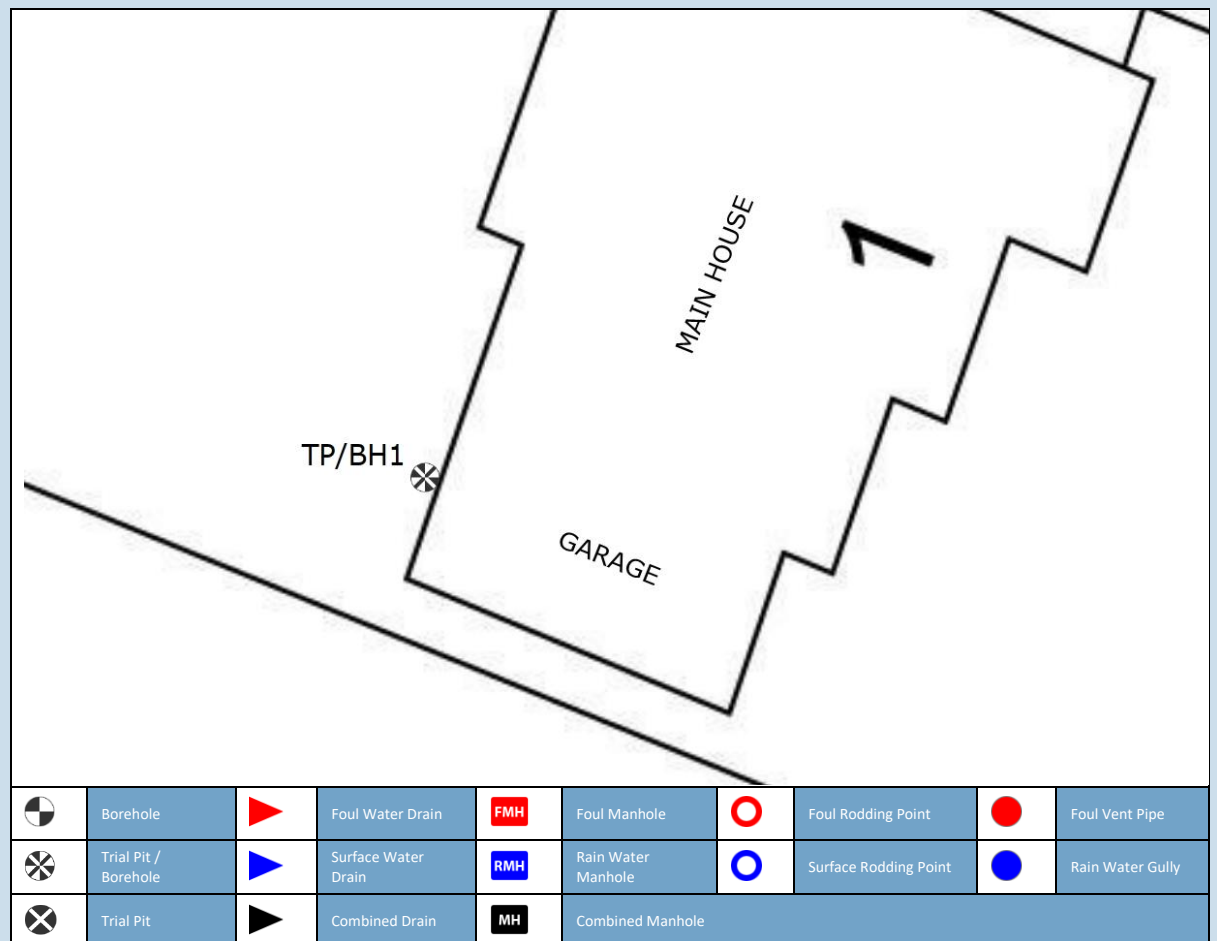
### Site Plan

Garage foundation was exposed and the underside of foundation (USF) recorded to be 0.7m bgl (TP/BH 1).

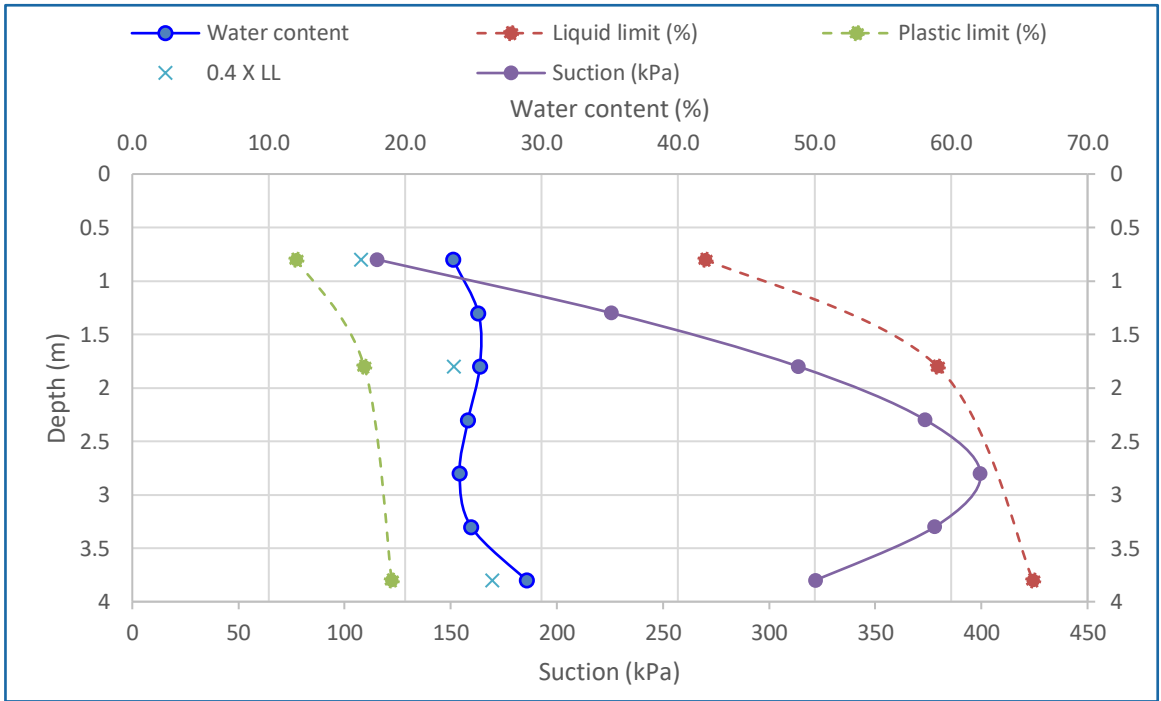
Plasticity Chart for Casagrande Classification

| Lab Ref | Depth (m) | WC (%) | LL (%) | PL (%) | PI (%) | .425 mm(%) | mod. PI (%) | Av. Suc. (kPa) | Description |
|---|---|---|---|---|---|---|---|---|---|
| 7 | 3.8 | 28.9 | 66 | 19 | 47 | 99 | 47 | 322 | Firm greyish orange slightly gravelly, silty CLAY with rare sand |
