# Site Investigation Report

168490.1.BSI

## Job Summary

Auger were commissioned by HGE Surveying Services Ltd to undertake a site investigation and CCTV inspection of the underground drainage within the area of concern (AOC) at the property.

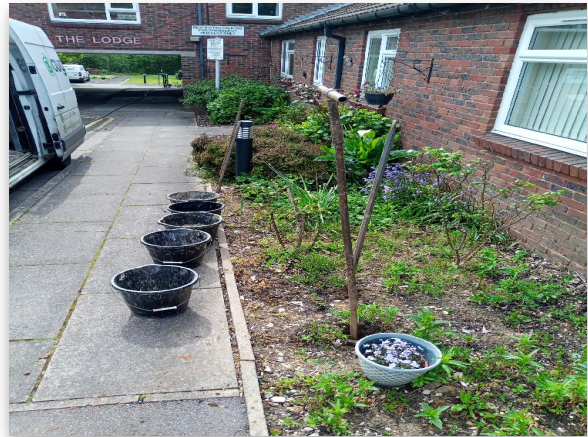
Fig 4.2: Trial Hole 4 Footing

Trial hole 4 was completed as a remote borehole to the front of the property and a depth of 3m was reached.

Soil samples were taken at 1.2m, 1.7m, 2.2m and 2.7m. No roots were found to be present.

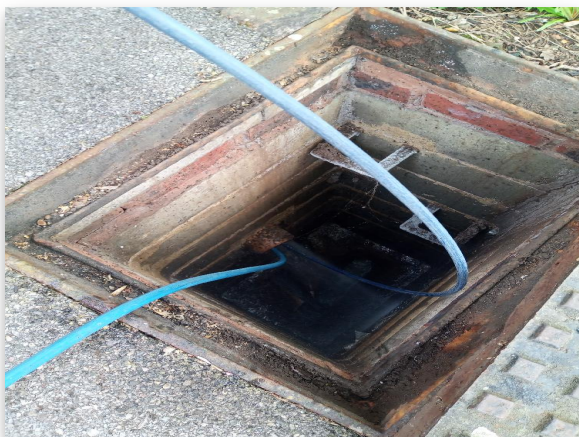
Fig 6.1: MH1

Our survey of line 1 revealed cracking.

| Refer Back to Client | <p>It is recommended that the following repairs are carried out to prevent an escape of water from the system:</p> <p><b>Line 1</b></p> <p>Install a 100mm patch liner approximately 1.8m upstream of MH1. Deep manhole entry will be required to install the liner.</p> <p>Install a 100mm patch liner approximately 2.5m downstream of MH1. Deep manhole entry will be required to install the liner.</p> <p><b>Line 3</b></p> <p>We need to perform root cutting of the drains for approximately 2 hours prior to lining.</p> <p>Install 6m of 100mm liner directly upstream of MH2.</p> <p><b>Line 5</b></p> <p>We need to perform root cutting of the drains for approximately 1 hours prior to lining.</p> <p>Install a 150mm patch liner approximately 0.7m downstream of MH2.</p> <p>Install a 150mm patch liner approximately 1.6m downstream of MH2.</p> <p>We will now refer the claim back to the client in order to progress the claim.</p> |

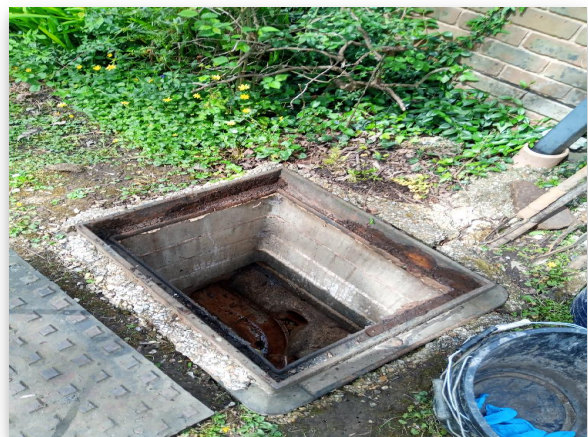
Fig 6.2: MH2

Our survey of line 3 revealed root ingress and cracking.

Our survey of line 5 revealed root ingress and cracking.

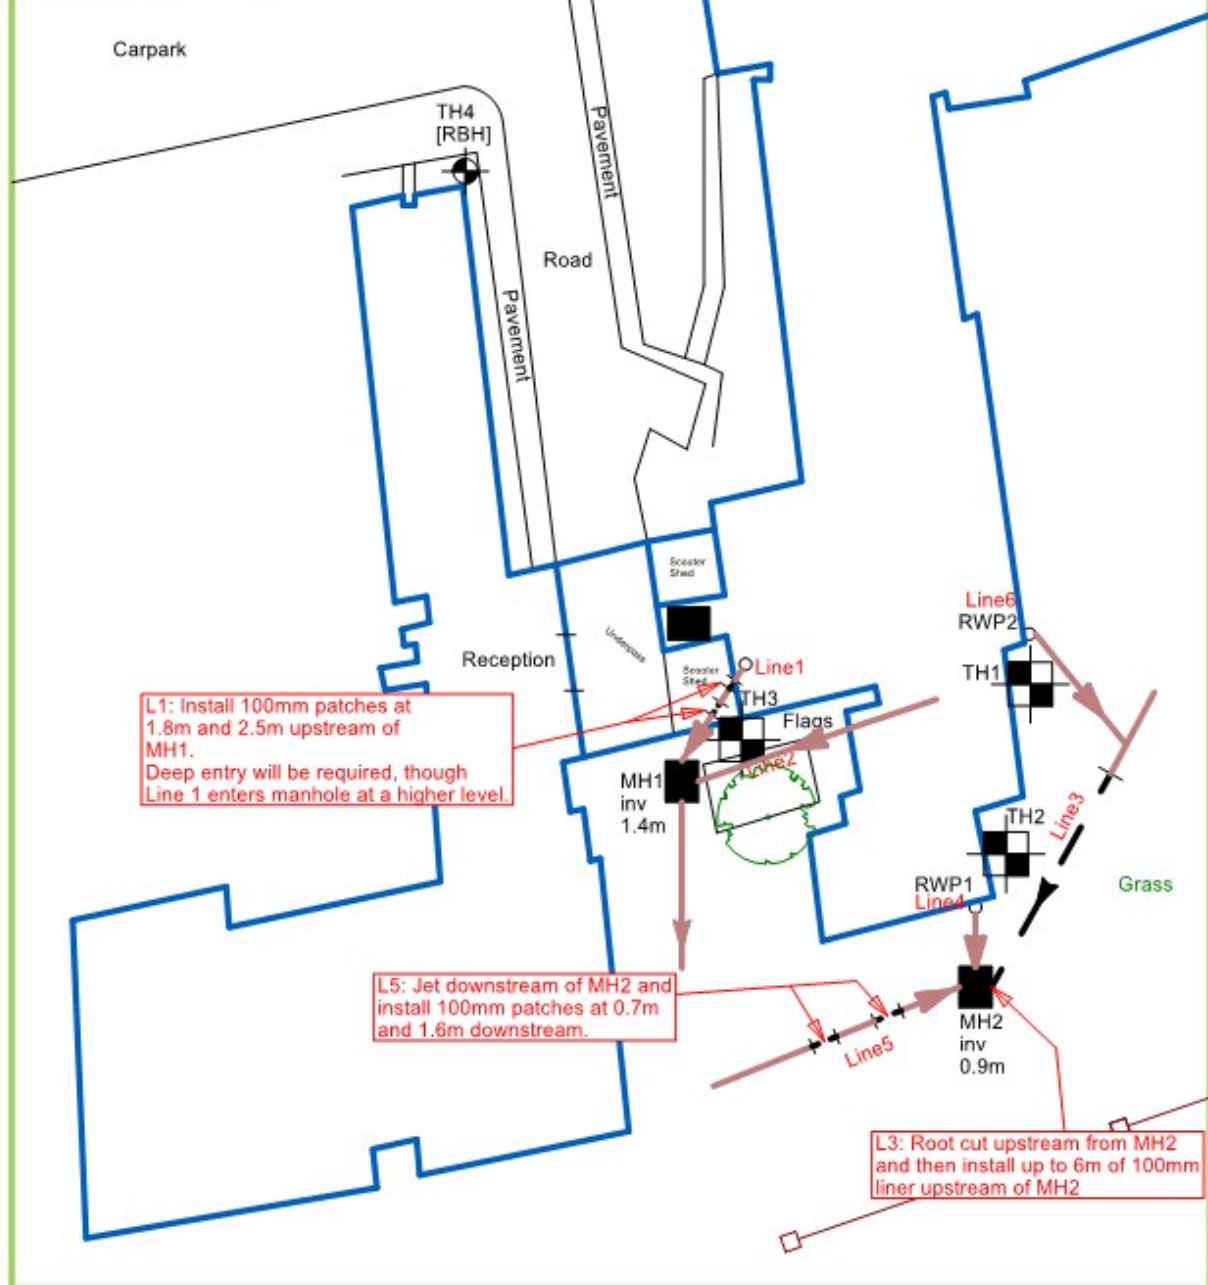
Confined space/deep entry  
Jetting & Root cutting  
4 100mm patches  
6m 100mm liner
