Our ref: GE20814/WP01/220429

**RE: Manor Farm, Bedhampton Phase 2 deep Borehole – Preliminary Information**

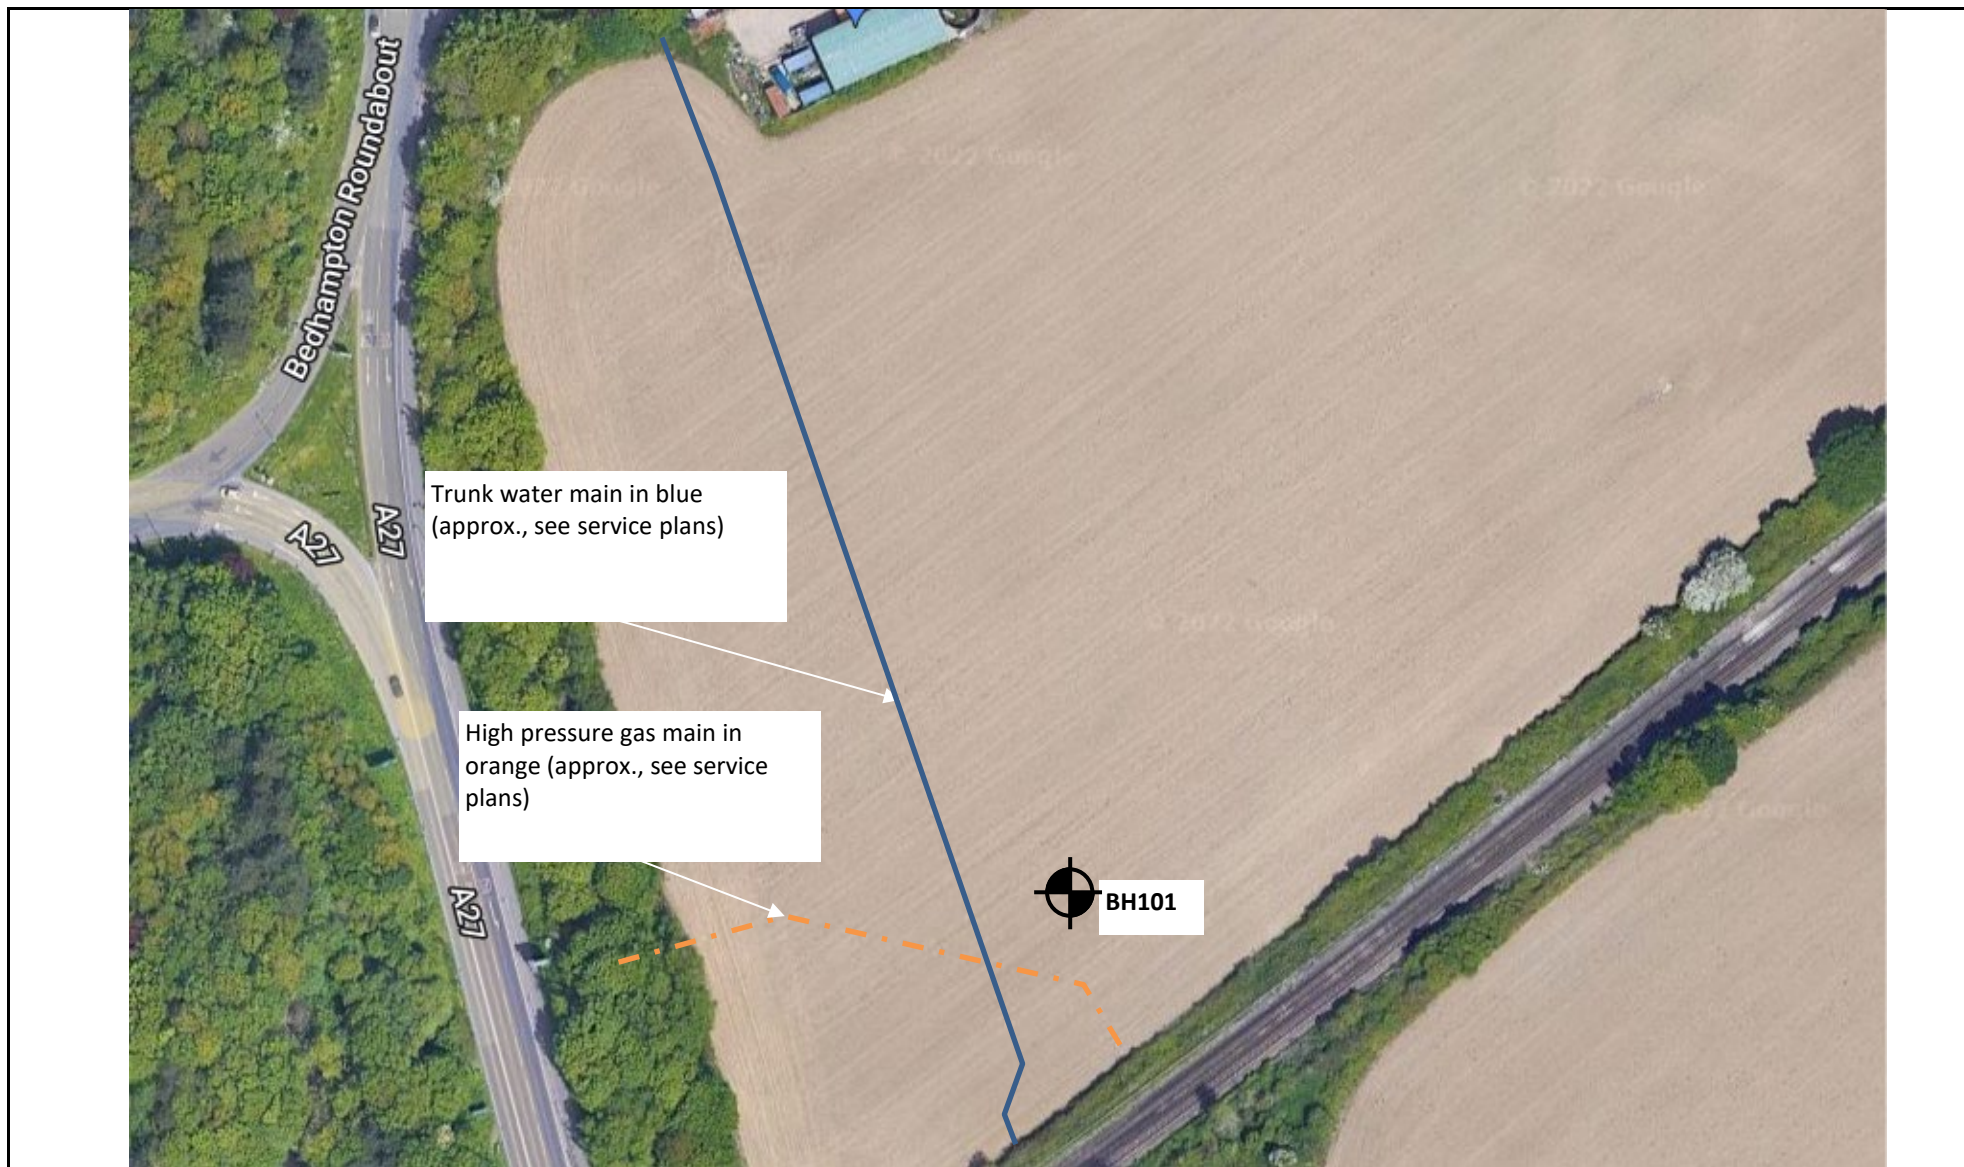
| <b>Project:</b> | Manor Farm, Bedhampton Ph2 deep BH | | | <b>Title</b> | Exploratory Hole Location Plan (Aerial) | |

Whilst a summary of the ground conditions encountered is presented in Table 1, reference should also be made to the individual exploratory hole logs for further information which are presented within Appendix A. The exploratory hole locations are shown on Figure 2.

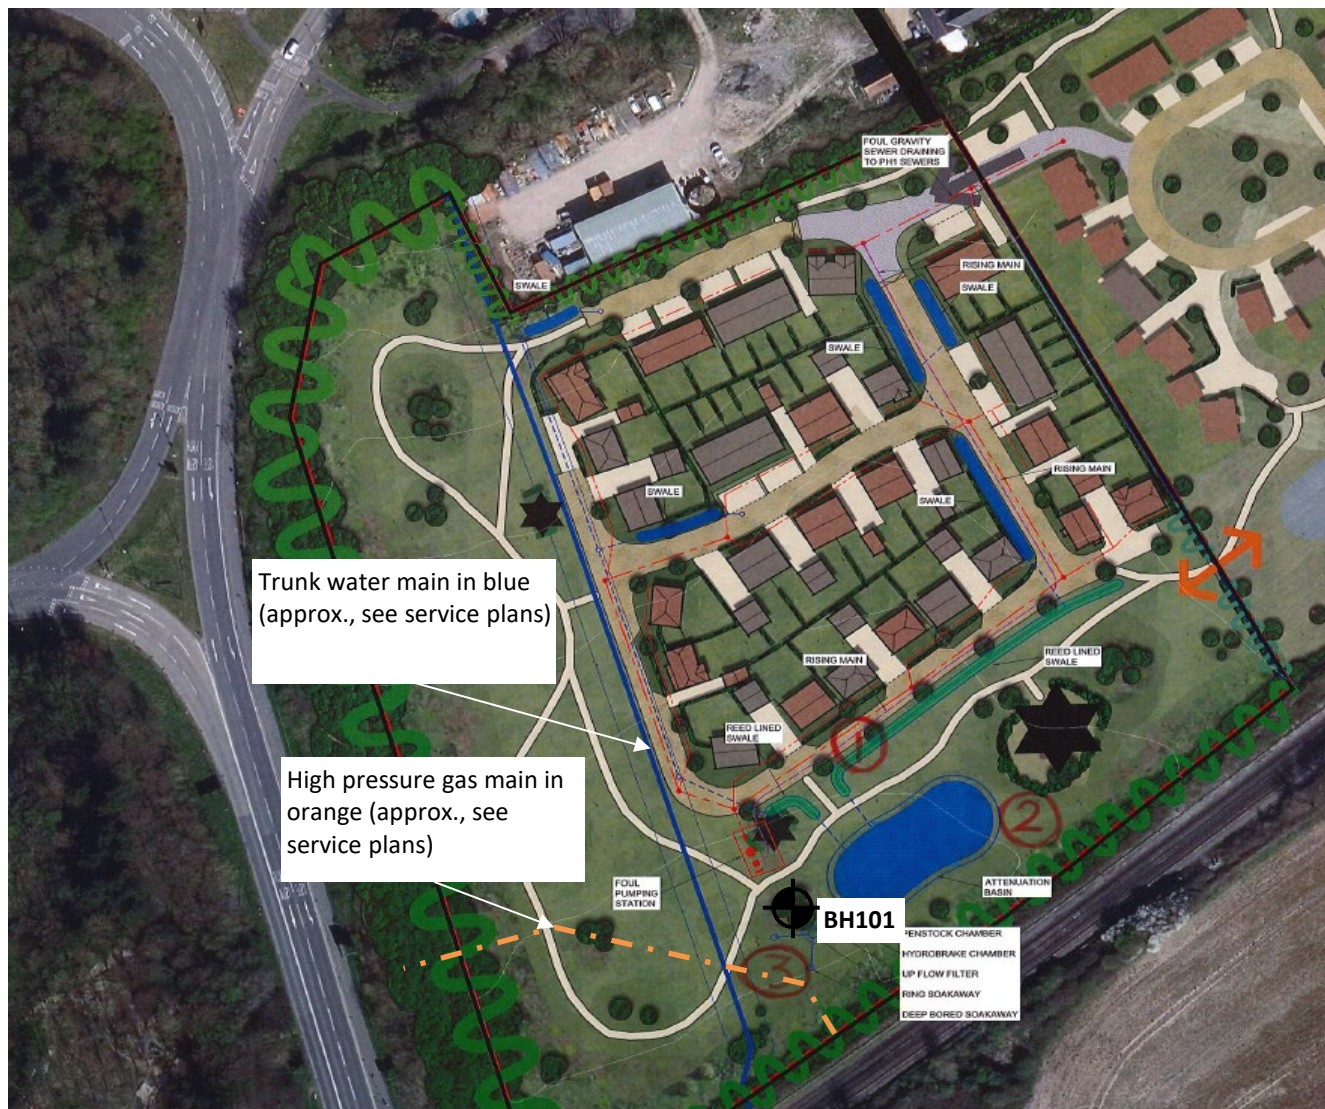
| <b>Project:</b> | Manor Farm, Bedhampton Ph2 deep BH | | | <b>Title</b> | Exploratory Hole Location Plan (Proposed development) | |
