# Design and Access Statement: Braxell Lawn

1 - 6 Braxell Lawn  
Warnford Crescent  
Leigh Park  
Havant  
PO9 4QA

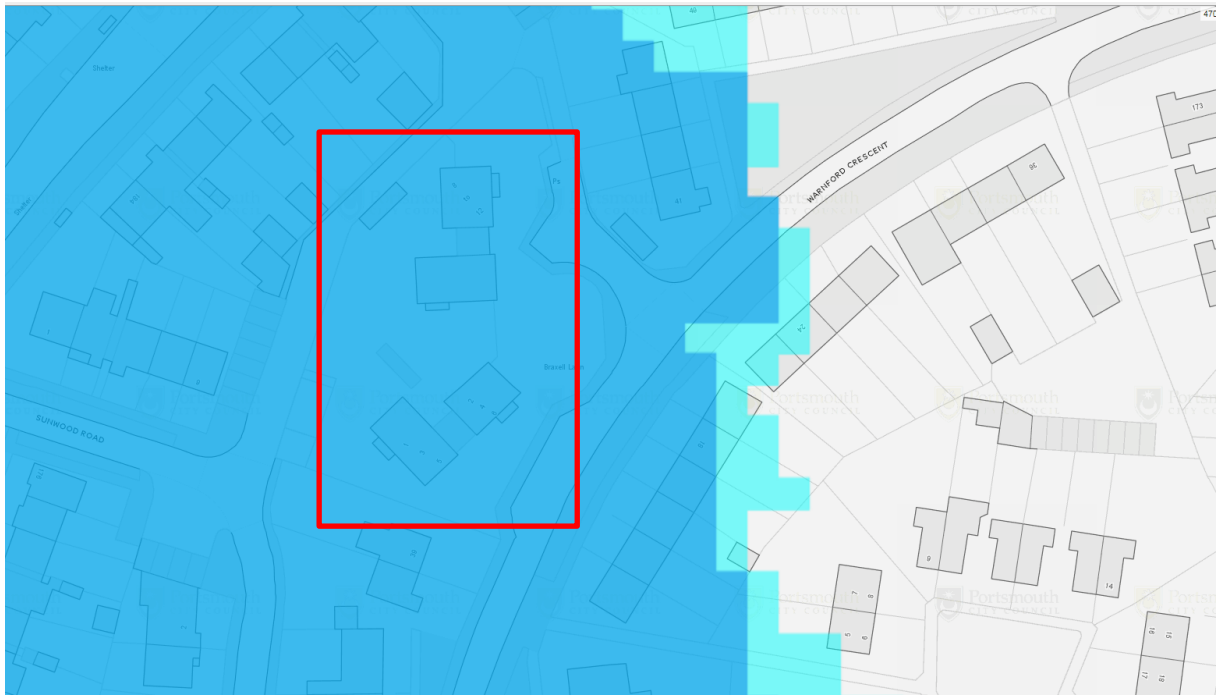
Figure 2: Flood risk map

The Environment Agency flood map, shown in Figure, indicates that the site is inside the area of flood risk zone 3; the site is shown highlighted in the red box.

The works will not alter the volume of surface drainage run off as there is no proposed increase to the footprint of the building. Therefore, the overall works will not increase flood risk in the area.
