| SURVEY OF TREES AT HAYLING BILLY PUB, 117 ELM GROVE, HAYLING ISLAND | | | | | | | | | | | | | | | | | | | | | |

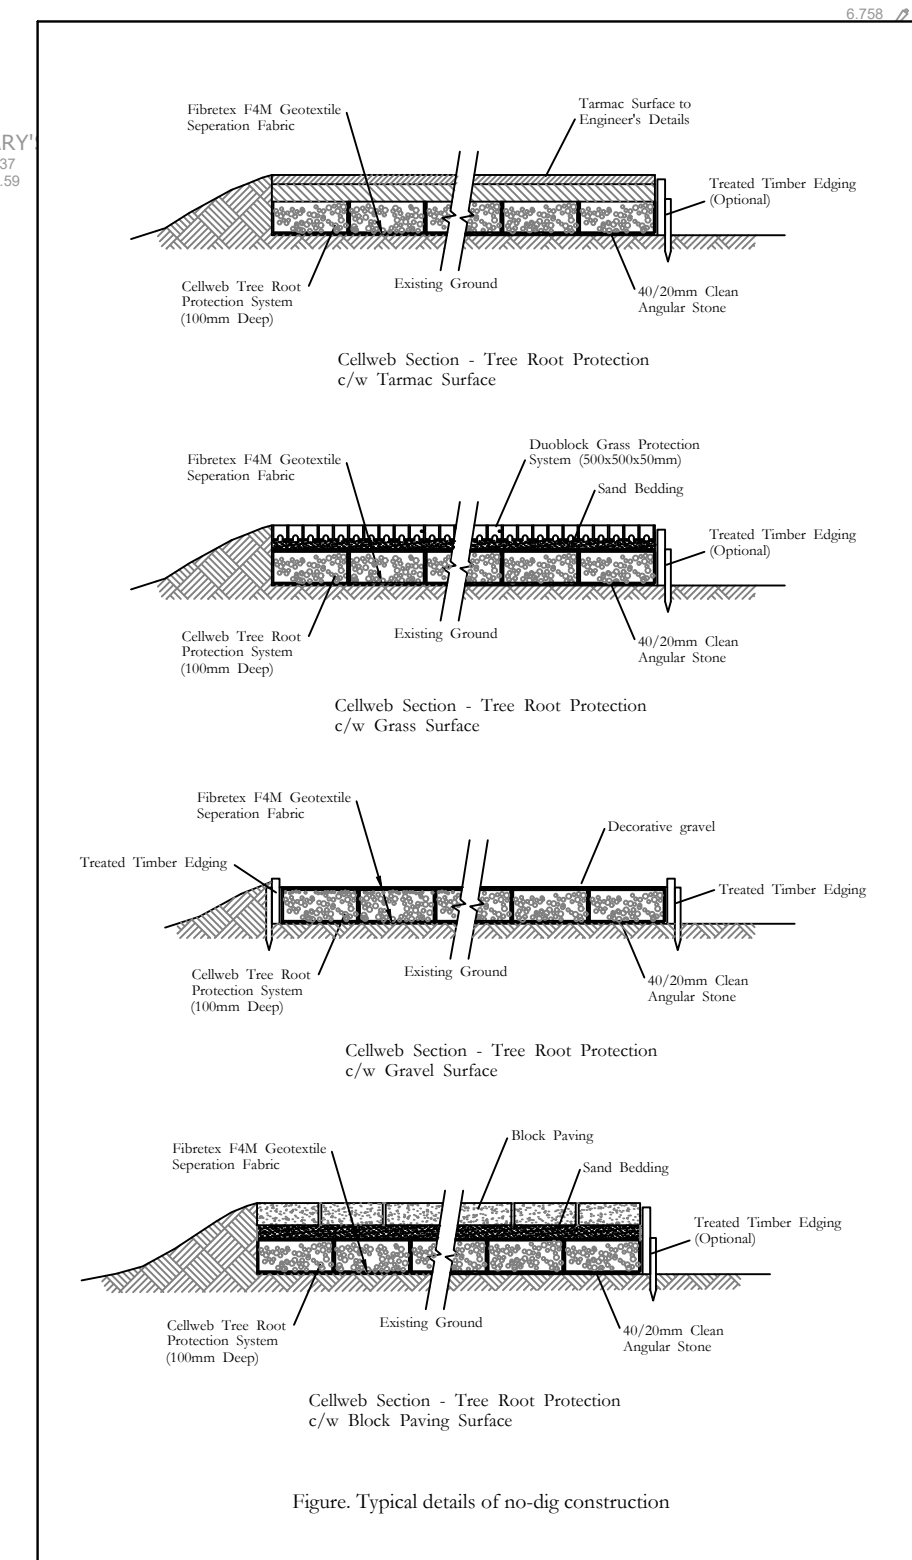
Note:  
The original of this drawing was produced in colour - a monochrome copy should not be relied upon.

Topographical Survey based on The Meon Survey Partnership LTD drawing number M1565.

Proposed layout based on New Leaf Studio drawing number SO-2267-05-LA-MCS551/Dr03 Rev E.

Refer to New Leaf drawing Cross sections through proposed surfaces beneath trees and within root protection areas drawing number SO-2267-05-LA-MCS551/Dr02 Rev C

Piling for foundation to be supervised by arboriculturist

Hand excavation for new foundation where within root protection area

- Existing site features
- Proposed structures
- Trees retained
- Root Protection Area (RPA)
- 2.0m high barrier as detail in Fig 3
- Minimum extent of no-dig construction. Actual deployment may be greater.
- New service corridor remote from root protection area

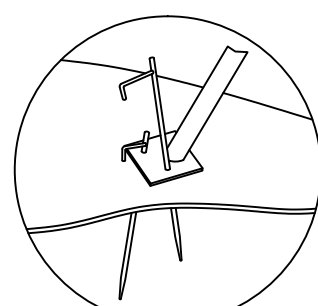
Figure 3 Example of a protective barrier including above-ground stabilizing systems

a) Stabilizer strut with base plate secured with ground pins

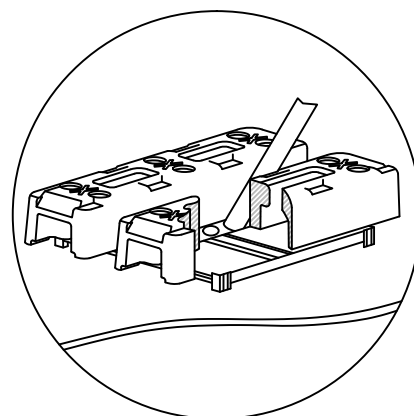
b) Stabilizer strut mounted on block tray
