## **ARBORICULTURAL** **METHOD STATEMENT**

**Southleigh Park House, East Leigh Road, Havant**

*-prepared on behalf of **Snell & Wilcox Pension Fund** –*

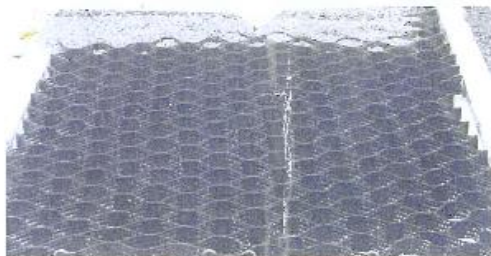
Ambleside Cellweb TRP area prior to installation.

Cellweb TRP across road during filling with green stone.

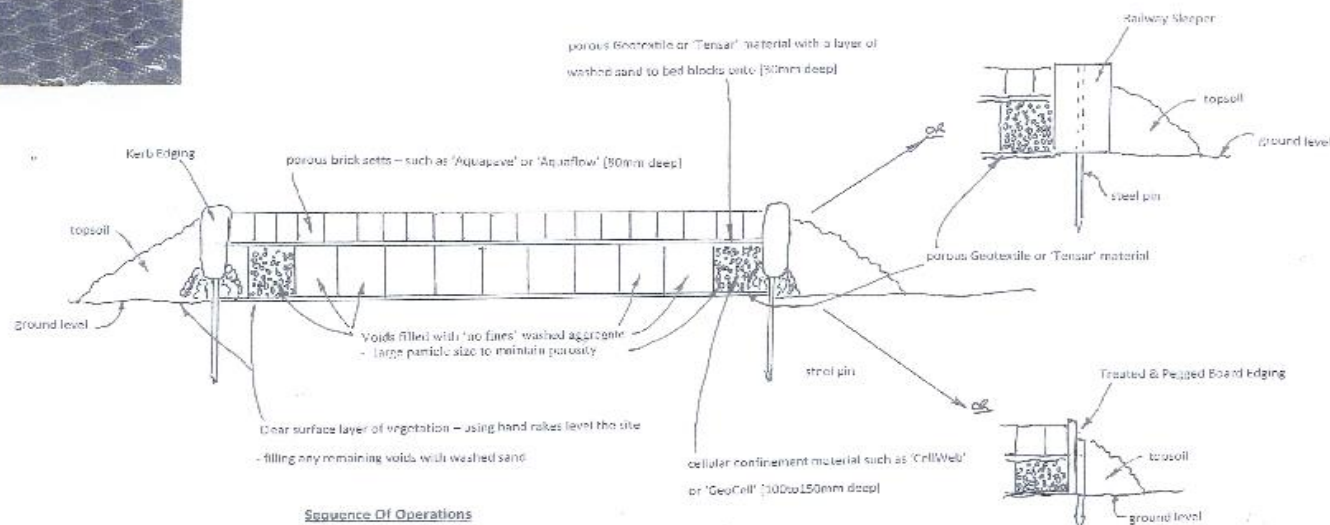
#### Sequence Of Operations

1. Spray the surface vegetation layer with an approved selective weed killer containing Glyphosate - allow the necessary period for this to be absorbed by the root system

6. Cover this surface with a geotextile membrane and over this apply a 30mm layer of washed sand
7. Over this lay a course of porous brick setts and bed them down level onto the sand - using a hand operated vibrating tamper lightly bed the materials down

8. Apply topsoil up to the top of the raised edging materials on each side to ramp down to ground levels and leave the site safe with no 'trips'
