April 2017  
CBA10552 v1E

PMC Construction &  
Development Services Ltd

# ARBORICULTURAL DEVELOPMENT STATEMENT

Site:  
Land adjacent Blendworth Crescent,  
Havant,  
PO9 2BA

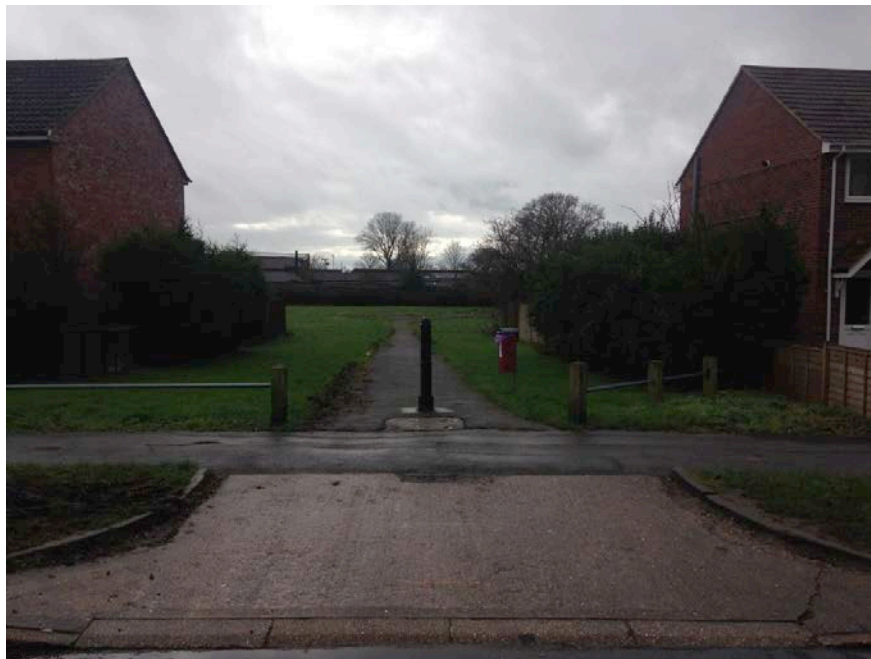
3.2 **Photograph 1:** A view of the existing site access from Blendworth Crescent

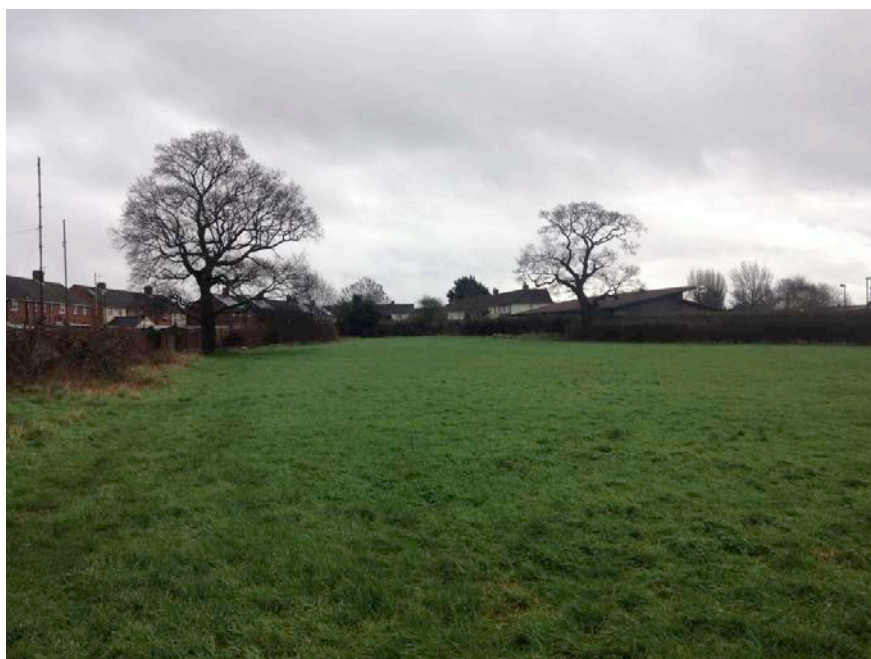
3.3 **Photograph 2:** A view of the eastern side of the site

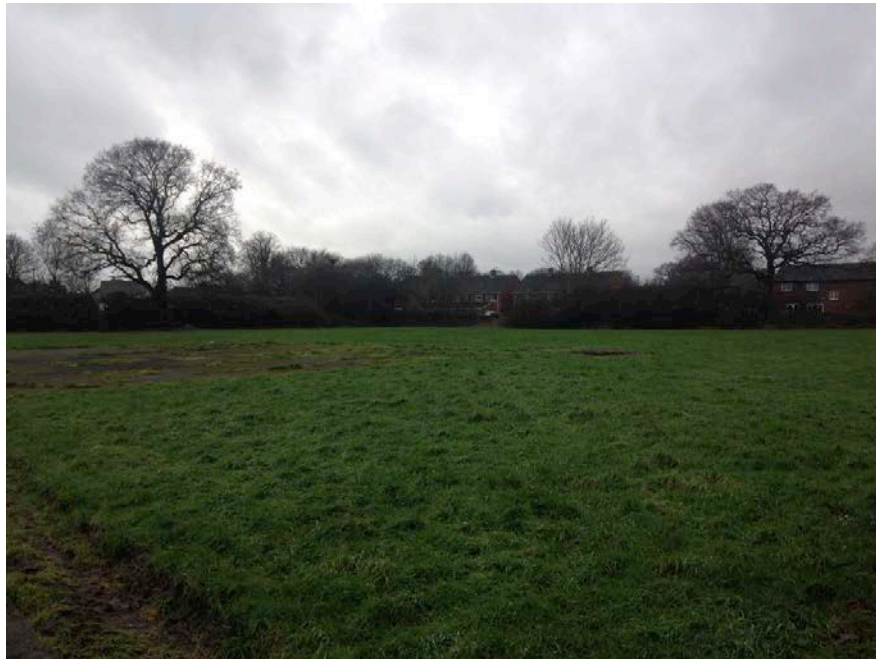
**3.4 Photograph 3:** A view of the western side of the site
