**A DESIGN & ACCESS &  
HERITAGE STATEMENT****Rev 'A'****for****Replacement Fenestration and Render to Elevations****to****5b King Street, Emsworth. PO10 7AX****1 ASSESSMENT OF PHYSICAL CONTEXT**

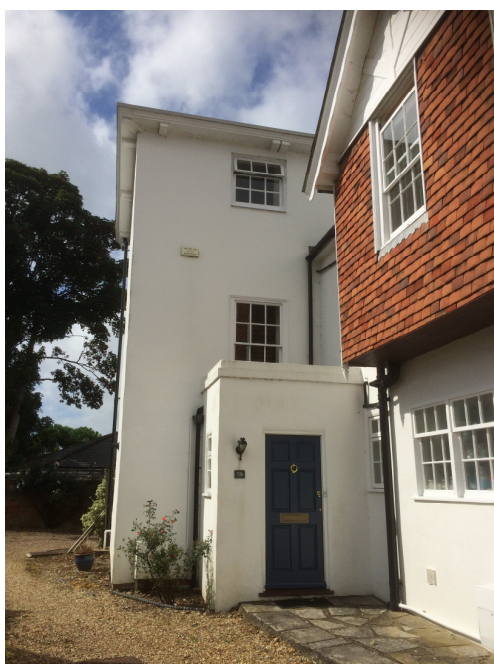
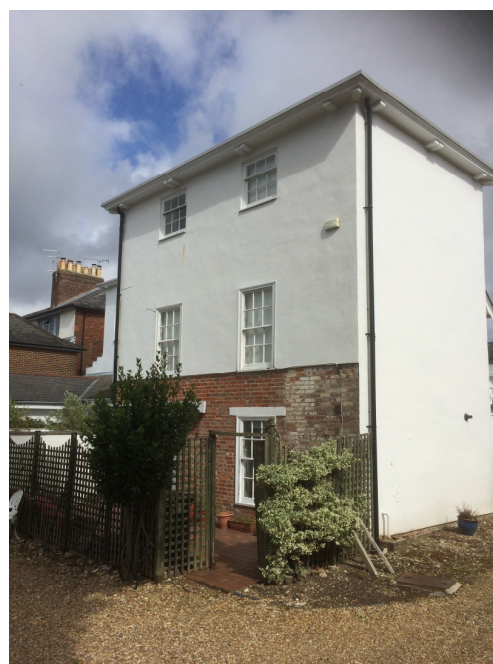
Fig 1 – Northeast elevation, viewed from King Street    Fig 2 - Southern elevations as viewed from rear

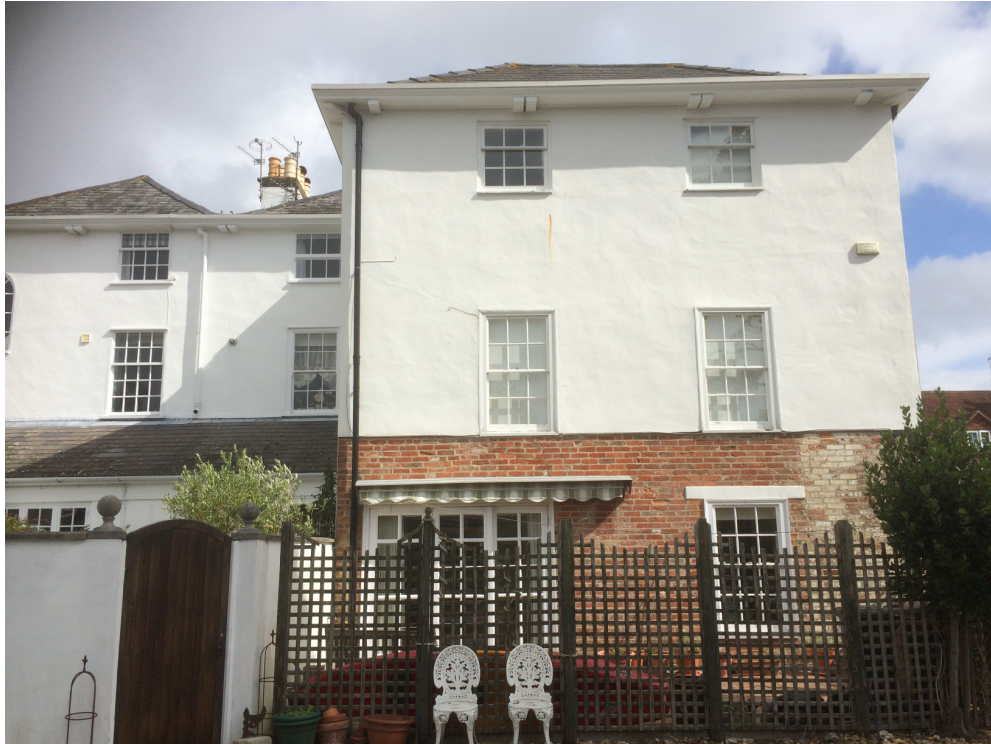
Fig 3 – Photo of the rear of the property also showing the rear view of 5 Kings Street (behind to the left), with original sash windows with horns and no external architrave around the frame.

The top sashes are to include horns and the external architrave is to be removed. It is proposed to move the frames back approx. 25mm to provide a slight reveal between the masonry face and frame to assist in throwing water away from the base of the sash. The detail between the masonry and the frame will be sealed and the render replaced with returned render beads to match the original and existing detailing as seen on 5 King Street.

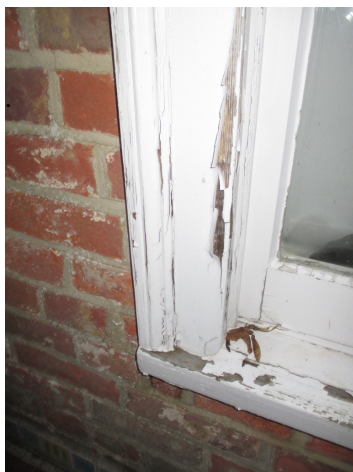
Fig 4 – Photo of typical timber window condition

The existing softwood timber sash windows along the southwestern façade are not in good condition and showing signs of decay, even after only being installed approx. 10 years ago. It is considered the quality of the softwood windows are poor and that any remedial works to repair them will not be worthwhile and that full replacement will provide the most sensible solution to ensuring the longevity of the property. The existing windows also do not fully match the profiles and detailing of what appear to be the original windows of the main listed building of 5 and 5a King Street, which include horns and also do not have the external architrave moulding detailing around the junction with the masonry. This existing architrave detailing may also be assisting

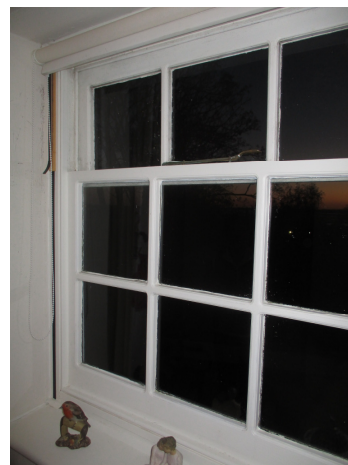
Fig 5 – Photo of existing second floor window with top sash being a top hung casement

The existing second floor windows, although appearing to be sash windows, are actually casement with the lower sash fixed and the top sash being top hinged.

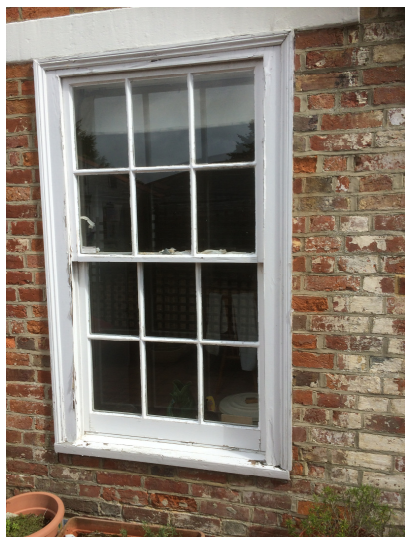
Fig 3 – Photo of typical timber sash window

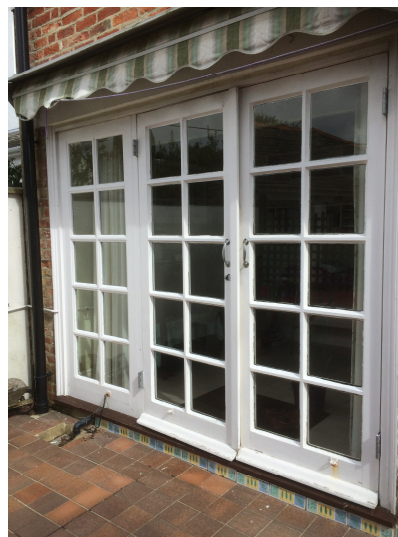
Fig 4 – Photo of existing doors/screen d.1

The French glazed timber doors and side screen, ref d.1 are also in similar poor condition, being of softwood, and also have oversized glazing bars which are disproportionate to the adjacent sash window profiling.

The French doors, d.1, are to be replaced with new profiling to include similar glazing bars reduced from 50mm wide to approx. half to 26mm width, being slightly wider to the window bars but allowing for structural integrity of the frame and doors. This will vastly improve the appearance to the fenestration being similar to the adjoining sash windows. The doors will also be glazed with Histoglass 10 double glazing units throughout, with individual panes set between bars. Both of the opening doors are to be bolted to the top and bottom of the frames with flush bolts mounted flush within each door style/rail and the a single door handle included to the main opening door to
