McCarthy & Stone

Elm Grove, Hayling Island

Proposed Drainage Plan  
Designers Risk Assessment and  
Maintenance Drawing

SO-2267-04-DE

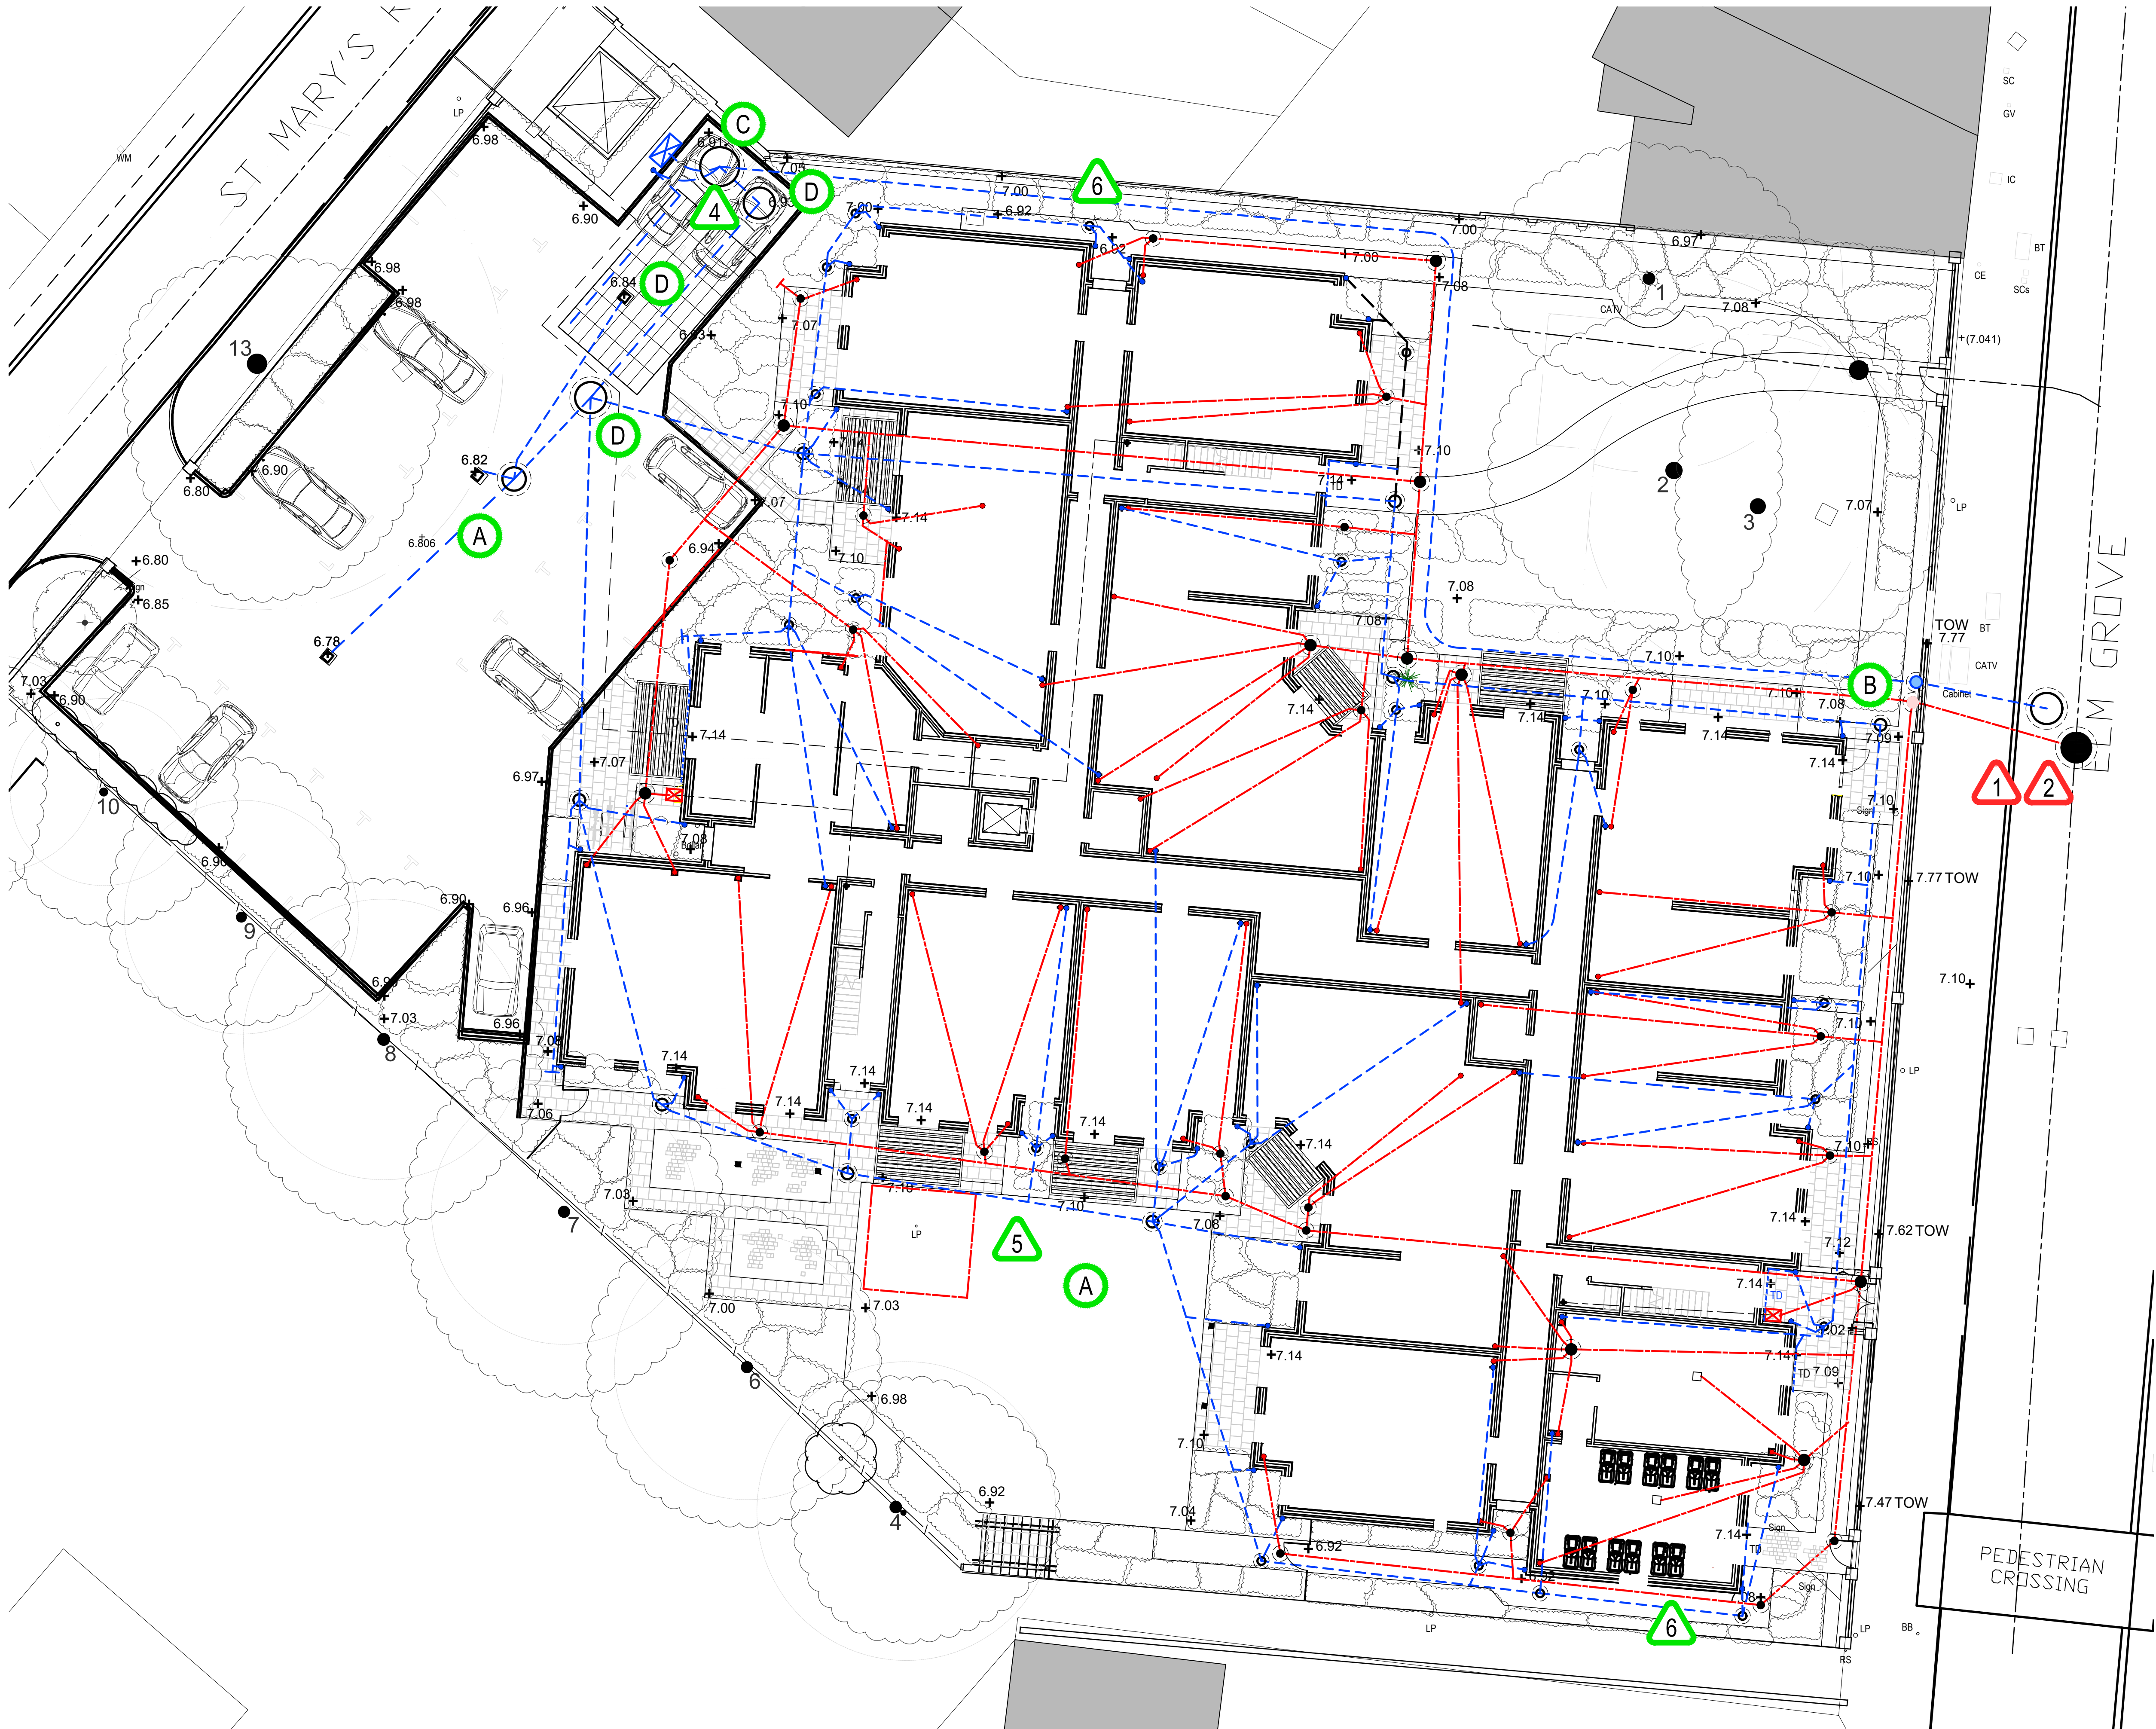
Construction of the new off-site public drainage connection will require Traffic Management and Statutory Approvals

Construction of the new off-site public drainage connection will require an excavation in excess of 2.0m in depth. The contractor must therefore make use of any necessary trench shoring measures and use all appropriate safe working practices.

Construction of the new on-site private drainage will require excavations up to 2.0m in depth. The contractor must therefore make use of any necessary trench shoring measures and use all appropriate safe working practices.

Construction works on each of the attenuation tank & pump station will require a large excavation up to an in excess of 2.0m in depth. The contractor must therefore ensure that the excavations are adequately supported and will not pose a risk to any of the adjacent works or tree protection zones. All appropriate safe working practices should be used around the excavations.
