## **Design and Access Statement**

### **Seawall upgrade works at 9 Harbourside, Langstone, Havant PO9 1TJ**

RG Carrell  
9 Harbourside  
Havant  
PO9 1TJ

October 2024

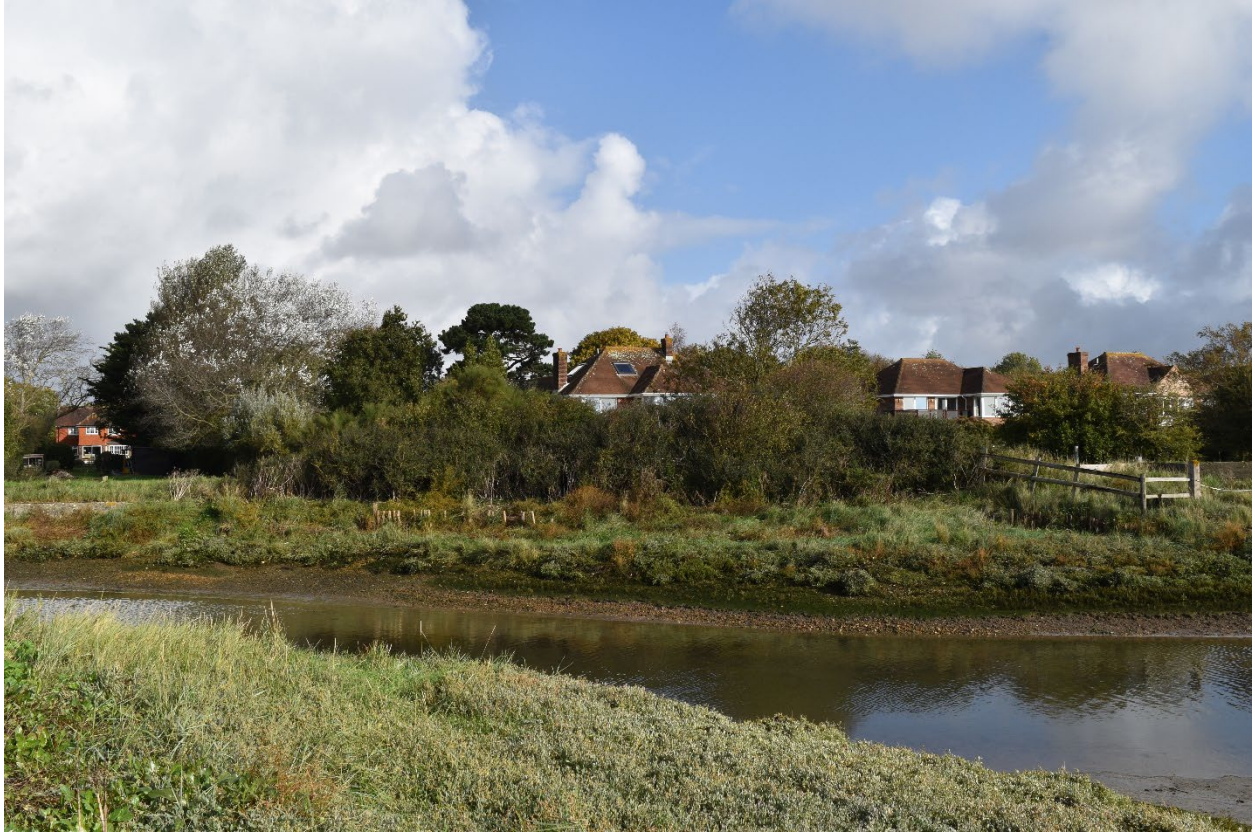
*West of frontage*

The blackthorn along the south side of the bank will remain.  
No disturbance to the vegetation south of the hedge.

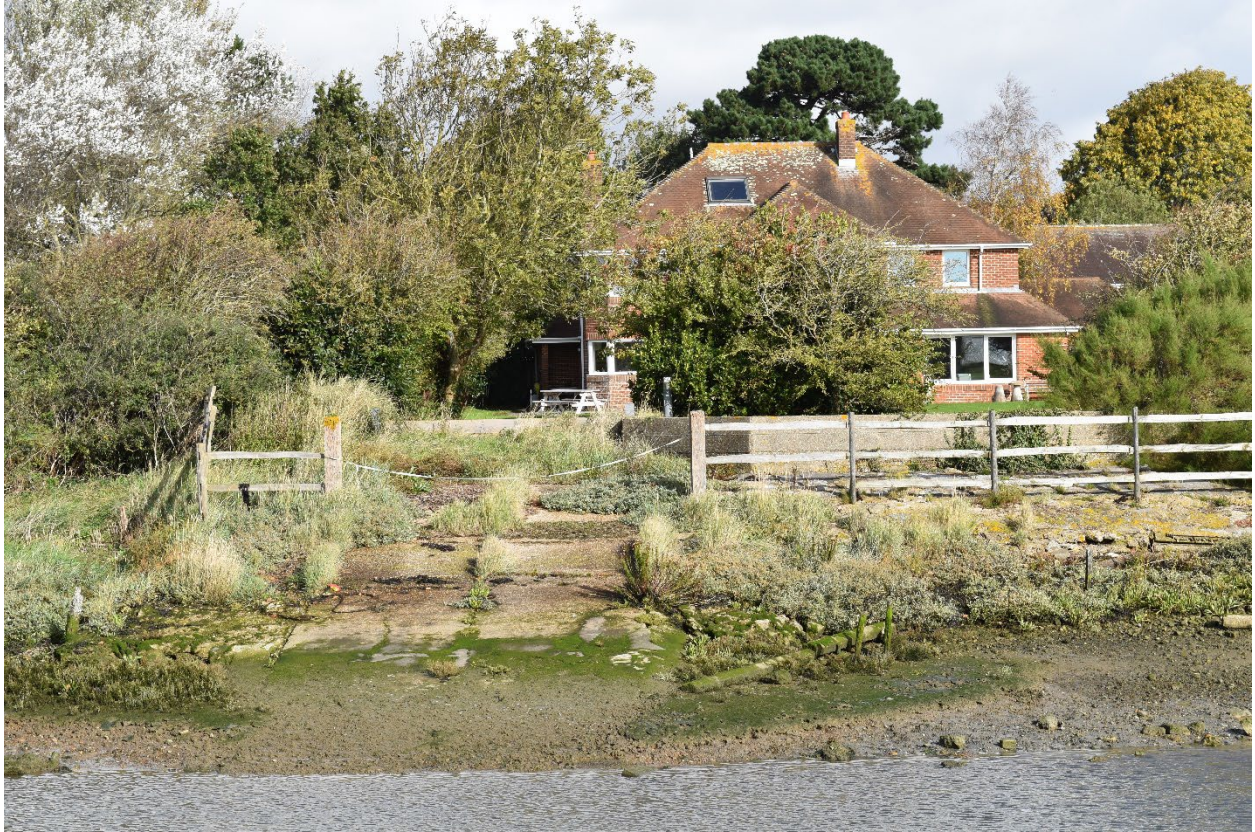
*Centre of frontage*

The rough concreted areas to the left and right of the slipway will be tidied up and the foreshore vegetation allowed to spread into the space created.

Concrete debris currently on the foreshore to be tidied up.

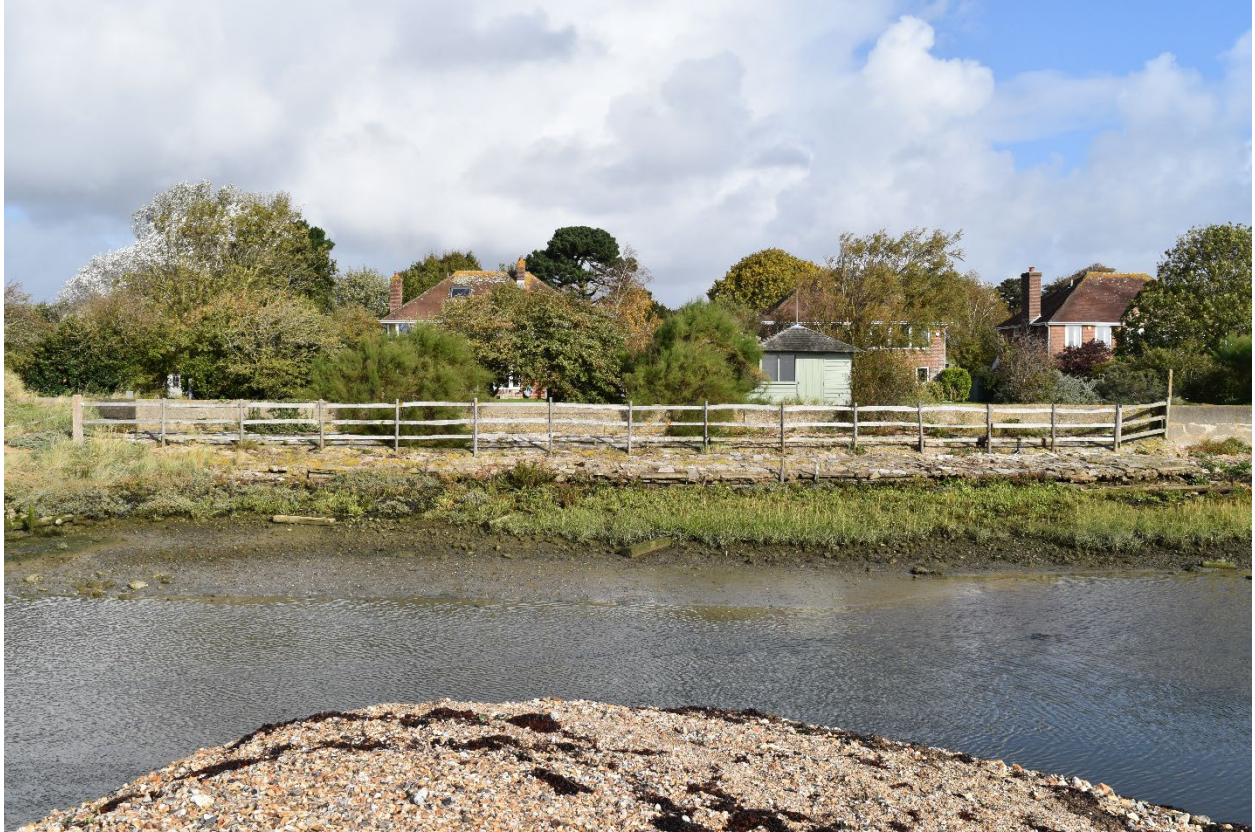
*East of frontage*

The new concrete wall will be of a similar height, approx. 10cm taller, and in the same position. The sloping apron will be taken up and replaced by a similar but shorter concrete apron, allowing the foreshore vegetation to extend.

The post and rail fence will be replaced by similar on the same alignment.
