| 1/5 | 1 East Street - Havant | |
| | Existing Window - Secondary Glazing Details | |
| PG | 23/201PM13 | HAVANT |

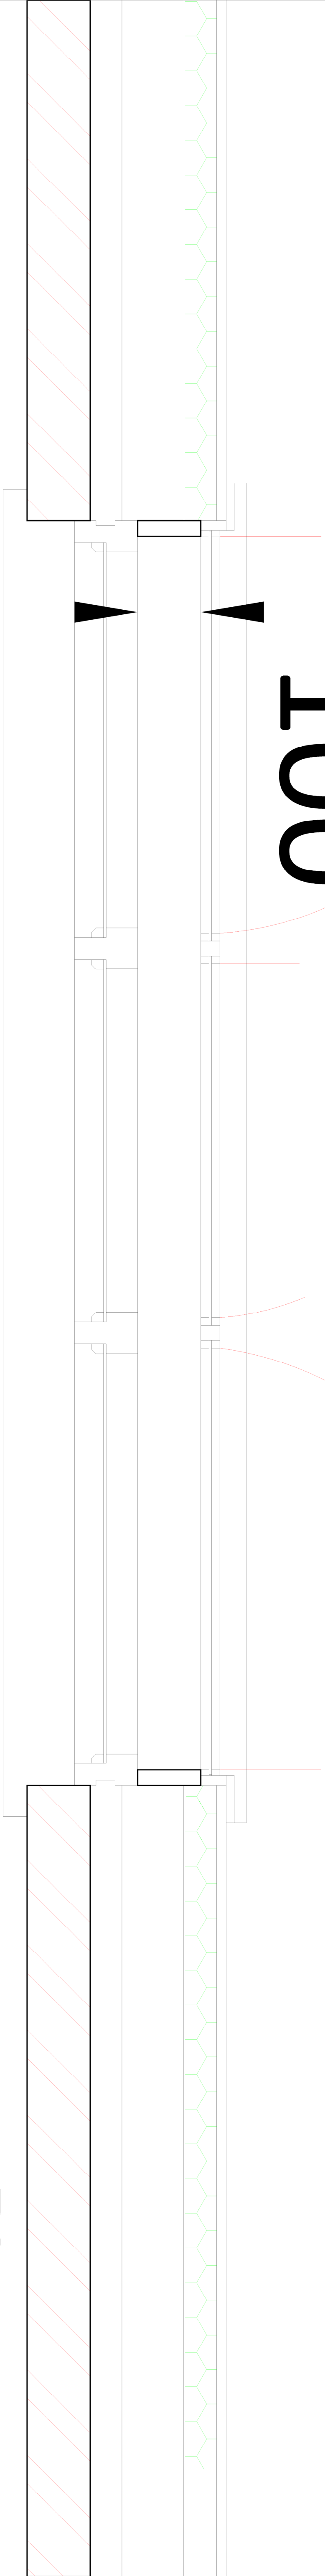
Inward opening to enable cleaning

# Plan

Existing windows refurbished

Curved beading 6mm x 15mm  
(caulked and painted)

Beading 15mm x 13mm  
painted softwood

ex. architrave  
relocated

25mm x 25mm verticals

6mm secondary glazing  
on painted timber framing  
(3 panes)

# Elevation

100mm air space lined with 25mm absorbent material
