## **ARBORICULTURAL METHOD STATEMENT** for

**15 Billett Avenue, Waterloo**

*-prepared on behalf of* **Peter Ernest Homes Ltd.** –

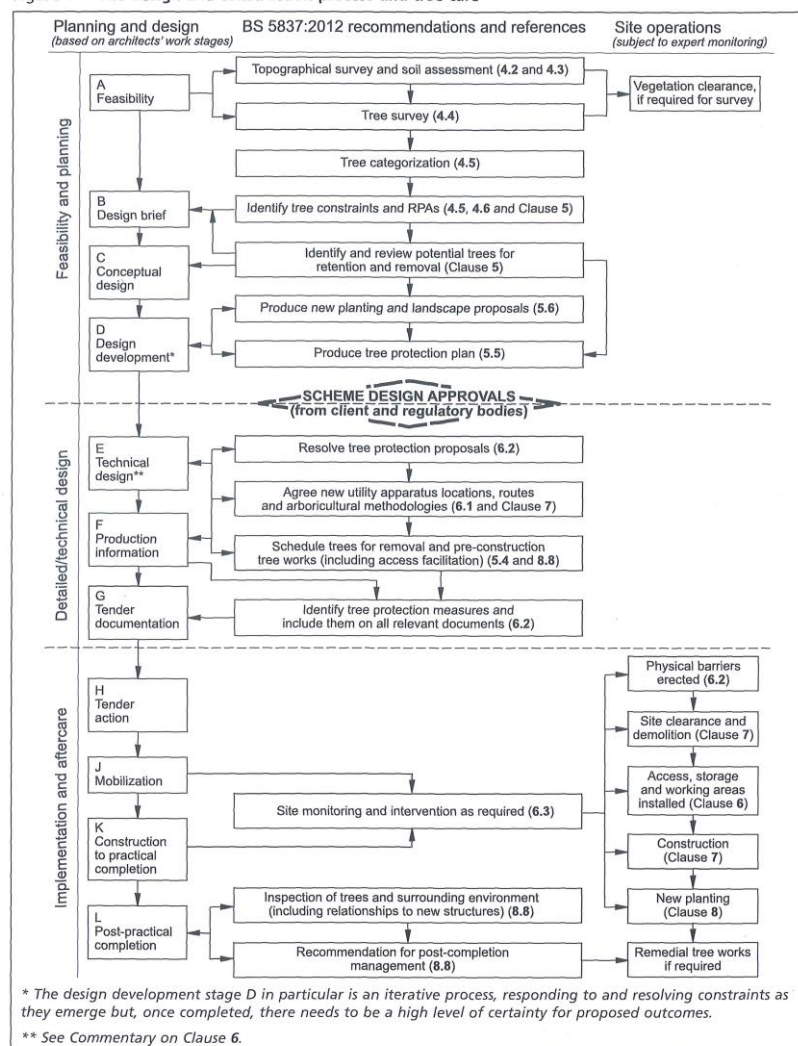
Figure 1 The design and construction process and tree care

Figure 1 - Flow Diagram  
& Tree Survey Notes

| <u>Appendices</u> | <u>Subject</u> |
|---|---|
| BH1 | Figure 1- Flow Diagram from BS5837 + Tree Survey Notes |
