## **APPENDIX G**

### **Operation and Maintenance**

# Phase I Environmental Assessment

**Langstone Technology Park, Havant, PO9 1SA**

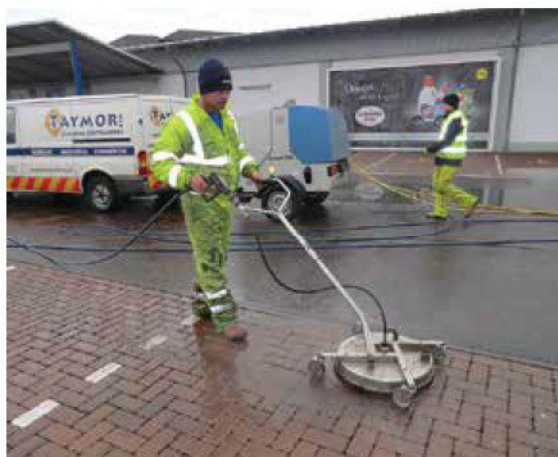
Figure 20.30 Deep cleaning a supermarket car park, Dundee (courtesy Abertay University)

A brush and suction cleaner (which can be a lorry-mounted device or a smaller precinct sweeper) should be used for regular sweeping. Care should be taken in adjusting vacuuming equipment to avoid removal of jointing material. Any lost material should be replaced. It is also possible to clean the surface using lightweight rotating brush cleaners combined with power spraying using hot water, as shown in **Figure 20.30**. This is done every two years at the site shown.
