Summary report

## Langstone Technology Park, Langstone Road, Havant PO9 1SA

## Executive summary

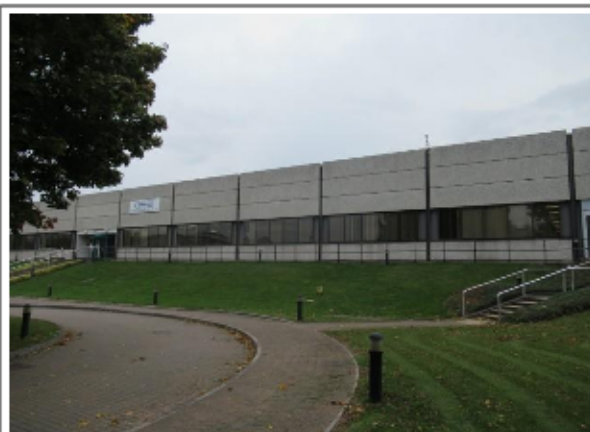
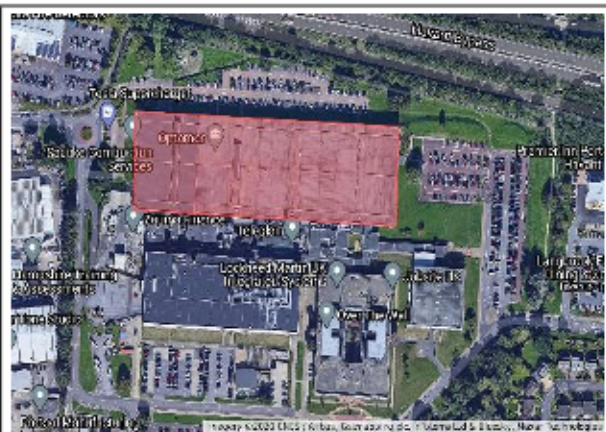
Building 1000, Langstone Technology Park, Langstone Road, Havant PO9 1SA

The building is constructed of a steel frame, assumed to be supported on concrete pad foundations and perimeter ring beams with a ground bearing concrete slab. Upper floors are constructed of a concrete waffle slab accessed via lifts and stair cores. Elevations are formed from a concrete frame and pre-cast concrete panels set with steel channels. A concrete retaining wall with a steep grass embankment is provided around the ground floor areas. Fenestration to the property includes steel framed single glazed windows, various steel framed pedestrian door sets, revolving door sets and isolated loading bays.

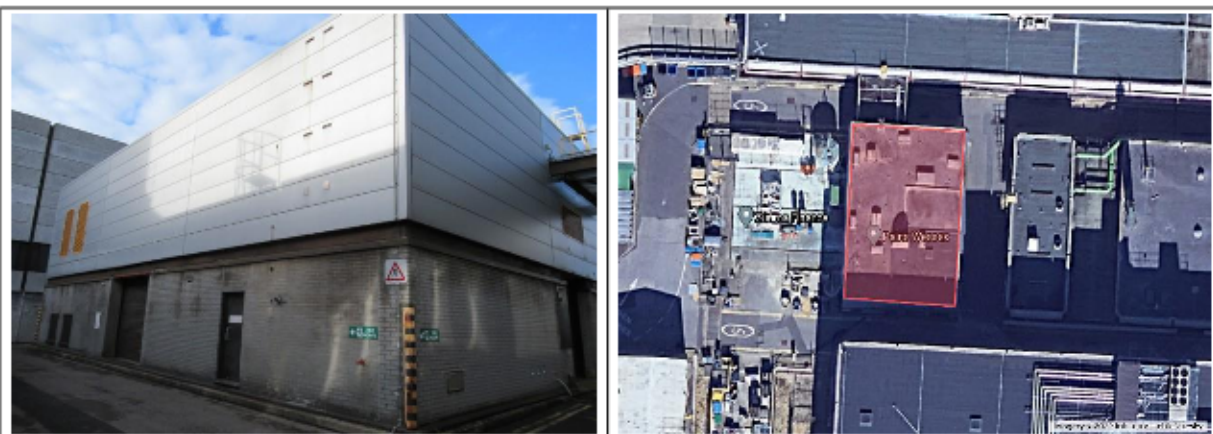
Building 2000, Langstone Technology Park, Langstone Road, Havant PO9 1SA

The building is constructed of a steel frame, assumed to be supported on concrete pad foundations and perimeter ring beams with a ground bearing concrete slab. Elevations are formed from a concrete frame and pre-cast concrete panels set within steel channels above a lower course of masonry brickwork. Fenestration to the property includes various steel framed pedestrian door sets, isolated loading bays and louvered openings.

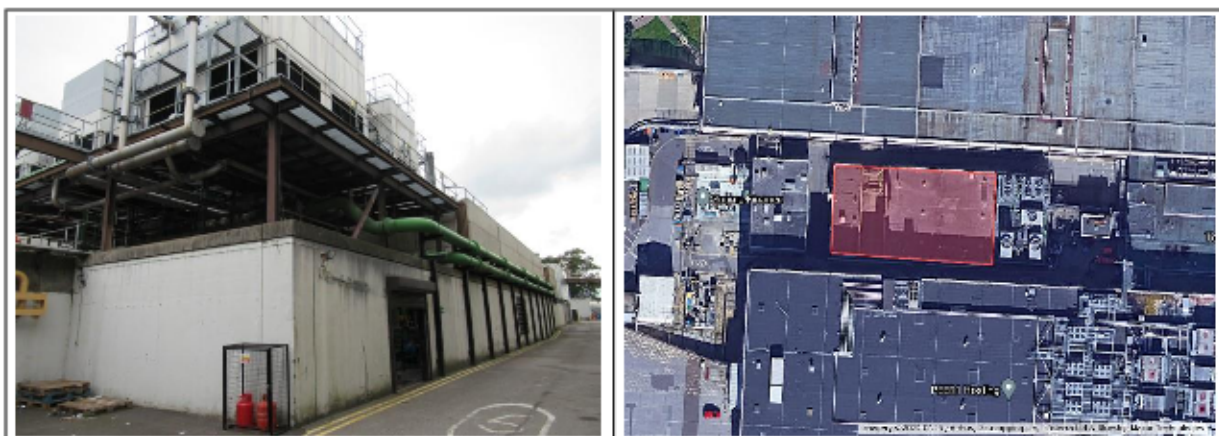
Building 3000, Langstone Technology Park, Langstone Road, Havant PO9 1SA

The building is constructed of a steel frame, assumed to be supported on concrete pad foundations and perimeter ring beams with a ground bearing concrete slab. Elevations are formed from a concrete frame and pre-cast concrete panels set within steel channels above a lower course of masonry brickwork. A mezzanine floor level is provided to a partial area, accessed via steel stairs. Fenestration to the property includes various steel framed pedestrian door sets, isolated loading bays and louvered openings.
