# Phase I Environmental Assessment

**Langstone Technology Park, Havant, PO9 1SA**

Issued: November 2020

Delta-Simons Project No. 15-0754.07

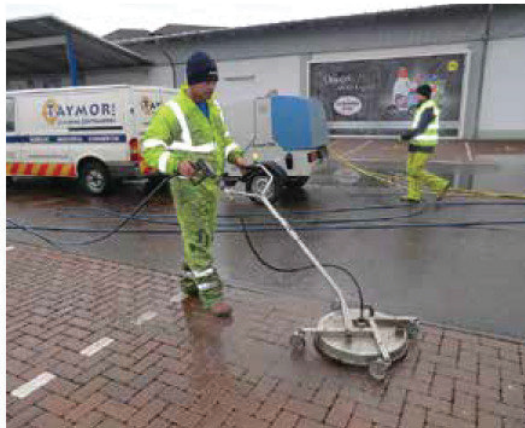
Figure 20.30 Deep cleaning a supermarket car park, Dundee (courtesy Abertay University)

A brush and suction cleaner (which can be a lorry-mounted device or a smaller precinct sweeper) should be used for regular sweeping. Care should be taken in adjusting vacuuming equipment to avoid removal of jointing material. Any lost material should be replaced. It is also possible to clean the surface using lightweight rotating brush cleaners combined with power spraying using hot water, as shown in **Figure 20.30**. This is done every two years at the site shown.
