**Arboricultural Impact Appraisal and Method Statement**  
42 Bedhampton Hill, Havant

15 June 2015  
13201-AIA5-PB

This report contains the supporting tree information relating to the development proposal to establish an improved highway access arrangement, a detached single storey swimming pool facility and a single storey extension to the western most existing care unit building at 42 Bedhampton Hill, Havant.

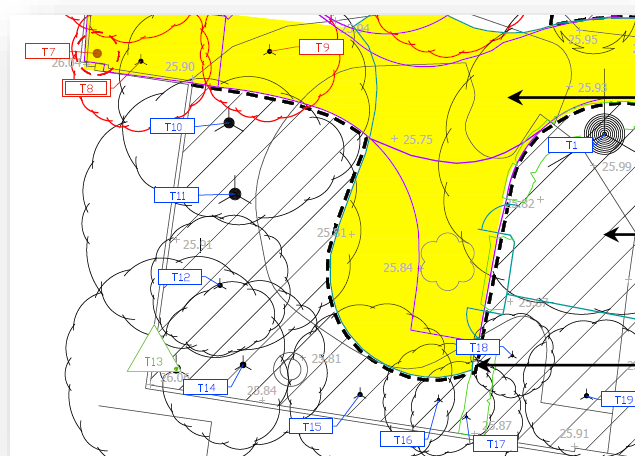
The yellow fill is the precautionary area

The light black diagonal hatch is the CEZ

The heavy black dashed line is the CEZ boundary

These areas are illustrated on our plans and annotated as follows:

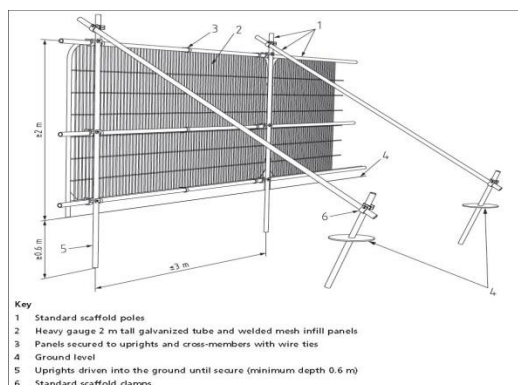
**Figure 1:** Recommendations taken from figure 2 of BS 5837.

Various fencing options are illustrated in figure 1 and photos 2–4 below. The minimum specification for the fencing must be as described in figure 2 of BS 5837 (figure 1 below) or an equivalent design that effectively restricts access to the RPA it protects.

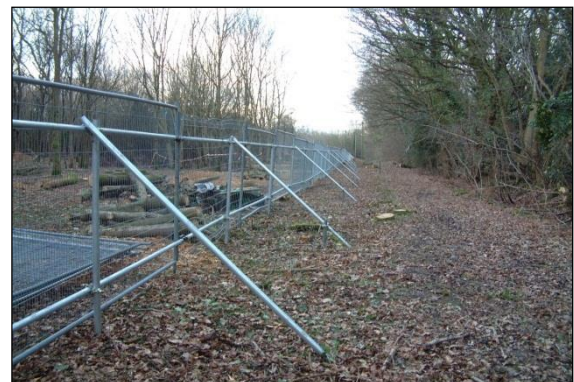
**Photo 2:** Heras fencing wired to scaffold braced posts is a robust and effective interpretation of the BS specification.

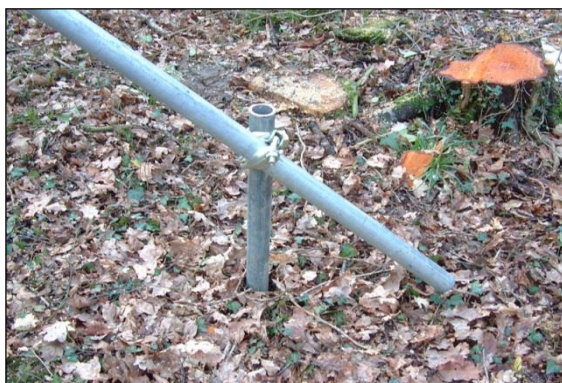
**Photo 3:** Close up of bracing detail, essential for increasing the stability of the vertical framework.

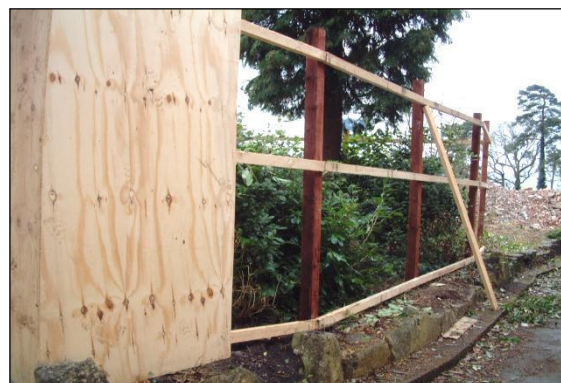
**Photo 4:** Board specification on secure wooden posts is a suitable alternative to the standard braced scaffold design.

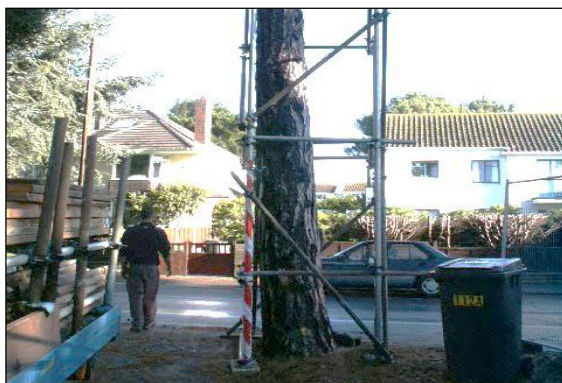
**Photo 5:** A scaffold braced framework surrounding the trunk reduces the risk of accidental impact.

Where individual trunks or branches are vulnerable to impact damage, a framework of scaffold or wood can be constructed to provide protection (photos 5 and 6).

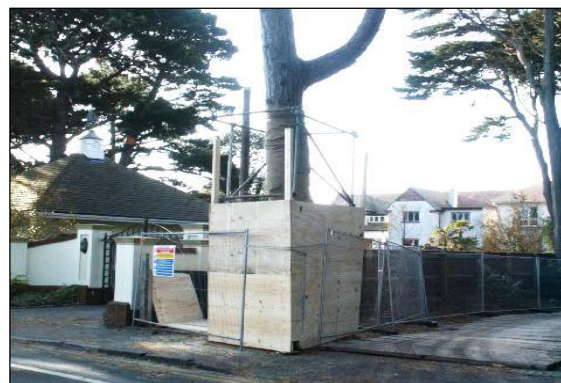
**Photo 6:** Board secured to scaffold framework adds another layer of protection for vulnerable trunks and branches.

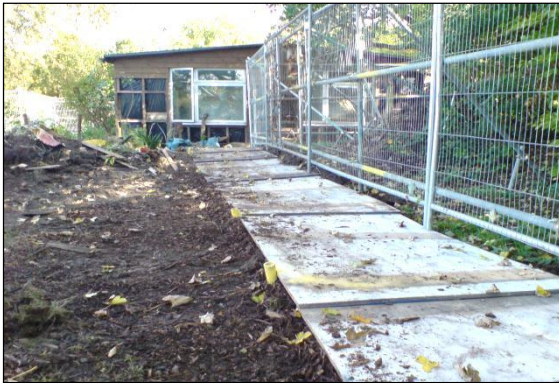
**Photo 7:** Heavy-duty plywood set onto a compressible woodchip layer and pinned into position is suitable to spread the loading from pedestrian access.

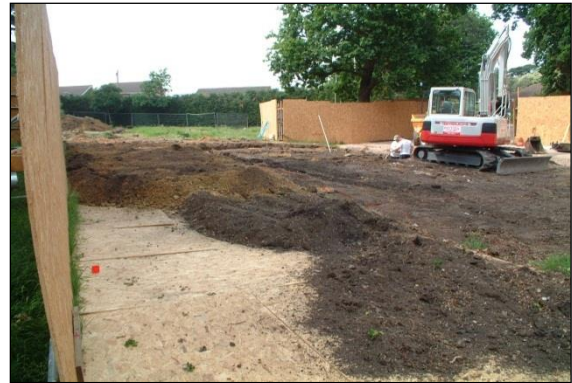
**Photo 8:** Spreading soil excavated from footings is an effective way of buffering the plywood surface from the wear of light vehicles.

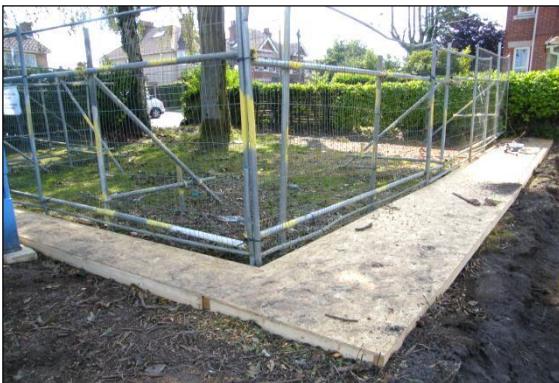
**Photo 9:** Plywood fixed to a wood frame is another effective method of protecting soil from pedestrian compaction.

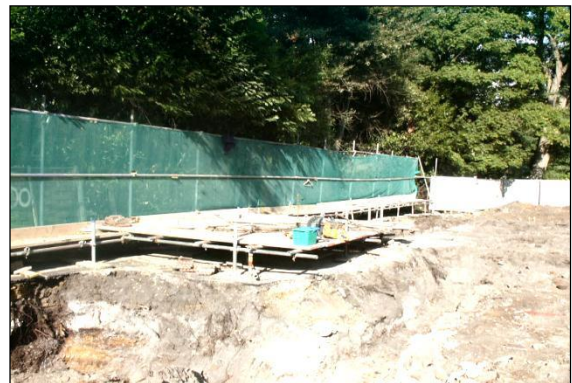
**Photo 10:** A scaffold framework attached to the main scaffold fencing can be used to support either scaffold planks or plywood to create an elevated platform with a gap beneath.

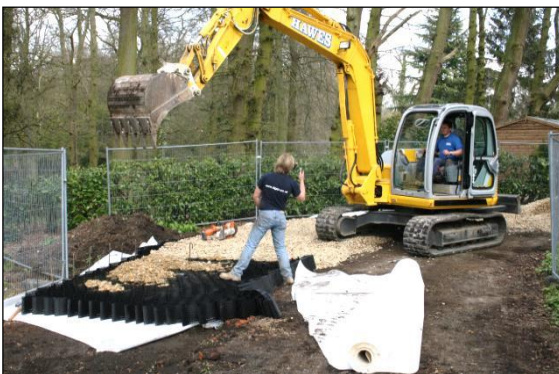
**Photo 11:** Cellular products are a very effective means of providing ground protection where heavy vehicle use is expected.

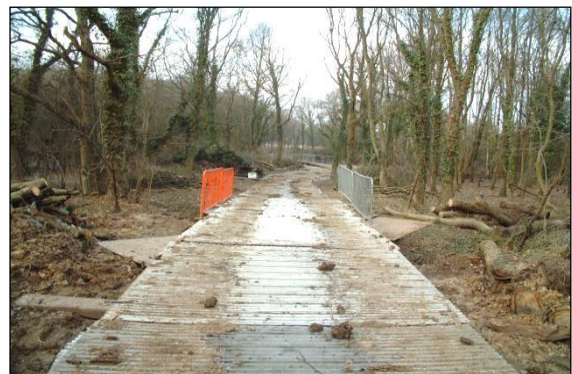
**Photo 12:** Custom designed sectional tracks can be joined to support very heavy traffic use through sensitive areas.

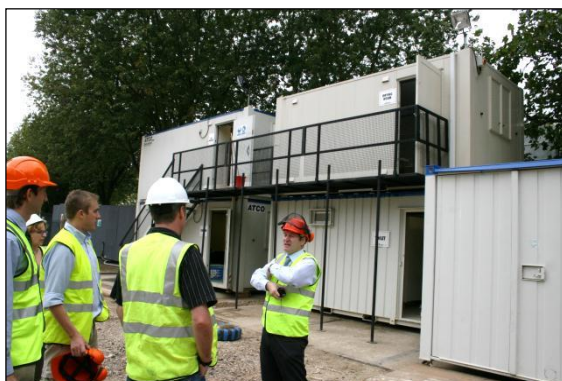
**Photo 13:** A combination of retaining existing surfacing and using temporary construction cabin accommodation can be a very effective means of preventing damage to sensitive areas.

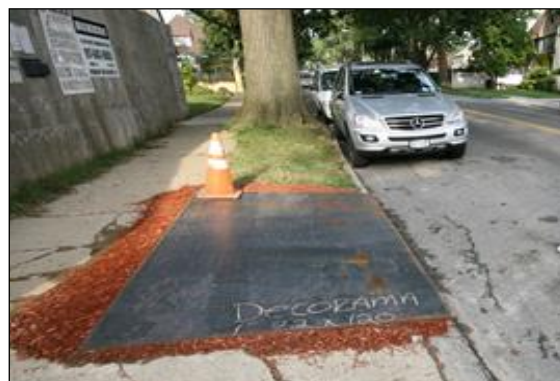
**Photo 14:** Steel plates can be an effective way of temporarily reinforcing weak surfacing over a construction access during the development activity.

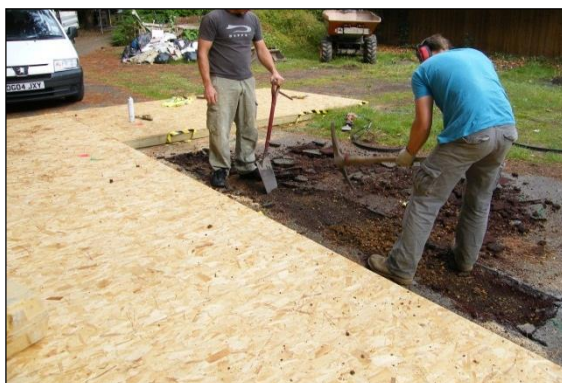
**Photo 15:** Careful hand-digging using conventional tools is acceptable for exposing roots in RPAs.

Precautionary areas are RPAs outside the CEZ, i.e. they are areas where construction activity can take place, but it must be carried out with care to avoid damaging the sensitive rooting environment. BS 5837 (7.2) makes provision for excavating in RPAs, explaining that all excavation must be carried out carefully using hand-held tools and preferably by compressed air soil displacement, taking care not to damage the bark and wood of any roots (photo 15, 16 and 17).

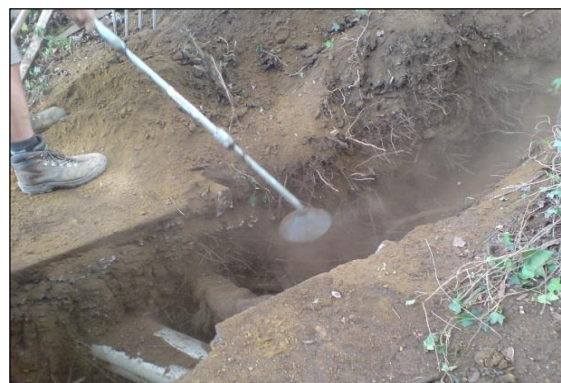
**Photo 16:** Air spades are very effective at exposing roots and services with minimal damage.

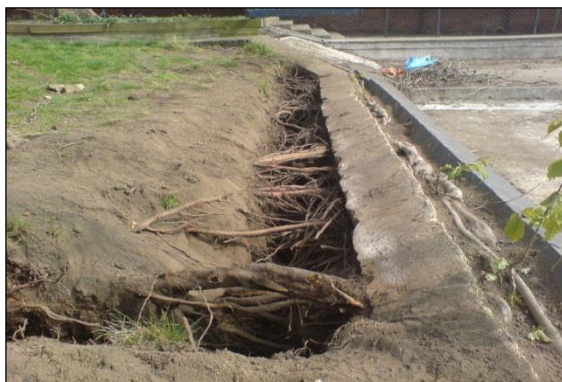
**Photo 17:** Air spades are particularly useful where roots are very dense.

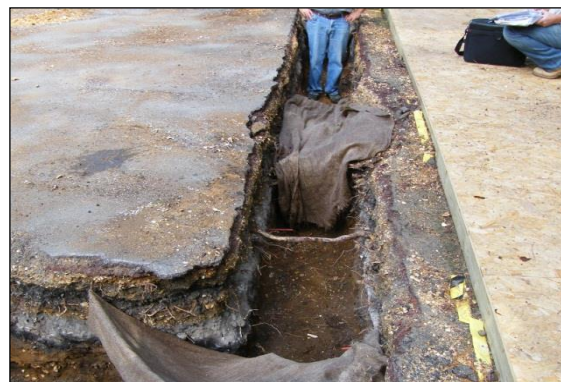
**Photo 18:** Exposed roots must be protected from light, drying out and extremes of temperature by covering with hessian sacking and boards until they can be covered back with soil.

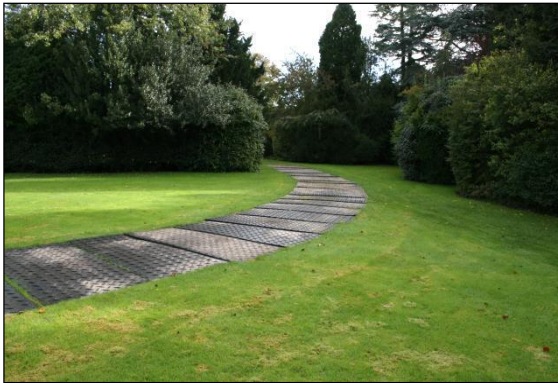
**Photo 19:** Ground protection must be used where repeated foot or vehicle traffic could cause compaction in sensitive RPAs. It can be as simple as plywood for pedestrians, but must be more robust for vehicles.

In summary, there should be no vehicular or repeated pedestrian access unless existing ground protection is retained or new protective measures are installed (photo 19). All exposed RPAs must be protected until there is no risk of damage from the development activity.

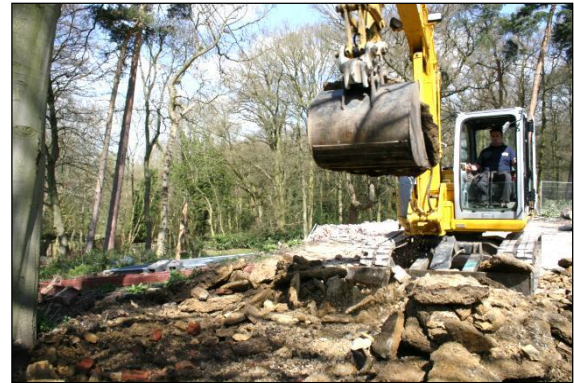
**Photo 20:** Machines with a long reach can be used to lift out heavy surfacing and structures as long as the machine sits outside the RPA and the exposed surface is protected before there is any further access.

2. Machines with a long reach may be used if they can work from outside RPAs or from protected areas within RPAs (photo 20), but they must not encroach onto unprotected soil in RPAs.

3. Debris to be removed from RPAs manually must be moved across existing hard surfacing or temporary ground protection in a way that prevents compaction of soil. Alternatively, it can be lifted out by machines, provided this does not disturb RPAs (photo 20).

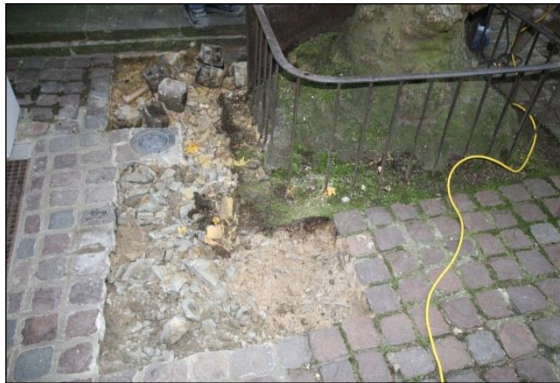
**Photo 21:** Careful lifting of cemented-in sets round this tree allowed them to be re-laid on a permeable sand base, improving the water input into the soil around the trunk.

1. Appropriate tools for manually removing debris may include a pneumatic breaker, crow bar, sledgehammer, pick, mattock, shovel, spade, trowel, fork and wheelbarrow (photos 21 and 22). Secateurs and a handsaw must also be available to deal with any exposed roots that have to be cut.

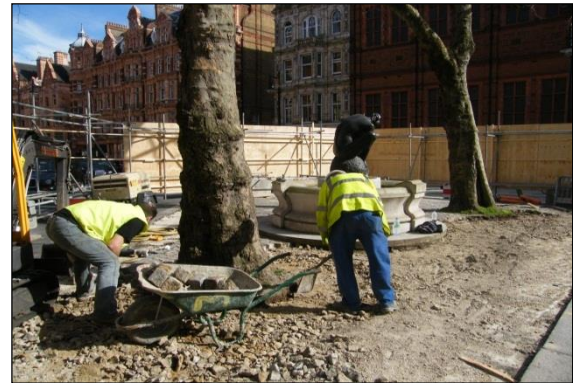
**Photo 22:** These trees had impermeable surfacing right up to their trunks, which had to be removed by hand before installing new structures.

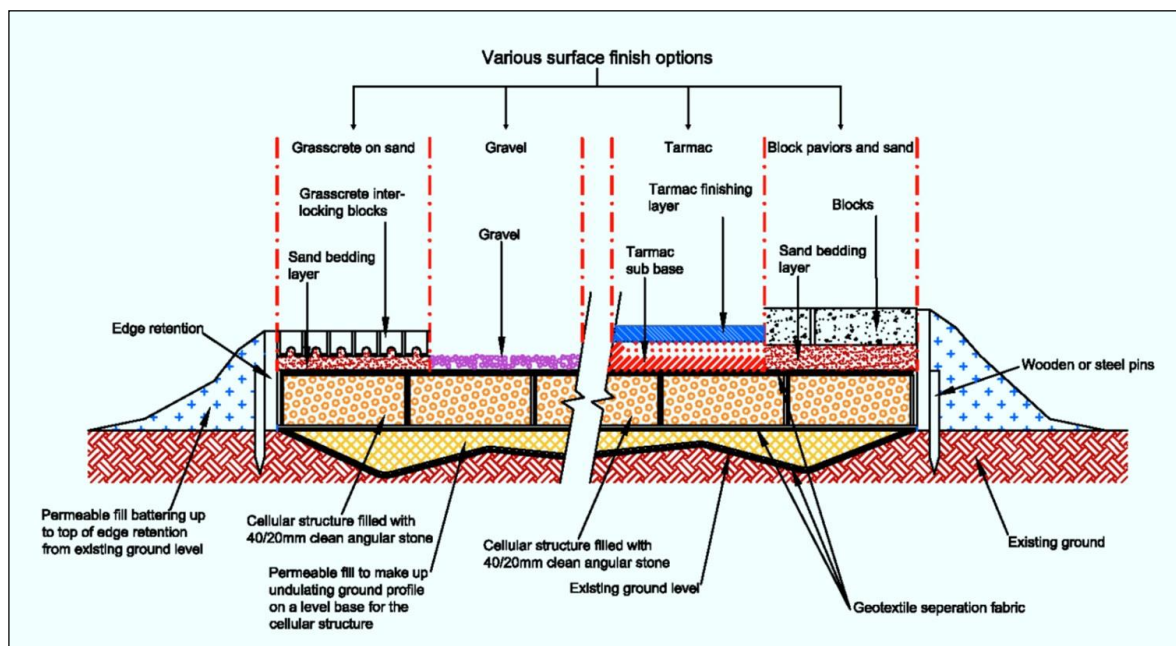
**Figure 23:** This conceptual cross-section illustrates the structural elements of the system and the multiple surfacing options that can be used with it.

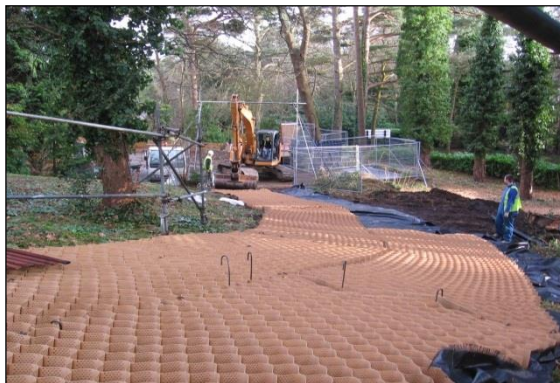
**Photo 24:** The three-dimensional cells are opened up, spread across the area to be surfaced and pinned in place ready for the stone filling.

BS 5837 (7.4.2.) sets out that no-dig, three dimensional cellular confinement systems can be used as the basis for extending hard surfacing into RPAs. It is our experience ([www.barrelltreecare.co.uk/case-studies/SurfacingNearTrees.pdf](http://www.barrelltreecare.co.uk/case-studies/SurfacingNearTrees.pdf)) that this type of surfacing can be installed in the majority of situations without any significant adverse impact on adjacent trees, provided that proper consideration is given to all the circumstances. Most of our experience is with the CellWeb system supplied by Geosynthetics Ltd ([www.geosyn.co.uk](http://www.geosyn.co.uk)) and because of its sustained good performance over time, this is our preferred choice of product. The product is made from heavy-duty plastic that can be pulled apart to open into cells. These are then filled with washed stone, after the product is spread over the ground and pinned in place. This forms a base layer that acts as a floating raft, spreading the load across the whole construction width. The base layer can be topped with a variety of finishes as illustrated in figure 23. Photos 24 and 25 show the product spread over the ground and then filled with stone to produce the base layer.

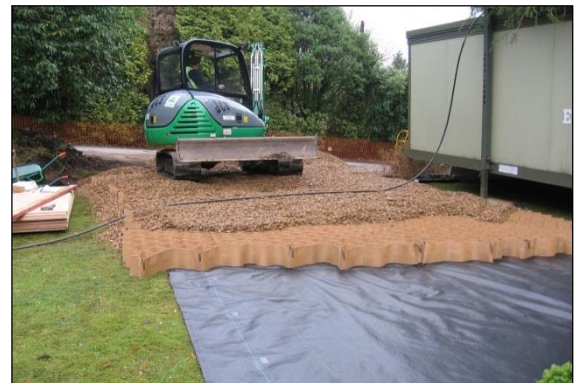
**Photo 25:** The stone-filled cells spread the load of traffic and the geotextile membrane on the ground prevents migration of the stone into the soil profile.

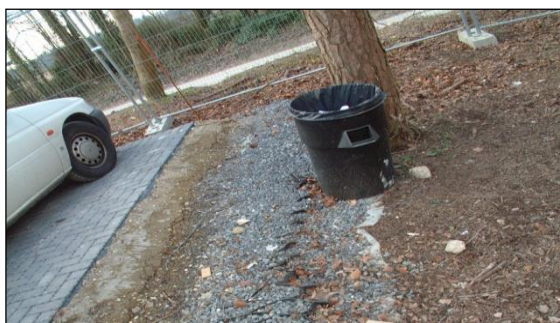
**Photo 26:** A conventional concrete haunching can be used to retain new surfacing as long as it is not dug into a trench - here it is placed on top of the CellWeb layer.

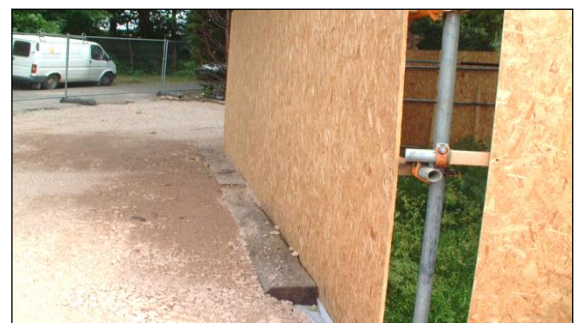
**Photo 27:** Although this is only a temporary surface, railway sleepers pinned into the ground can be used to retain the edges of new surfacing.

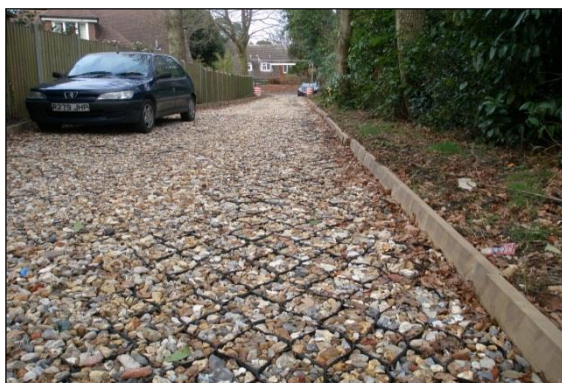
**Photo 28:** Wooden board pinned in place or held in position with backfilled topsoil can provide more informal and rustic surface edging.

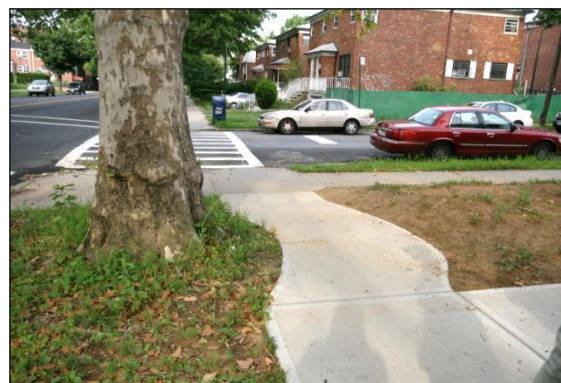
**Photo 29:** In some situations, it may be appropriate to cast a free floating concrete surface directly onto the soil surface provided provision is made to prevent soil contamination while the concrete is being poured, i.e. an impermeable membrane separating the concrete from the soil.

In some situations, limited-width floating concrete rafts constructed directly onto the soil surface may be acceptable for both pedestrian (photo 29) and vehicular access (photo 30), but the design must not include any strip-dug supports. If concrete is poured directly, precautions must be taken to ensure that no toxic fluids can contaminate the adjacent soil. Alternatively, elevated paths supported on low impact frames or post supports allow a decking surface to cross sensitive areas (photos 31 and 32). Where paths are installed very close to trunks, provision must be made for distortion from future root growth by selecting flexible components for the supporting frame and surfacing (photo 33).

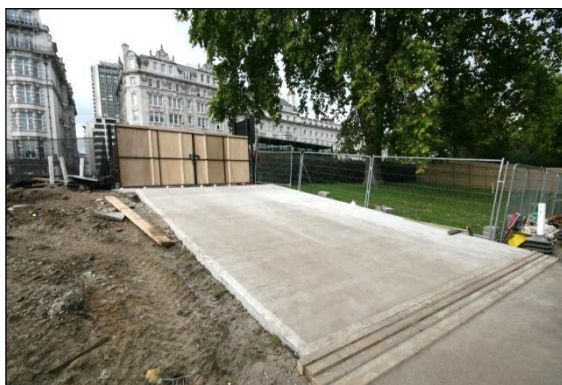
**Photo 30:** This temporary access for heavy construction traffic on the outer edge of a RPA is a concrete slab cast above ground level and will be removed when the project is completed.

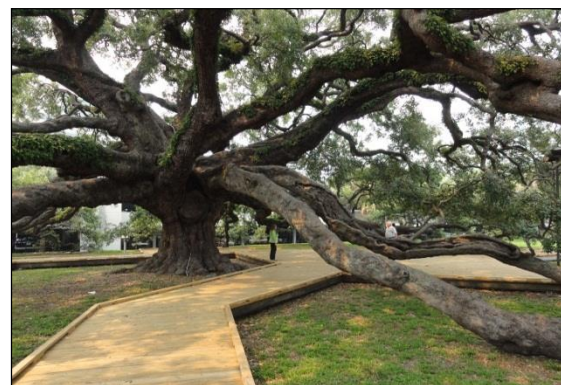
**Photo 31:** Board walks supported on posts or a light frame are another way of providing pedestrian access across sensitive RPAs.

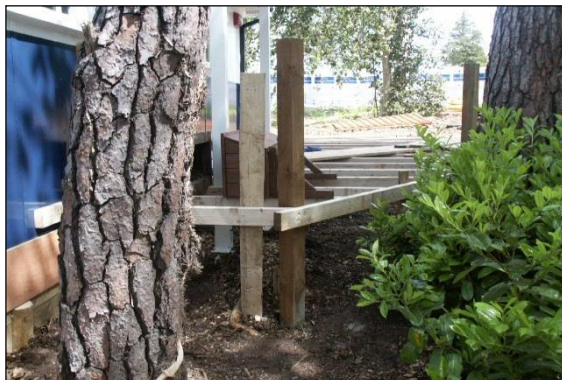
**Photo 32:** New surfacing can be supported above the ground on posts leaving the soil surface beneath undisturbed.

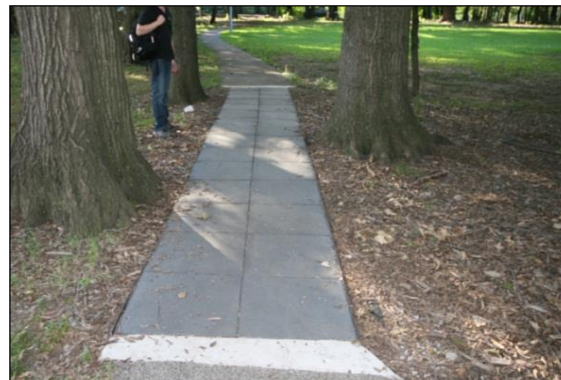
**Photo 33:** Where surfacing is needed close to rapidly growing buttress roots, a light metal frame with rubberised surfacing will allow the path to distort without cracking as the roots grow.

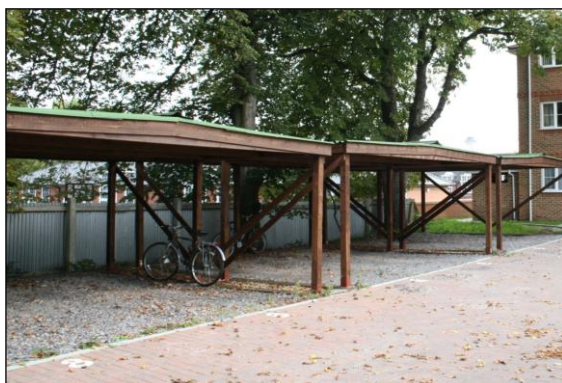
**Photo 34:** These carports are formed by wooden posts above a three dimensional cellular no-dig and load-spreading surface of permeable crushed stone.

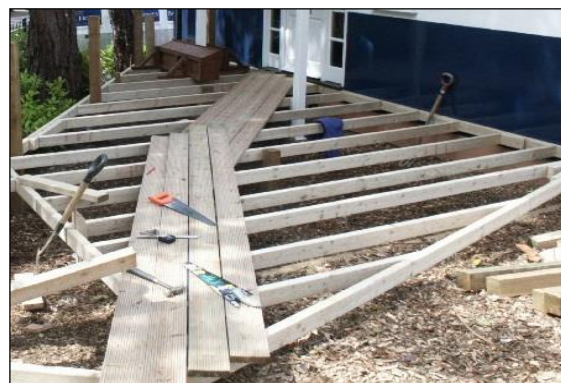
**Photo 35:** This deck supported above the ground on small posts provides a low-impact alternative to conventional stone patio surfacing in RPAs.

Light structures do not normally require substantial foundations and can have permeable bases. Ideally, their bases should be of a no-dig, load-spreading construction set directly on to the soil surface. They require a flat base and so an undulating site will need levelling to provide a suitable surface. Excavation of any high points by up to 5cm and filling depressions with permeable fill to provide a flat base will normally be acceptable provided no roots greater than 2.5cm in diameter need to be cut. If large roots are found, the preferred course of action would be to raise the base level of the structure by filling rather than cutting roots. However, if this is not practical and large roots have to be cut, the situation should be discussed with the supervising arboriculturist before a final decision is made. Light covering structures can be fixed onto a frame that can rise directly from the base or be fixed to supports either banged into the ground or set in carefully dug holes (photo 34). Provided the supports are well spaced, i.e. greater than 1.5m apart, and of a relatively narrow diameter, i.e. not in excess of 15cm, it is unlikely they will cause any significant disturbance to RPAs (photo 35).

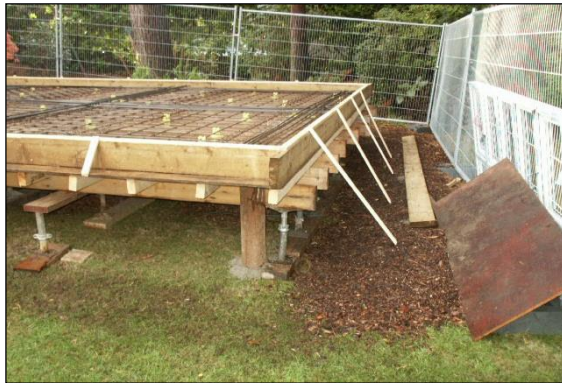
**Photo 36:** Small diameter piles (less than 150mm) are an effective means of supporting structures in RPAs with minimal disturbance.

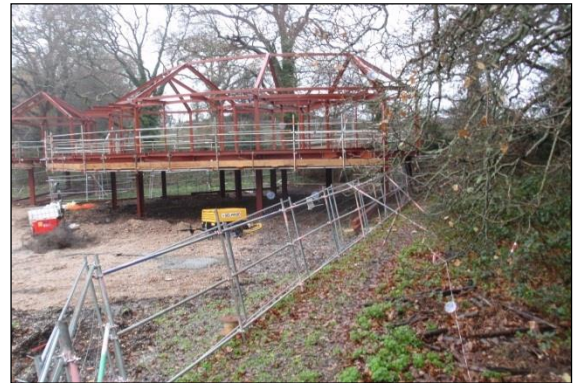
**Photo 37:** It is possible to support very large structures on piles within sensitive RPAs without any significant adverse impact on tree roots.

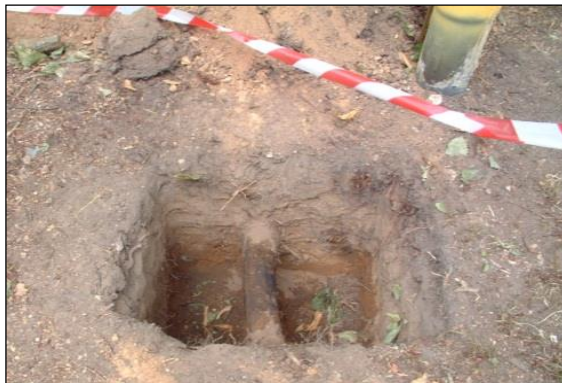
**Photo 38:** Where piles are proposed close to trunks, it is essential to excavate 50–75cm deep to see if there are any significant roots in the way, with provision to move the pile location if roots are found (note the pile was finally installed to avoid this root).

Conventional strip foundations in RPAs for any significant structure may cause excessive root loss and are unlikely to be acceptable. However, BS 5837 (7.5) confirms special engineered foundations can be used in RPAs. Damaging disturbance can be significantly reduced by supporting the above ground part of the structures on small diameter piles and beams or cast floor slabs set above ground level (photos 36 and 37). The design should be sufficiently flexible to allow the piles to be relocated if significant roots are encountered in the preferred locations (photos 38 and 39). Before the actual installation of the new structure starts, any vulnerable RPA should be protected by temporary ground protection as set out in paragraph 6 above (one option shown in photo 39). At expected pile or gate pier locations, gaps in the ground protection should be left to allow access to the soil beneath. The preferred pile locations should be carefully excavated to a depth of 60cm to establish if there are any significant roots over 2.5cm in diameter that could be damaged. If significant roots are found, they should be dealt with as set out in paragraph 7 above or the pile location may have to be moved slightly (photo 38).

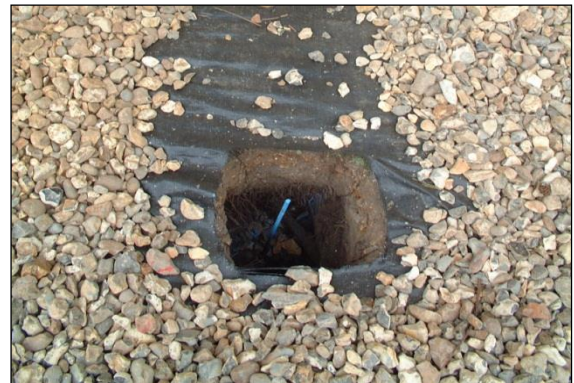
**Photo 39:** Ground protection must be used to spread the load of the piling rig once excavation has confirmed that no substantial roots are in the preferred pile location.

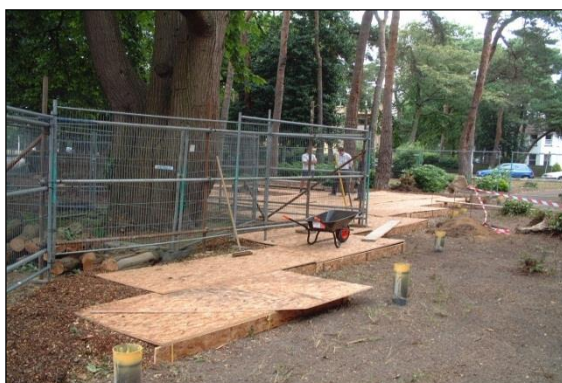
**Photo 40:** Once the piles have been installed (yellow tops), the ground protection to support the piling rig is removed ready to fix the void-former onto the bare soil, in advance of pouring the building slab.

Once the piles have been installed, the ground protection is usually removed ready for the installation of the slab supporting the structure (photos 40 and 41). It is important to note that the lowest points of the new structure, i.e. the underside of the main slab and any pile-capping beam must be above the ground level between the piles and there should not be any further excavation. The supported structure base can be pre-cast and imported to the site ready to fix or can be cast in position using shuttering for the sides and a biodegradable void-former for the base (photo 42). BS 5837 (7.5.4) recommends that where impermeable structures cover significant proportions of RPAs, it may be necessary to provide water input through redirecting roof drainage beneath the supporting slab (photo 43).

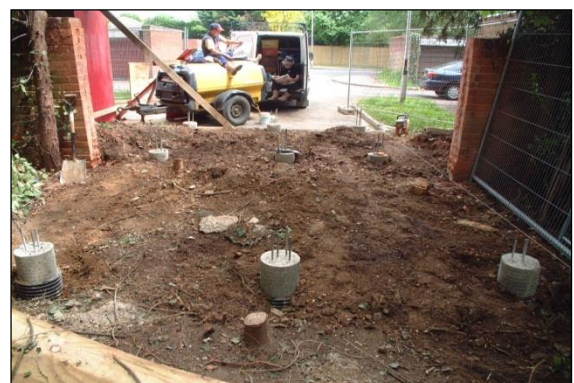
**Photo 41:** Piles can also be used to support bridges across sensitive RPAs, but the temporary ground protection has to be removed before the main structure is either imported in or cast on site.

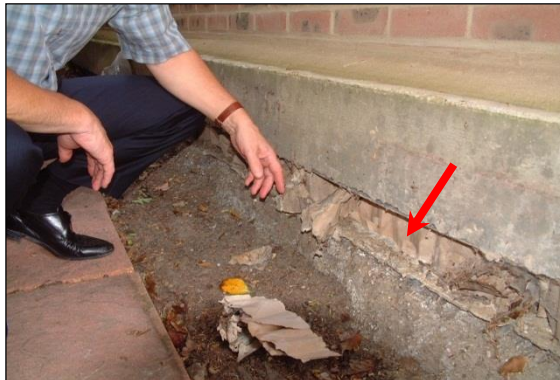
**Photo 42:** Where a slab is cast on site, a biodegradable void-former (red arrow) temporarily supports the weight of the liquid concrete until it sets. The void-former can then be wetted and washed away to leave a void or left to degrade naturally, both of which allow movement of air beneath the slab.

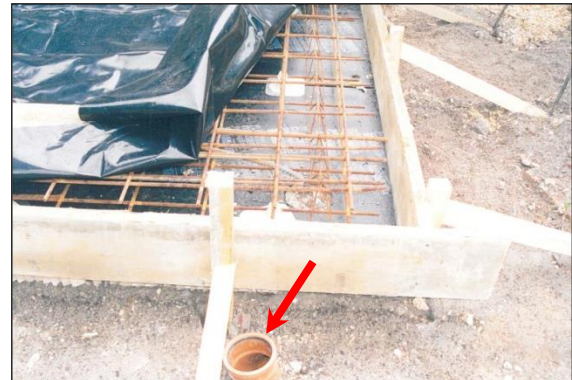
**Photo 43:** This reinforced base slab for a double garage has drainage provision (red arrow) beneath the structure to redirect roof runoff to supply roots with water.

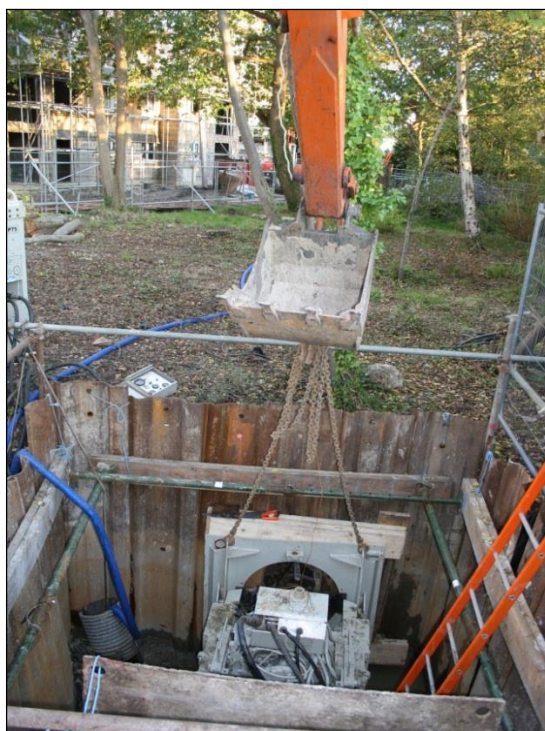
**Photo 44:** If possible, thrust boring is the preferred option for installing service routes through the RPAs of important trees, but there has to be space at the start and finish to dig substantial working pits.

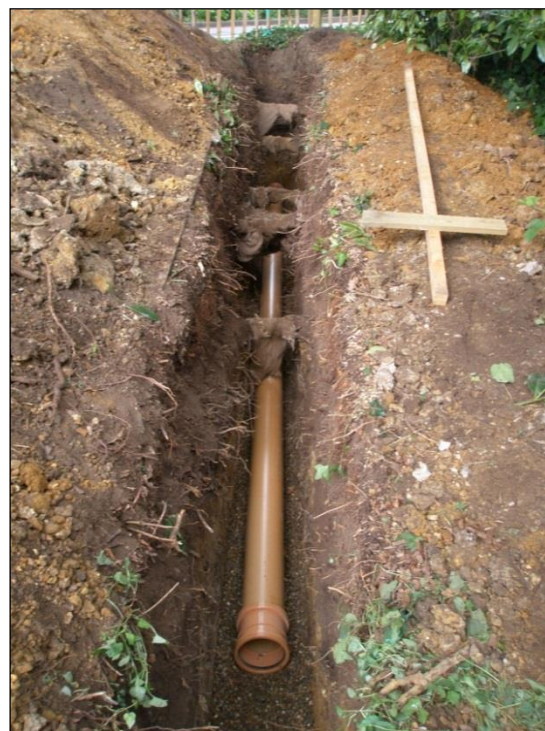
**Photo 45:** Continuous trenches dug by hand so that important roots can be retained (with the service ducting threaded beneath) is an effective means of minimising damage (note the ground protection boards with soil piled on top on the left).

Excavation to upgrade existing services or install new services in RPAs may damage retained trees. Where possible, all services should be outside RPAs and installation in RPAs should only be chosen as a last resort. If installation within RPAs is being considered, as advised in 4.1.3 of the NJUG guidance, the decision should be made in consultation with the LPA or the supervising arboriculturist before any work is carried out. If service installation is agreed within RPAs, the NJUG protocol as set out in 4.1.3 of its guidance should be used to decide the most appropriate method. In summary, this sets out that "*Acceptable techniques in order of preference are; a) trenchless, ... b) Broken trench – hand-dug ... c) Continuous trench – hand-dug*". If trenchless methods are to be used, there is normally a starting pit and a finishing pit that have to be dug at each end of the service run and these must be outside RPAs (photo 44). Where a hand-digging option is agreed (photo 45), any roots discovered during the excavations should be dealt with as

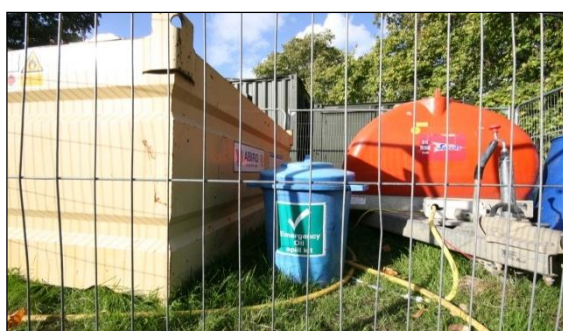
**Photo 46:** Where fuel or other chemical are stored on site, it is now standard practice to have emergency spillage kits available to restrict the environmental impact of accidents.

Spilt chemicals that can soak into RPAs will kill existing roots and may prevent new roots growing, so provision must be made to minimise the risk of contamination to soil within the normal risk management protocols for the site. This would normally include means of containing spillages and procedures for clearing them up if they occur (photo 46).

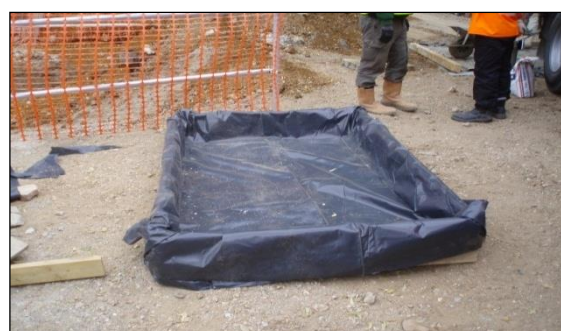
**Photo 47:** Soil bunding or a supporting framework covered in heavy-duty plastic sheeting is essential where there is a risk of spillages contaminating RPAs.

All cement mixing and vehicle washing points must be located outside RPAs, with provision to contain any spillages. Where the contours of the site create a risk of polluted water or toxic liquids running into RPAs, a precautionary measure of bunding or a frame, sealed with heavy-duty plastic sheeting sufficient to prevent contamination (photo 47), must be used to contain accidental spillages.

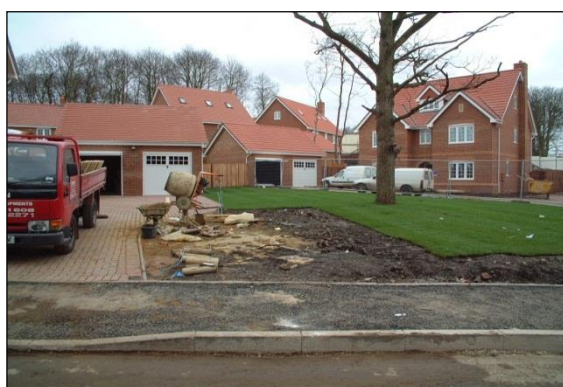
**Photo 48:** The RPA of this tree was not effectively protected during construction and excessive compaction of the soil meant it died soon after this turf covered up the damage.

Soft landscaping activity after construction can be extremely damaging to trees. No significant excavation or cultivation, especially by rotovators, should occur within RPAs. Where new designs require levels to be increased to tie in with new structures or the removal of an existing structure has left a void below the surrounding ground level, good quality and relatively permeable top soil should be used for the fill. It should be firmed into place, but not over compacted, in preparation for turfing or careful shrub planting. Ideally, all areas within 1m of tree trunks should be kept at the original ground level and have a mulched finish rather than grass to reduce the risk of mowing damage (photos 48 and 49).

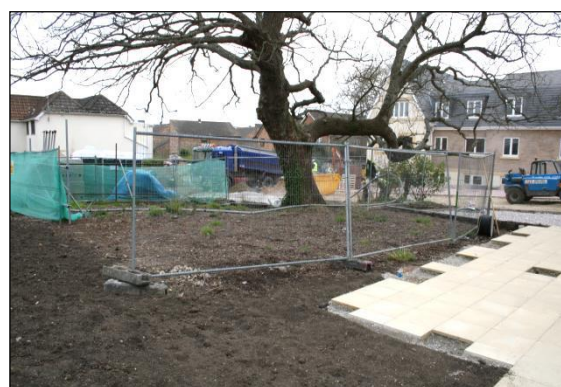
**Photo 49:** This tree had tarmac parking within its RPA that was removed and replaced with an organic mulch near the trunk and limited no-dig surfacing on the outer edges of its RPA.
