**FLOOD RISK ASSESSMENT  
FOR  
PROPOSED RESIDENTIAL DEVELOPMENT  
LAND AT BELLS FIELD, ST. MARY BOURNE  
ON BEHALF OF  
HYDE HOUSING ASSOCIATION LIMITED**

**JANUARY 2015**

**[Issue 6]**

**Document Title:** Flood Risk Assessment

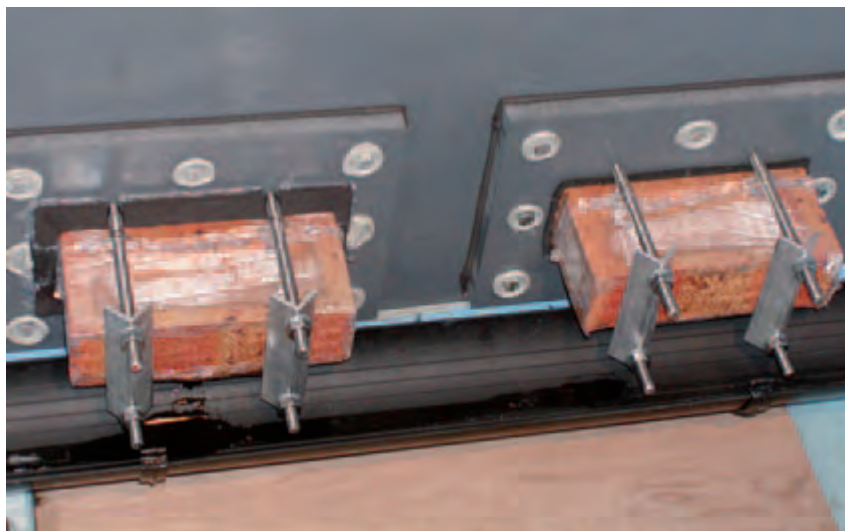
**Figure 6.1 Pressed facing bricks being tested**

The recommendations given in this section on building materials are based primarily, but not exclusively, on recent laboratory investigations (permeability and drying tests on 13 typical building materials subjected to 1m head of flood water). An illustrative example of testing is given in Figure 6.1.

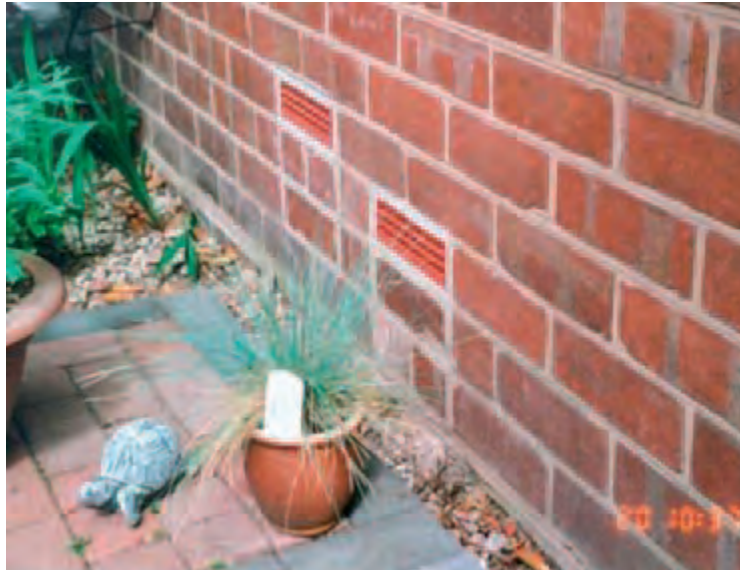
Figure 6.11 Periscopic air vent (courtesy Severn Trent Water)

Air vents: special designs of air vent are available in the market to prevent water ingress in circumstances where the predicted flood depth is low (i.e. < 0.3m); e.g. periscopic air vent, see Figure 6.11. Careful consideration should be given to effectively sealing any associated joints.

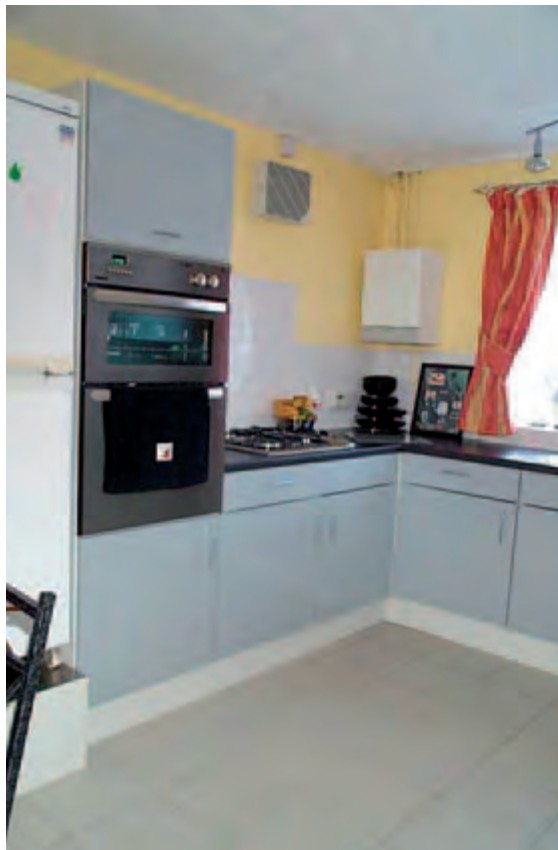
**Figure 6.12 Main kitchen appliances (such as oven and fridge/freezer) placed above floor level (courtesy of Norfolk County Council and FLOWS Project)**

An illustrative example of a resilient kitchen is given in Figure 6.12, e.g. raised oven and fridge/freezer on plinth and use of ceramic tiles on the floor. In this figure it can be seen that the kitchen units are made of stainless steel. Due to its relatively high cost this is a suitable solution only in cases where the predicted frequency of flooding is high (see Chapter 4).
