# Asbestos Survey

Trevor Howell Car Sales

Purbrook Tyres

Purbrook Garage services Ltd

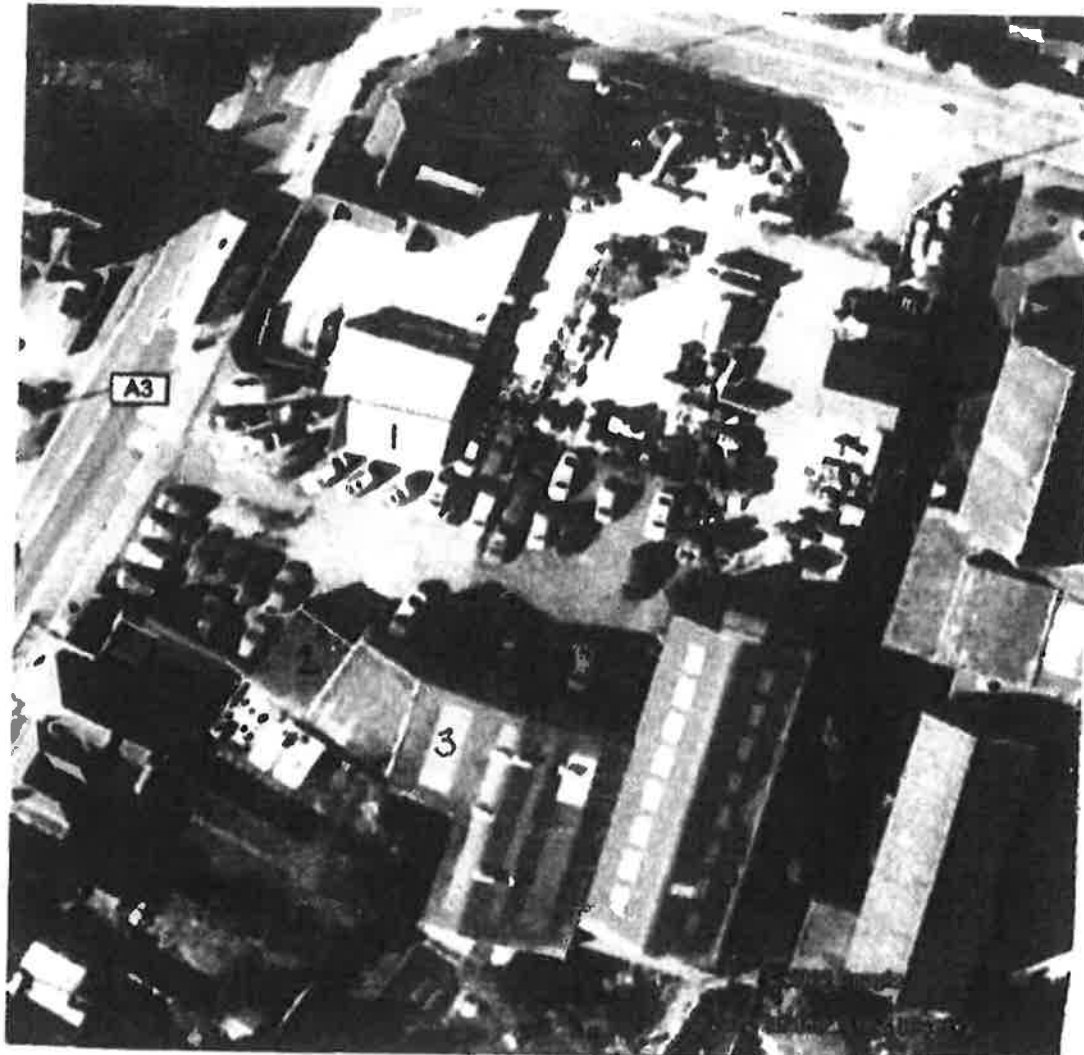
Ariel view of the three premises

The Ariel view in this report is not to scale and is illustrative only to indicate approximate locations.

- 1, Trevor Howell Car Sales
- 2, Purbrook Tyres
- 3, Purbrook Garage Services Ltd
