# Heritage Statement & Schedule of Repair Accolaid/14/00212/CMP

## Alterations, Additions For Restaurant Conversion V.6.

25 South Street, Emsworth  
Hampshire, PO10 7EG.

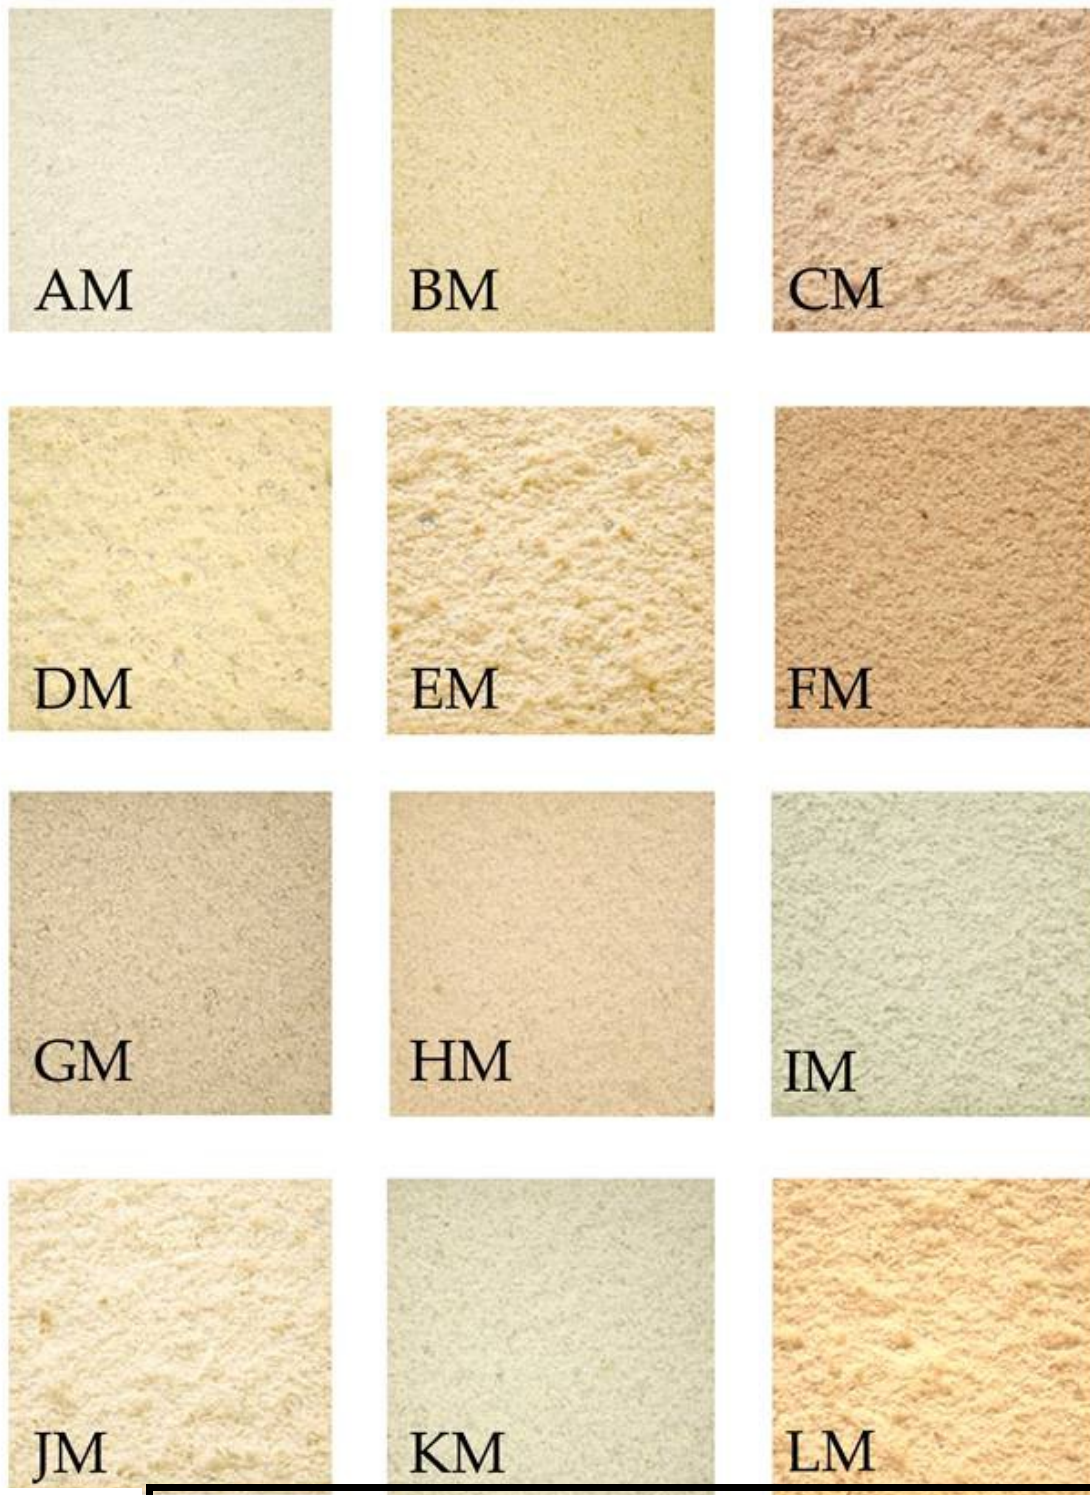
### Standard Lime Mortar Colour Chart

This is a general indication of colour. No warranty is given or implied that the goods will all respects be equal to these images. A site sample panel should always be built. 25 Kg bags of these colours are available.

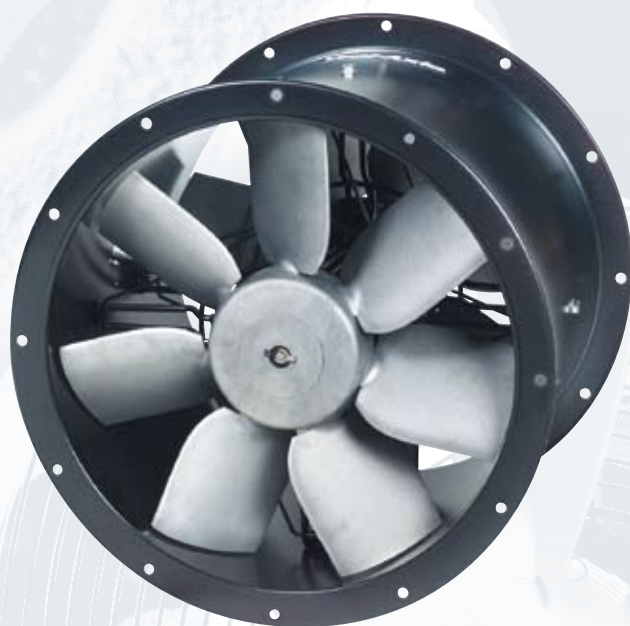
## CONTRARROTATING CASED AXIAL FANS

### TCBBx2 / TCBTx2 Series

Range of cylindrical cased axial fans fitted with aluminium impellers and manufactured from high grade rolled galvanised steel and protected against **corrosion by cataforesis primer and black polyester paint finish.**

Fitted with **2 contrarrotating complementary impellers** manufactured from die-cast aluminium. All models are supplied with pre-wired wiring junction box located on the outside of the fan casing for easy wiring access.

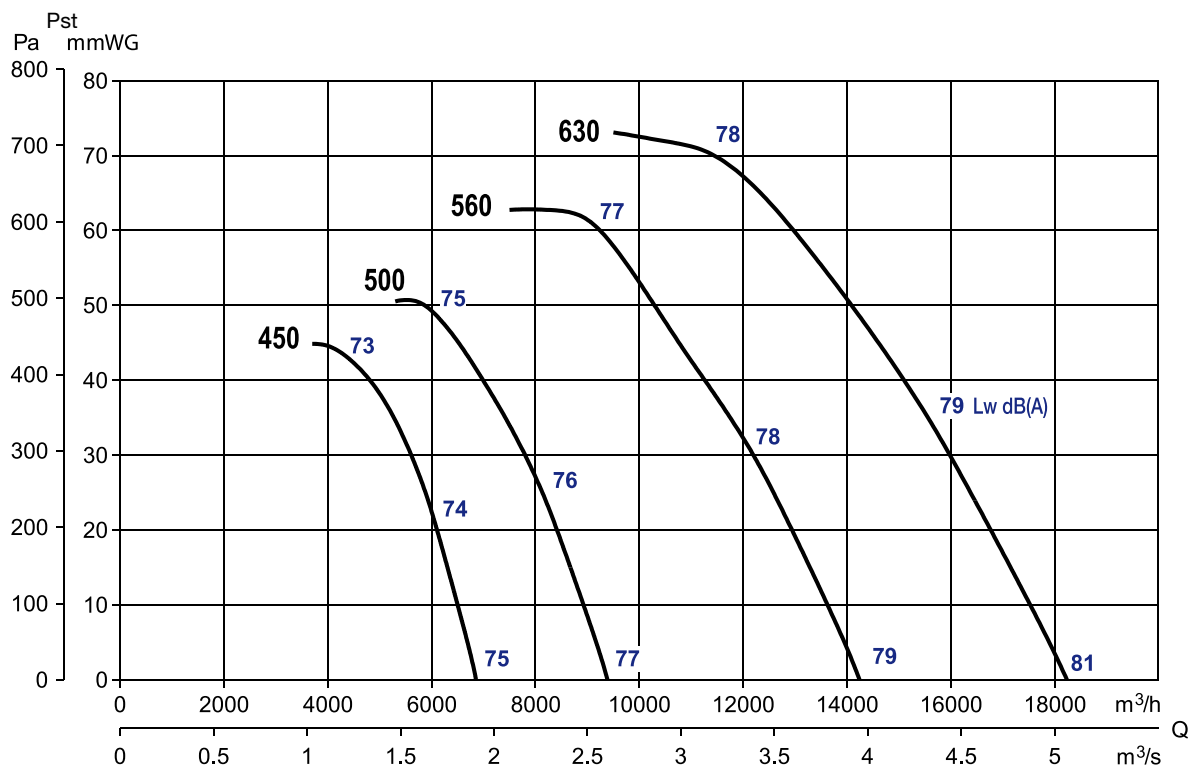
## Performance curves

- Q = Air volume in, m<sup>3</sup>/hr and m<sup>3</sup>/s.
- Pst = Static pressure in mmWG and Pa.
- Dry air at 20°C and 760 mmHg.
- Performance data in accordance with ISO 5801 and AMCA 210-99 Standards.

The sound levels –NPS– shown in the technical characteristic chart, correspond to the value of sound pressure dB(A), measured in free field conditions at a distance equivalent to three times the diameter of the impeller with a minimum of 1.5 meters.

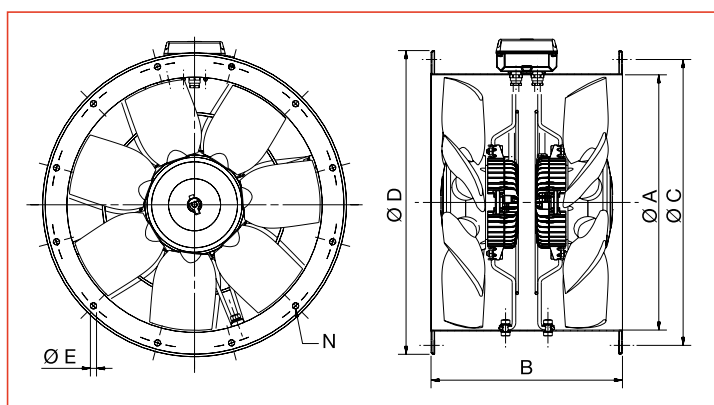
## Dimensions (mm)

| Model | Ø A | B | Ø C | Ø D | Ø E | Number of holes N |
| 450 | 537 | 375 | 500 | 450 | 12 | 8 |
| 630 | 725 | 520 | 690 | 630 | 12 | 12 |

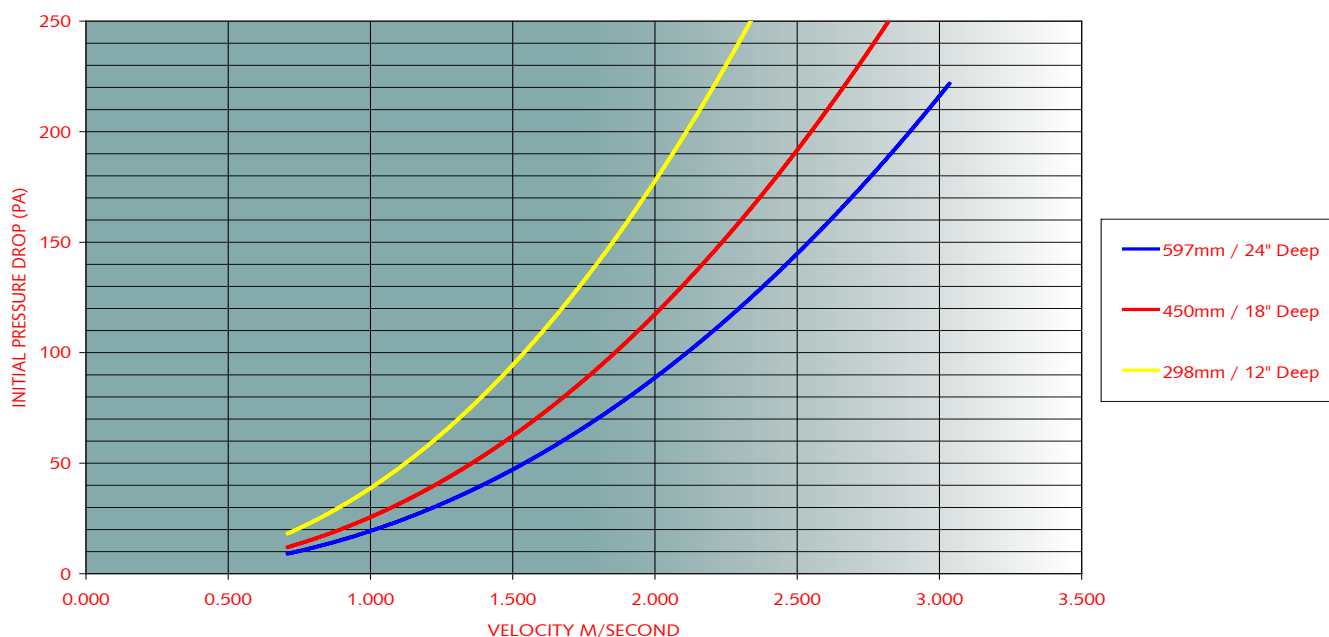
LINEAR VELOCITY M/SECOND V'S PRESSURE DROP  
MULTICARB ACTIVATED CARBON CELLS
