| REV. No. | DATE | DESCRIPTION | INITIALS |
|---|---|---|---|
| Manor Farm<br>Copseys | | | |
| Title Borehole sections & water table results in permeable road areas | | | Scale<br>1:20 @ A2 |
| | | | Drawing No.<br>4527:P22 |

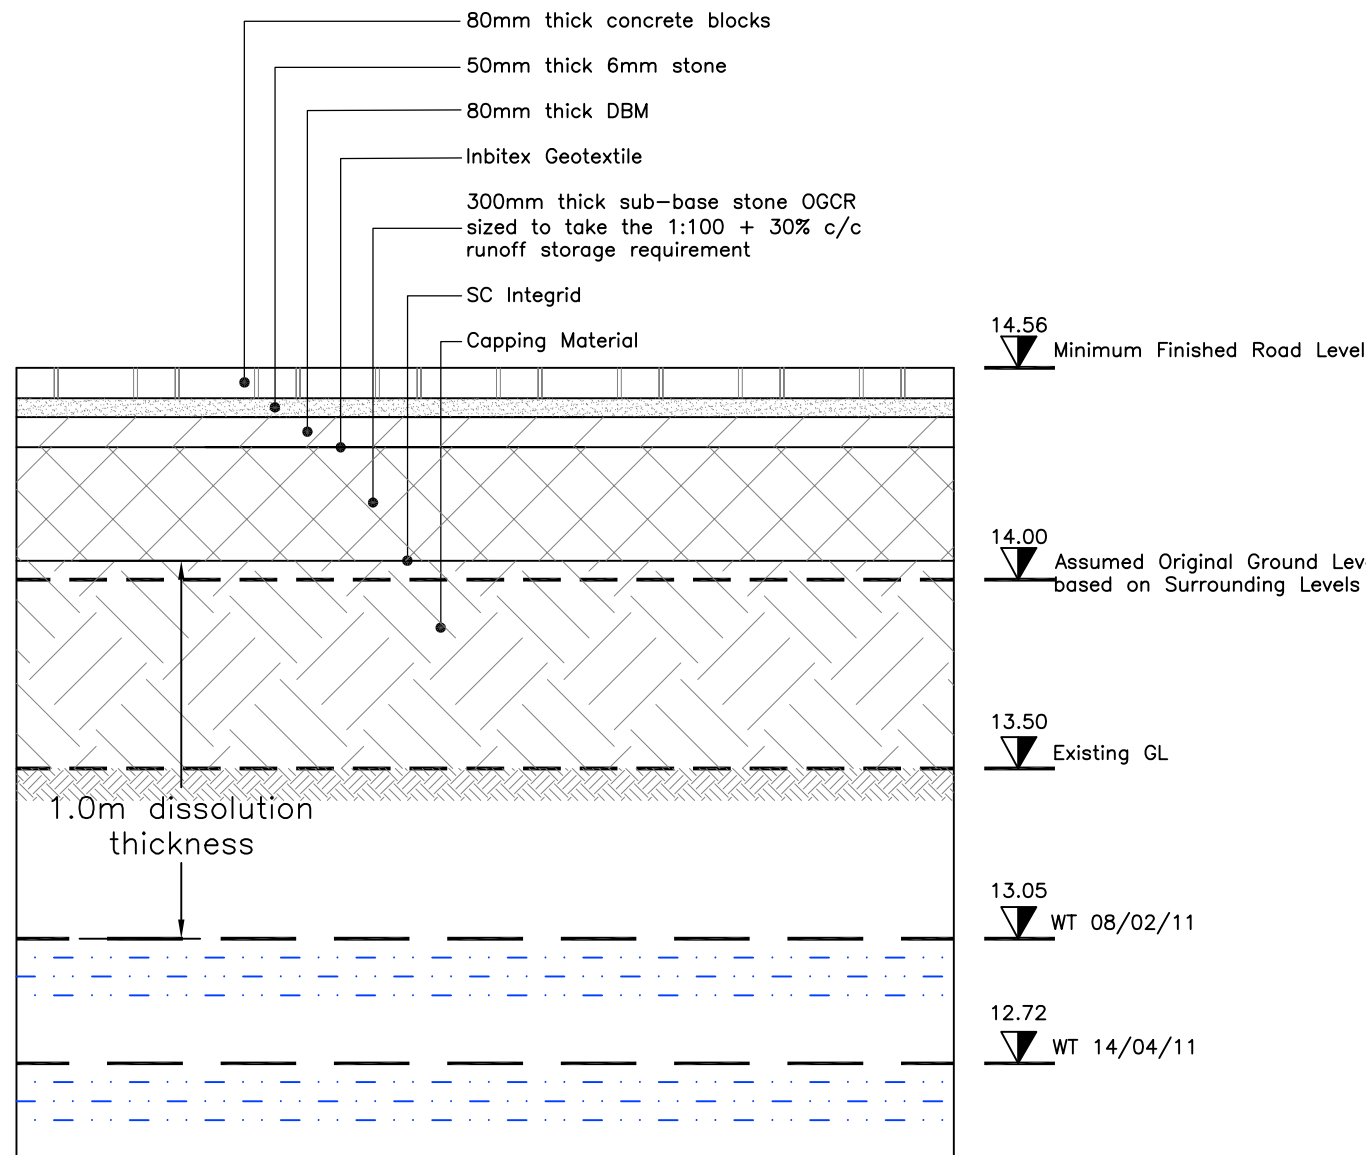
TYPICAL SECTION  
THROUGH BOREHOLE 4  
Scale 1:20

N.B. Borehole located in the low part of site in the area of the former brick works within fill material therefore water table possibly perched hence increased depth of cover required

| BOREHOLE LOGS | | | |
|---|---|---|---|
| BH4 | 13.50mAOD | 13.05m | 12.72m |
