**SOUTHLEIGH PARK HOUSE, EASTLEIGH ROAD, HAVANT, PO9 2PE**

**REMEDIATION STRATEGY**

**JULY 2025**

**Report No.**                        J25-046-R02

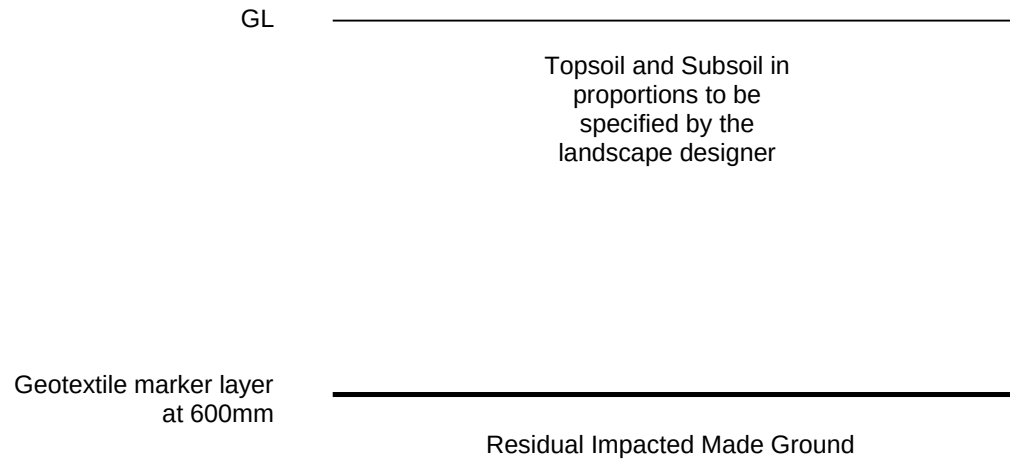
Cover System Diagram for Areas with Shrubs:

Where excavations into the existing Made Ground are required to create sufficient depth for the cover system to be installed, the geotextile is to be returned up the sides of the excavation to maintain separation between the imported cover material and the adjacent existing Made Ground.

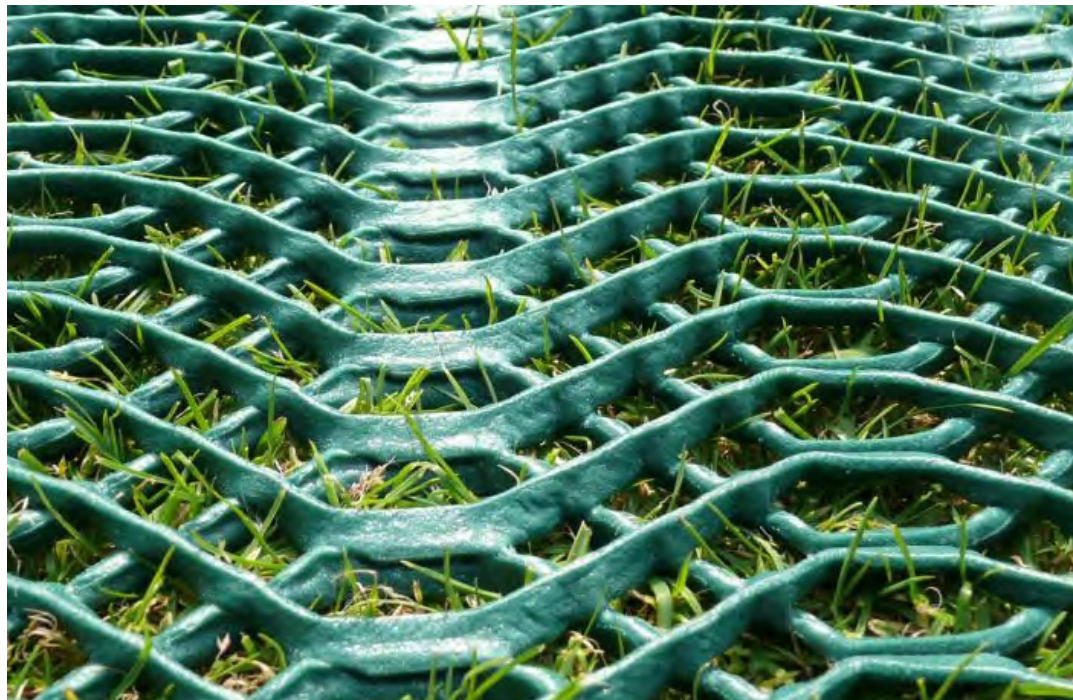
In areas of the proposed soft landscaping where residual Made Ground remains that overlap with the root protection areas (RPAs) of the remaining trees, it is not viable to install a 600mm thick cover system. These areas will therefore be laid to lawn with an underlying make up of 150mm of topsoil over a GR10 grass reinforcement mesh or similar over a permeable geotextile marker membrane (Terram Hi-Vis or similar).

The purpose of the reinforcement mesh is to create a thin permeable layer that will resist excavation and the permeable geotextile marker membrane will prevent soil mixing with the underlying Made Ground.

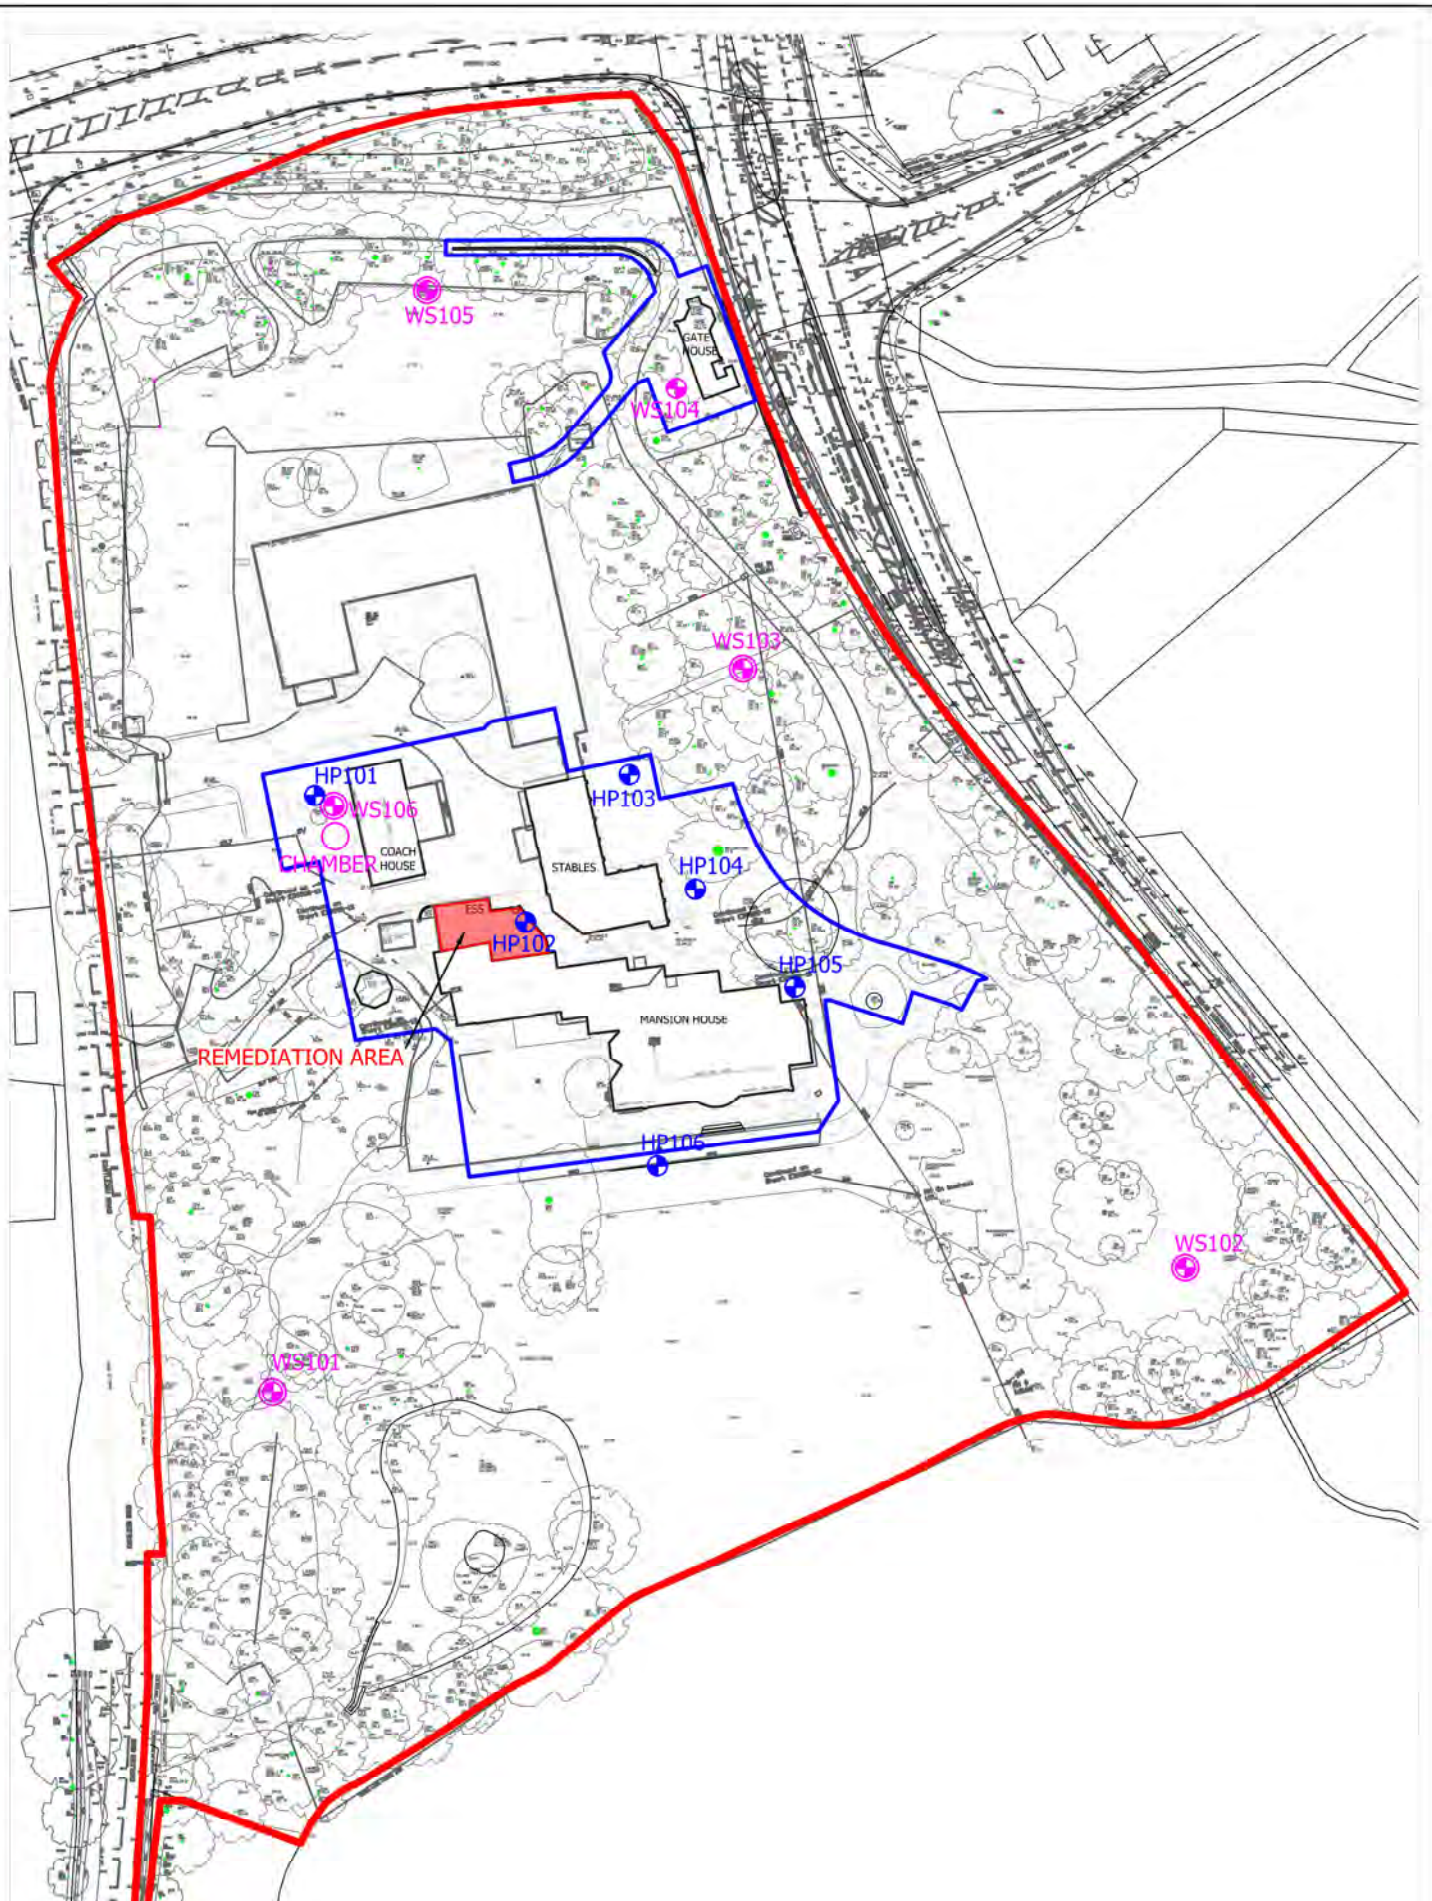
client BARGATE HOMES  
site SOUTHLEIGH PARK, HAVANT  
title REMEDIATION PLAN

**FIGURE 1: REMEDIATION PLAN**
