## Flood Risk Assessment and Drainage Strategy

**Hayling Golf Club, Ferry Road  
Hayling Island, Hants**

**Reference:** 24057

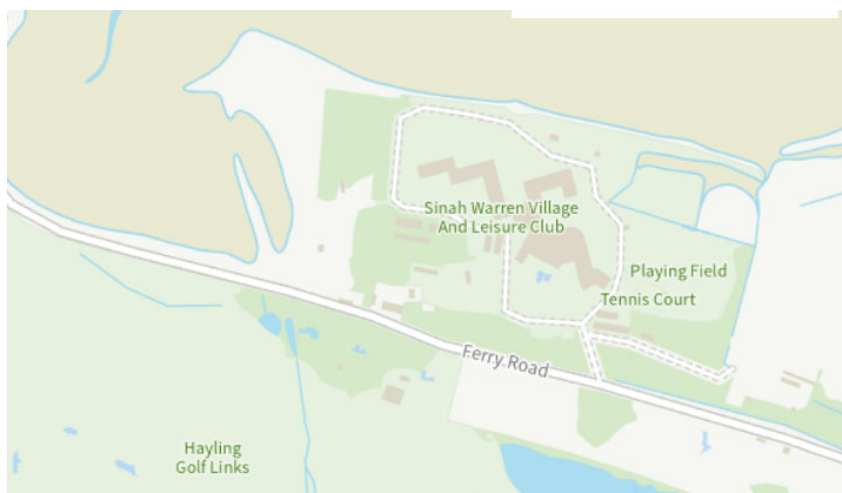
### Surface water flood risk

### Surface water

- ☒ Extent
- ☒ High risk  
More than 3.3% chance each year
- ☒ Medium risk  
Between 1% and 3.3% chance each year
- ☒ Low risk  
Between 0.1% and 1% chance each year

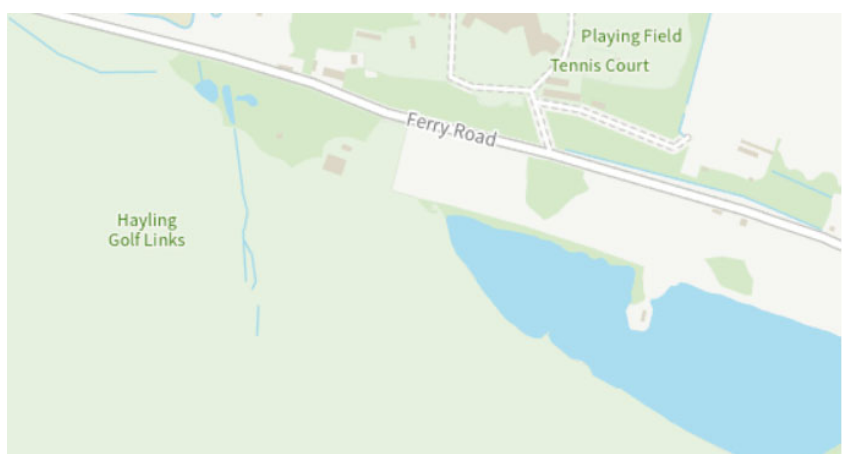
### Reservoirs

- ☒ Extent
- ☒ When river levels are normal
- ☒ When there is also flooding from rivers
